# Examination of the effect of aging process on marginal fit and fracture strength of temporary crowns prepared from different materials

**Aim:** The aim of this study is to investigate the effect of the aging process on the marginal fit and fracture resistance of temporary crowns prepared using different materials.

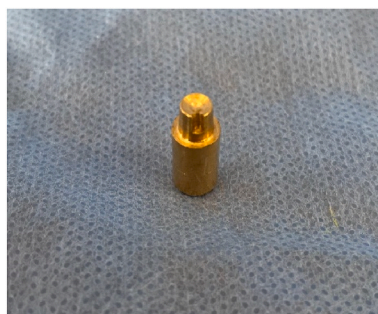
Fig. 1. Steel die used in the study.

The dies representing the prepared maxillary first premolar tooth, through which samples would be obtained, were prepared on a C turning machine (Space Turn LB2000, Okuma Corp, Japan) with 5 mm crown length and 6° taper angle with 1 mm chamfer finish line with anatomical occlusal surface in order to ensure standardization (Fig. 1).

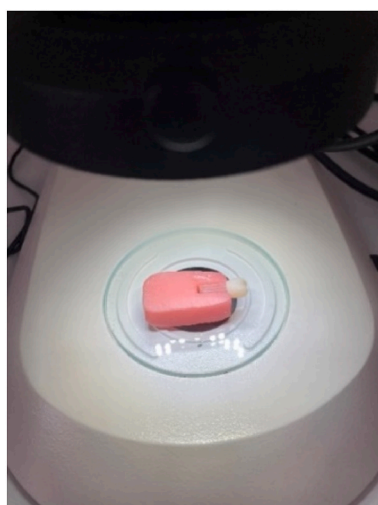
Fig. 4. Carrier mechanism prepared from autopolymerized acrylic resin.

In order to keep the samples in the same position during the evaluation of their marginal fit, a carrier was prepared from autopolymerized acrylic resin (Fig. 4).

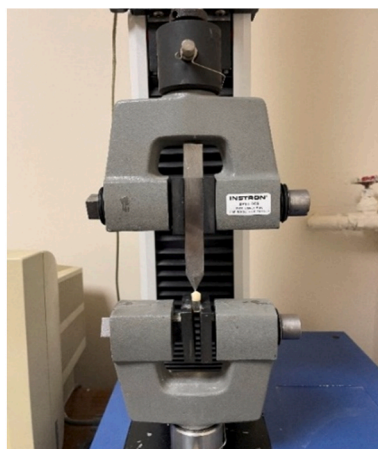
Fig. 6. Instron Universal tester.

Evaluation of fracture resistance was performed using Instron Universal tester (Instron Corp, USA) (Fig. 6). Temporary crowns were placed at a right angle on the tray designed to remain immobile during force application. Speed of Instron header was set at 1.5 mm/min and force was applied to the palatal tubercle of the crowns in a continuously increasing manner until the first fracture occurred. The data obtained were recorded in Newton (N) to the device's own software and data were statistically analyzed using Jamovi 2,2,5 statistical program (Sydney, Australia).

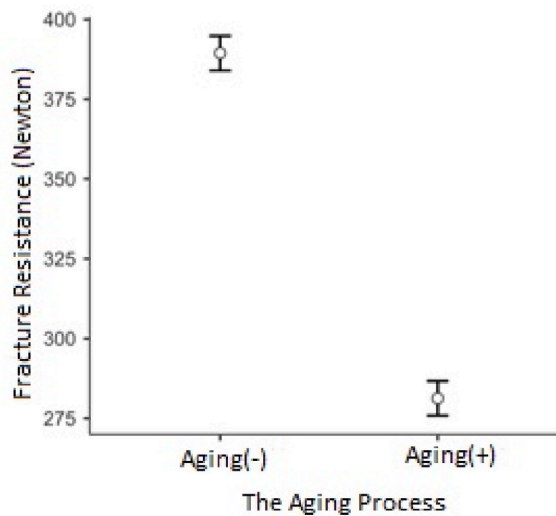
Fig. 17. Graphical representation of the fracture resistance values of aging and non-aging process temporary crowns, regardless of material type (95% confidence interval).

Regardless of the materials used, aged temporary crowns showed significantly ( $p < 0.001$ ) lower fracture resistance values compared to non-aged temporary crowns (Fig. 17, Table 8).
