CASE REPORT

Repair of left ventricular driveline tear in a SynCardia-total artificial heart patient

We report the case of a 64-year old Caucasian male patient with a tear of the left ventricular driveline just above the driveline-air tube junction. We describe the repair technique and the necessary set of tools.

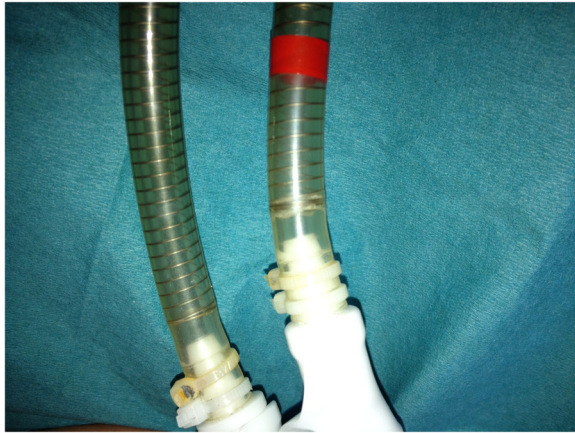
uneventful. The patient was switched to the Freedom driver and was discharged at home. The patient was re-admitted at postoperative day 172 due to progressive exertion intolerance caused by an air leak at the left ventricular driveline. Radiology showed mid-severe pulmonary congestion. Upon inspection, we noted a small horizontal tear above the connection of the driveline to the air tubes (Figure 1). After cutting through both cable ties that secure the drivelines with the connectors using a Xcelite 170 M general purpose shear cutter (Apex tool group, Sparks, MD, USA) (Figure 2) we cut off the left driveline slightly above the location of the tear with a high leverage cable cutter (Klein Tools, Lincolnshire, IL, USA) (Figure 3) and quickly switched the patient to a Companion Driver operating in a standard Intensive Care Unit Mode. The whole procedure was completed in approximately 5 minutes. Throughout the procedure the patient showed no clinical signs such as syncopal spell. Two days later the patient recompensated fully. He was switched to a Freedom Driver and discharged at home. Mechanical support of the patient is still ongoing.

Figure 1 Small horizontal tear at the left ventricular driveline.

intolerance. Therefore it is important to identify and repair quickly the defect. Other currently available repair techniques include banding the driveline with a silicon tube [3] or sealing it with cyanoacrylate adhesive. However this is only a provisory repair. Since the U.S. Food and Drug Administration (FDA) has approved a Humanitarian Use Device (HUD) designation for the SynCardia temporary Total Artificial Heart to be used for destination therapy in patients not being eligible for transplantation [4] and since the durability of the driveline could limit successful long-term support [5], the aim should be to definitively repair any driveline defect. As in this case, the repair can be easily facilitated by cutting the driveline at the location of the tear and reconnecting to the air tubes. During repair

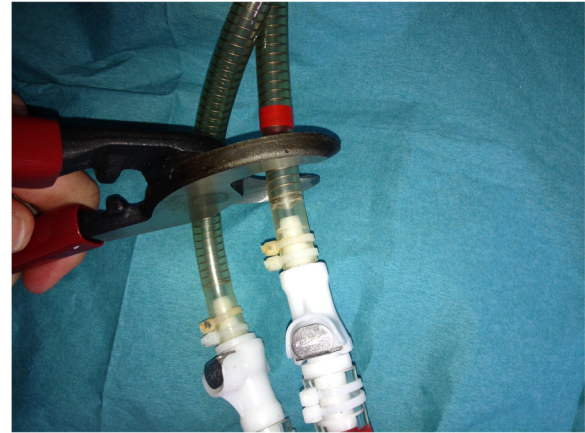
Figure 3 Cutting off the left driveline with the high leverage cable cutter.

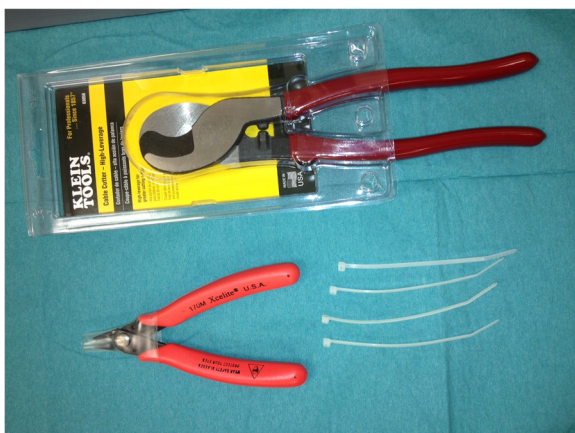
Figure 2 Set of tools: Xcelite 170 M general purpose shear cutter (Apex tool group, Sparks, MD, USA), high leverage cable cutter (Klein Tools, Lincolnshire, IL, USA), cable ties.
