# A Case Report of Metallosis With a Failed Distal Femur Plate

**Categories:** Orthopedics

**Keywords:** metallosis, distal femur locking plate, distal femur nonunion

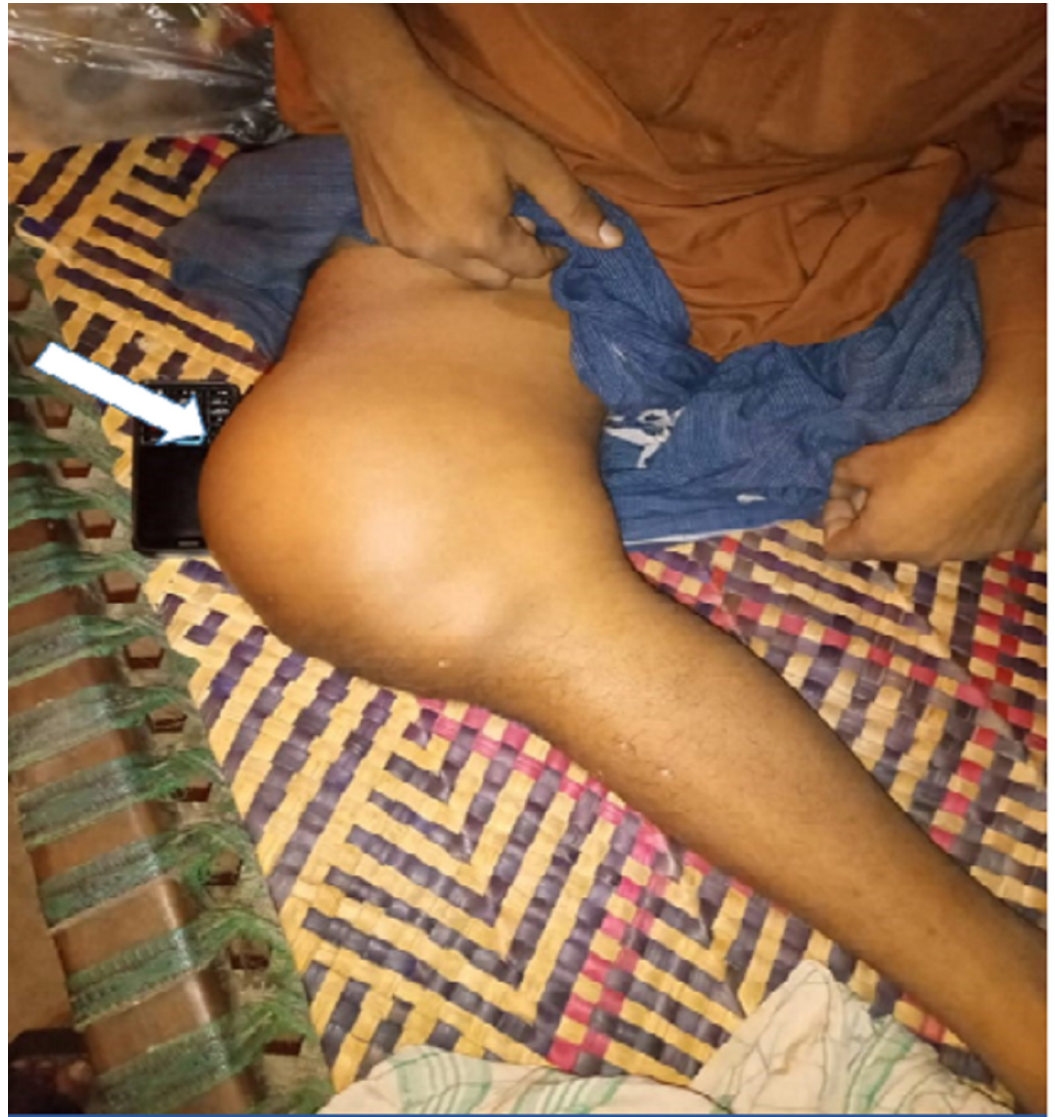
A thorough physical examination revealed swelling around the distal thigh with the right leg placed in flexion; the overlying skin was normal with visible veins (Figure 1). The swollen area was non-tender, fluctuant, and measured 10 × 15 cm in size.

**FIGURE 1: Examination showing the swelling around the right distal femur (white arrow) and around the knee joint measuring 10 x 15 cm in size.**

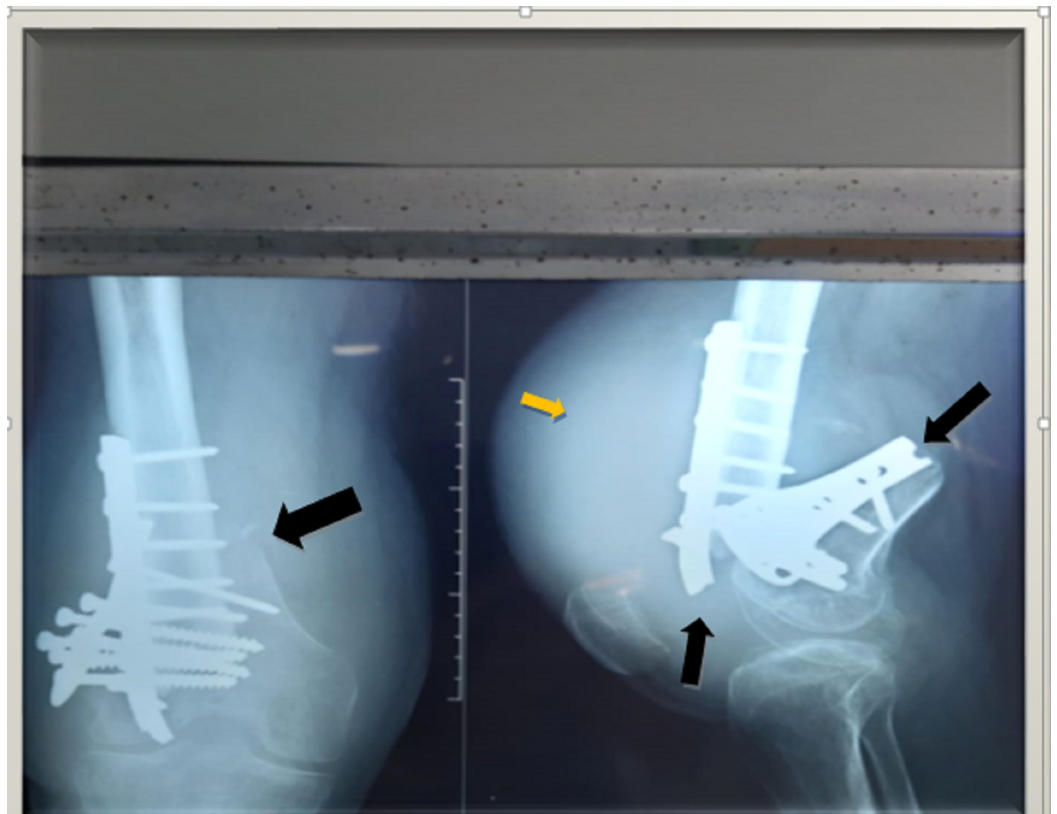
The patient's blood workup came back normal. Radiographs were done, which showed a failed plate (distal femur condylar plate) and breakage of the implant (Figure 2). A diagnosis was made of implant failure with non-union secondary to a distal femoral fracture of the right side. The patient was then told about his condition and was thoroughly counseled regarding the need for surgical exploration, to which he consented.

**FIGURE 2: X-ray on the right shows the right distal femur in AP view, revealing implant breakage with a fracture of the femur (black arrow). The image on the left shows a lateral view of the right-sided distal femur, clearly revealing an implant breakage (black arrows) along with soft tissue swelling (yellow arrow).**

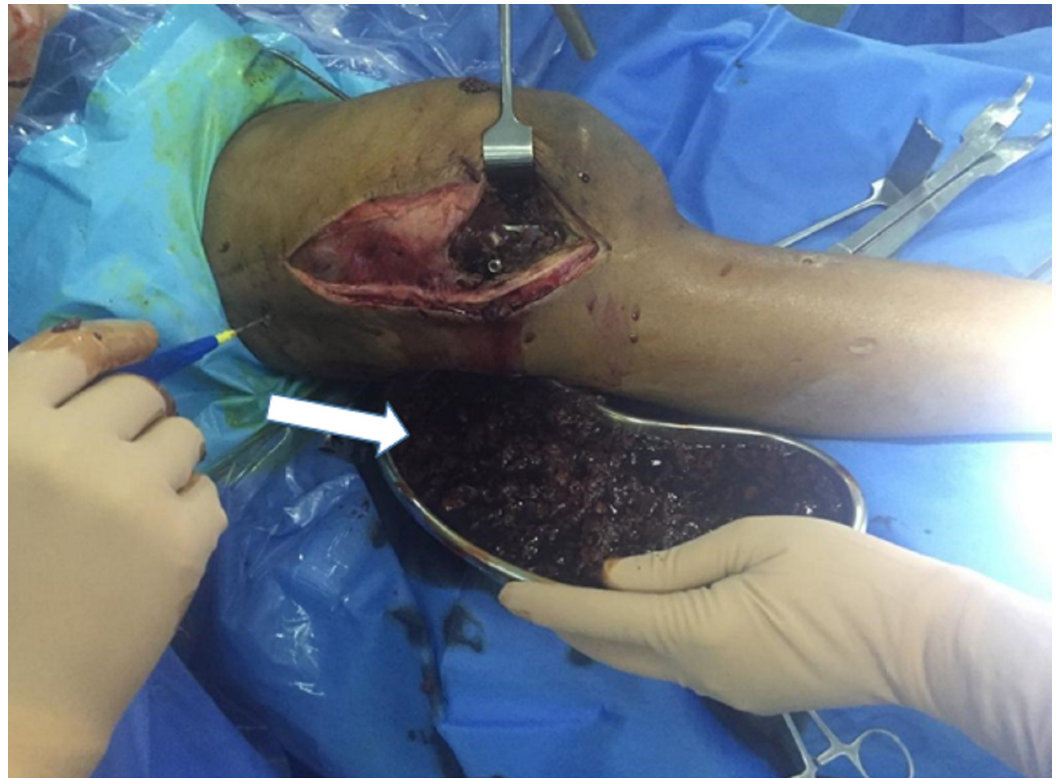
Surgery was conducted using a lateral approach. Once the incision was made, bloody, dark, dirty-colored thick material continuously drained out (Figures 3, 4). As a result, metallosis was suspected, and the collected material was sent for histopathology and detailed report (D/R).

**FIGURE 3: A lateral incision approach to the distal femur. Upon incision, there was drainage of turbid material (white arrow), which confirmed the diagnosis of primary metallosis (even though no metal on metal movement was present).**

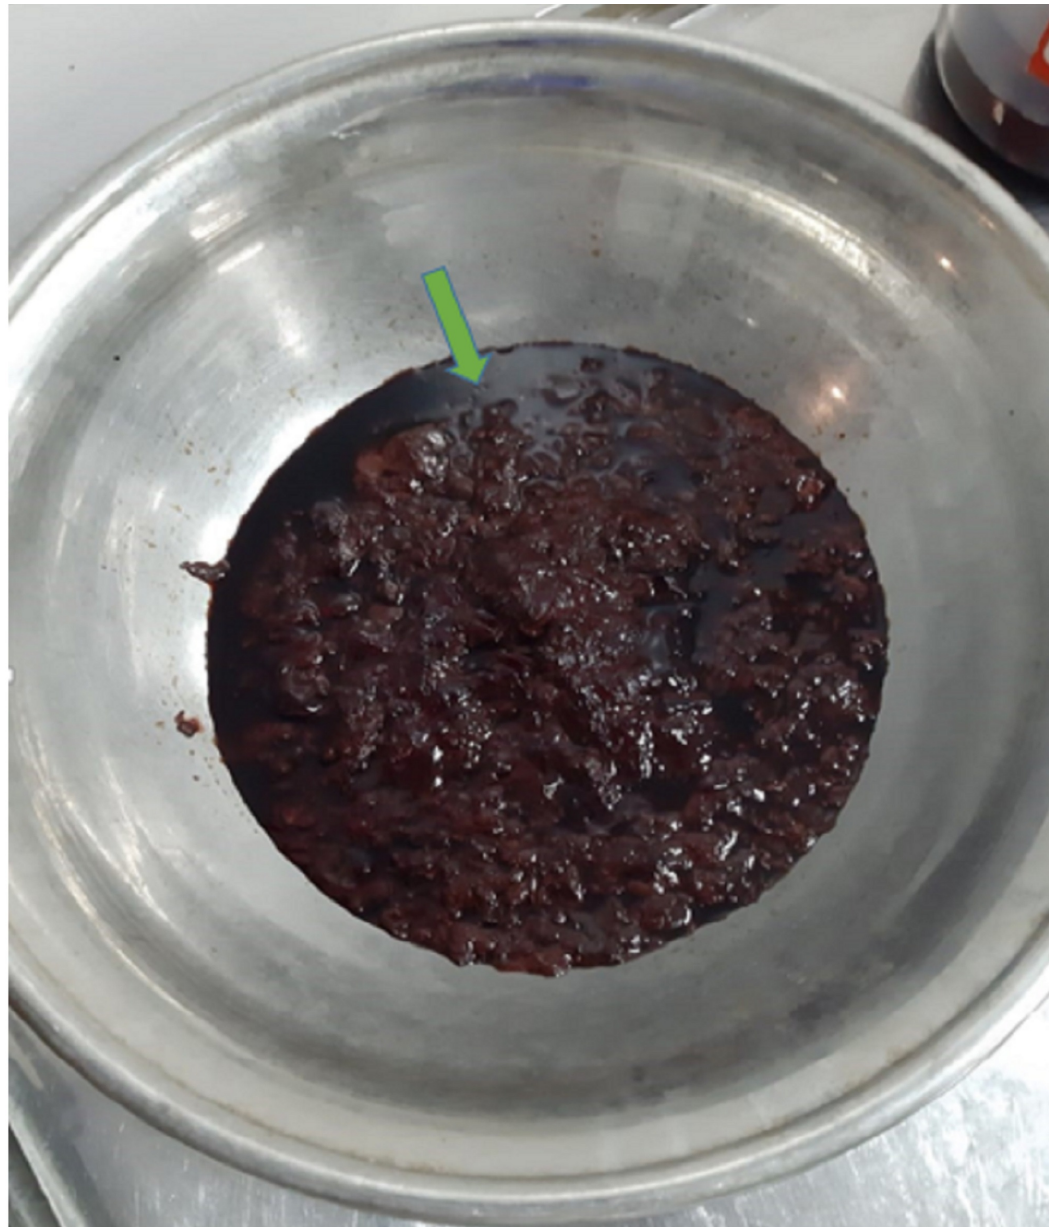
**FIGURE 4: Collection of thick, dirty-colored material (green arrow) drained during operative procedure.**

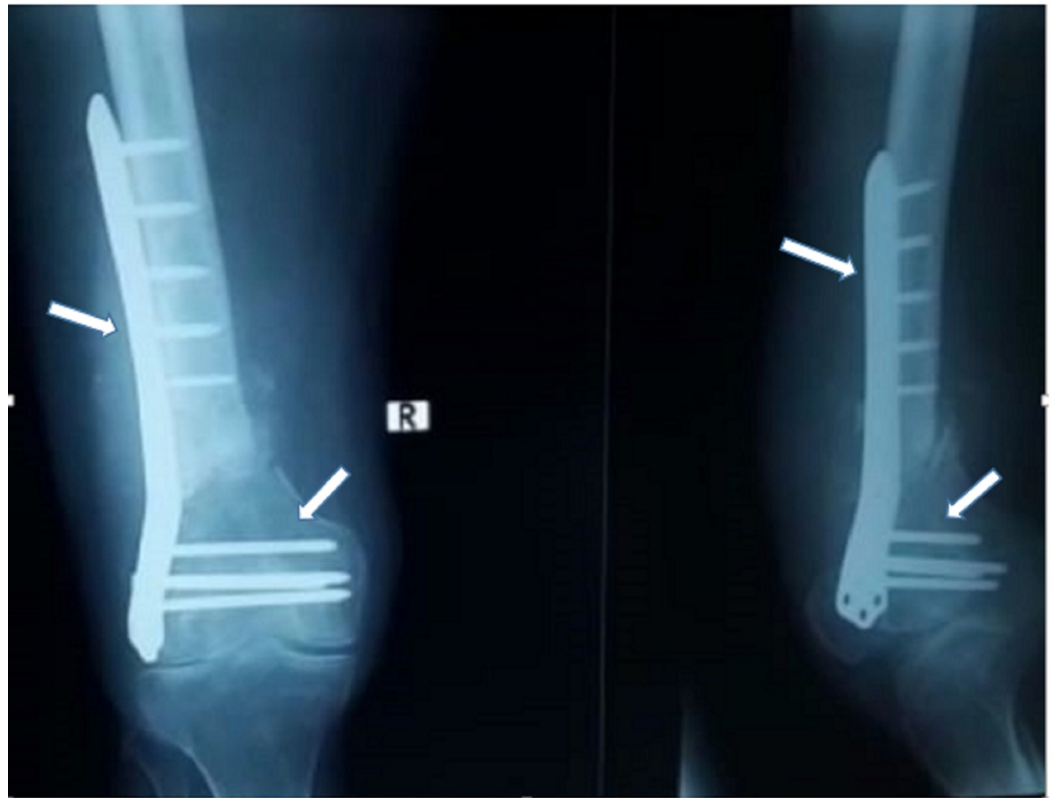
**FIGURE 5: Lateral view (on right side of picture) and PA view (on left side of picture) X-rays of right distal femur showing well-reduced and aligned distal femur fracture after the surgical procedure with locking plate insertion (white arrows) and debridement of necrotic material.**

The fracture was identified, the broken plate was removed, and thorough wound debridement was completed. The fracture was then reduced and fixed using a distal femur locking plate and a bone graft. The wound was closed in layers, and the stitches were removed after two weeks. Gradual knee movements were allowed as tolerated. Follow-ups were conducted every two weeks, and the patient was allowed to bear partial weight after six weeks and full weight after 12 weeks. Subsequent X-rays were done to document the signs of the union, which showed sclerotic changes at the fracture site signifying primary healing, as the locking plate was inserted in compression mode (Figure 5). The patient was able to gain a full range of movement at four months' duration.
