Novel Use of Echo Fusion and Cardiac Computed Tomographic Imaging Guidance for Percutaneous Paravalvular Leak Closure

Lucy M. Safi, DO, FASE, FACC, Vladimir Jelnin, MD, Ruchir Patel, MD, Kevin Oguayo, MD, Tilak K. R. Pasala, MD, and Carlos E. Ruiz, MD, PhD, FACC, FESC, MSCAI, Hackensack, New Jersey

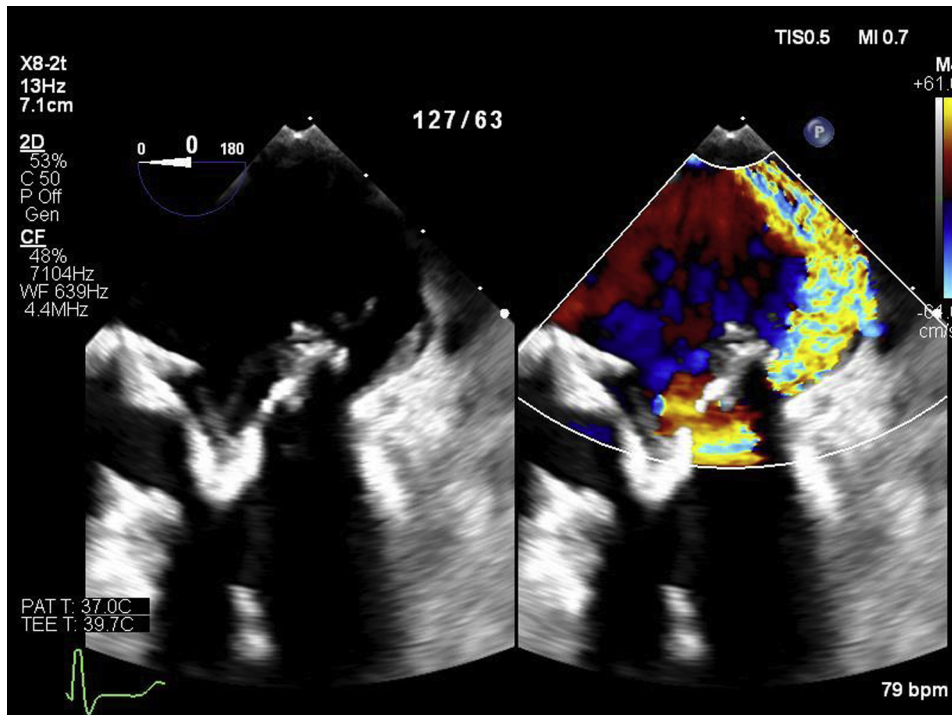
Figure 1 TEE color-compare images showing the severe PVL located at the posterolateral aspect of the prosthesis at a normotensive blood pressure.

The patient underwent transthoracic echocardiography, which showed eccentric, moderate to severe mitral regurgitation by color Doppler, mild tricuspid regurgitation, and estimated pulmonary artery pressure of 60 mm Hg (assuming a right atrial pressure of 3 mm Hg). TEE imaging showed a normally functioning bioprosthetic valve with trivial mitral valvular regurgitation and a severe PVL from the posterolateral aspect of the mitral prosthesis ([Figure 1](#), [Video 1](#)).

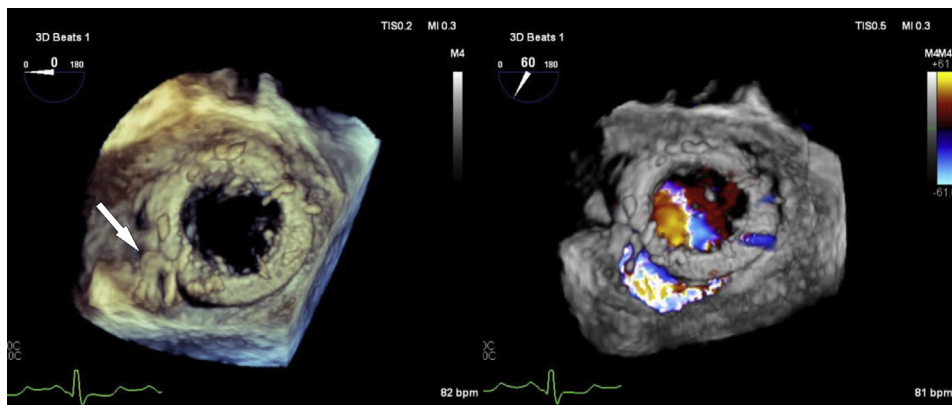
Figure 2 Three-dimensional TEE imaging of the mitral valve prosthesis in surgical view showing disruption of surgical sutures (*left, arrow*) and color Doppler seen through the PVL (*right*) located between 6 and 8 o'clock.

The etiology of the PVL was thought to be related to suture material dehiscence. There was no evidence of valvular "rocking" or vegetations. The PVL was located from 6 to 8 o'clock in the en face surgical view ([Figure 2](#)), measuring 1.3 × 0.5 cm in size ([Figure 3](#)).

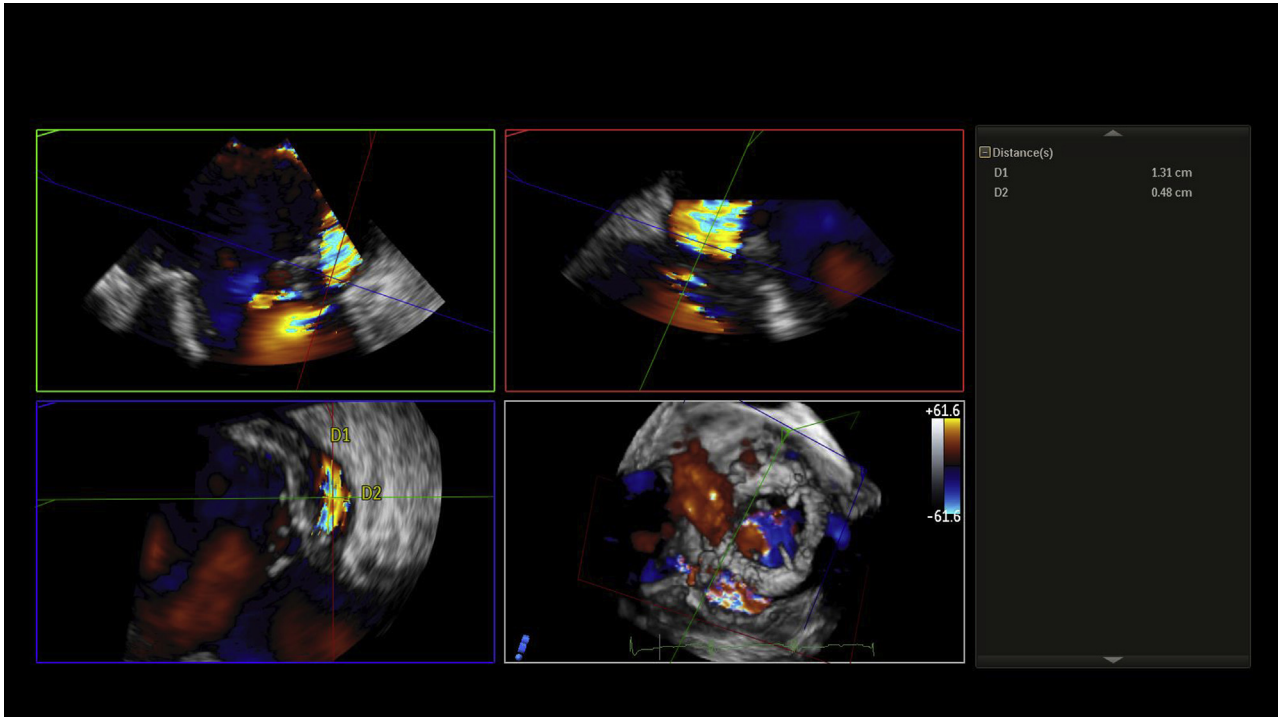
Figure 3 Measurement of the PVL using multiplanar reconstruction.

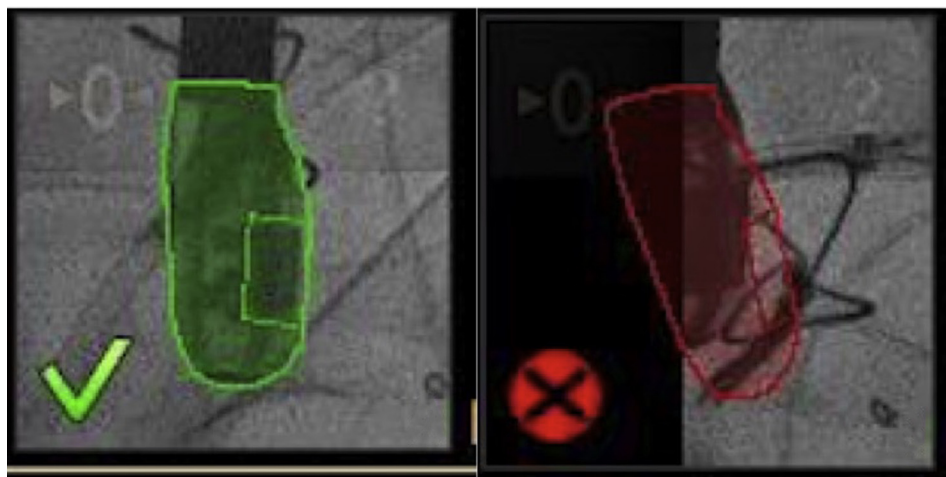
Figure 4 EchoNavigator image showing that the probe is coregistered with fluoroscopy (*left*) and not coregistered (*right*).

EchoNavigator software was completed. Coregistration allows localization of the TEE probe in fluoroscopic space (Figure 4). After successful coregistration, movement of the C-arm or the TEE probe will update the real-time overlay on fluoroscopy.

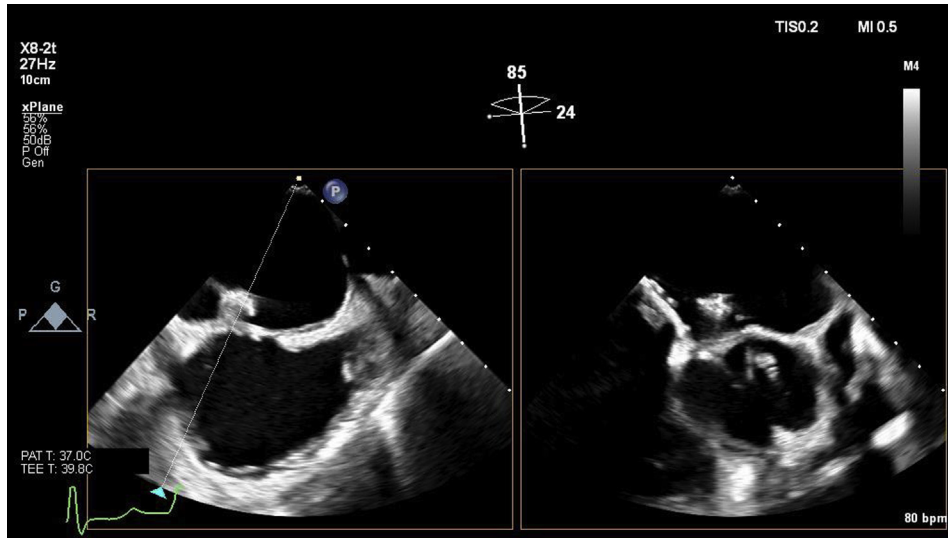
Figure 5 Biplane imaging showing transseptal puncture in the inferior aspect of the atrial septum.

A marker was placed at the ideal transseptal puncture site using EchoNavigator software. Biplane imaging was used to follow the transseptal needle to the appropriate location on the atrial septum for puncture (Figure 5).

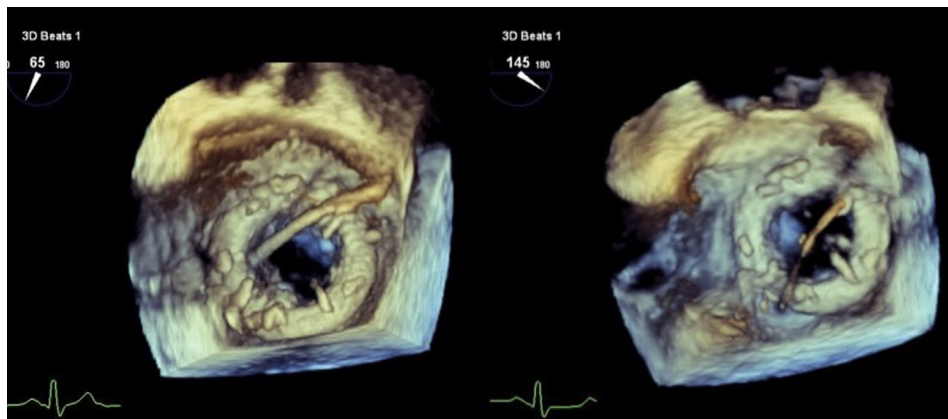
Figure 6 Intraprocedural 3D TEE imaging showing a wire across the mitral valve prosthesis (left) and a wire across the PVL (right).

After transseptal access was obtained, a soft Glidewire (Terumo Medical, Somerset, NJ) and angled catheter were used to cross the PVL. Three-dimensional TEE imaging was used to help guide the

wire through the PVL and not through the mitral valve prosthesis (Figure 6).

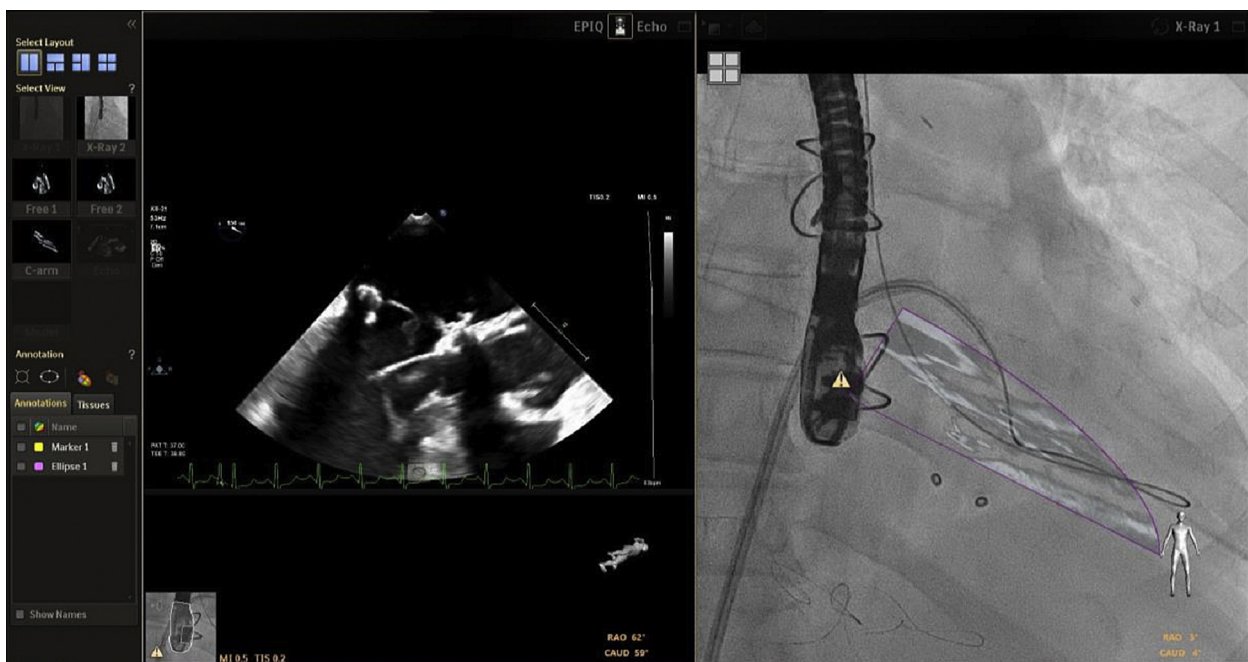
Figure 7 TEE image (left) and echo fusion image (right) showing wire across the PVL looping in the left ventricle and exiting into the aorta, creating a “rail.”

The wire was passed through the PVL, looped in the left ventricle, and out the aorta to create a "rail" for stability (Figure 7).

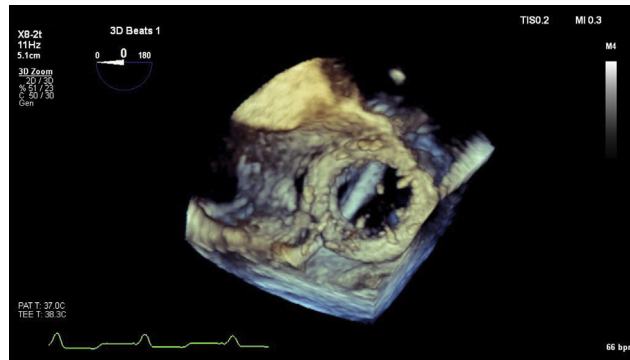
Figure 8 Intraprocedural 3D TEE imaging showing the catheter across the PVL from the surgical view.

The catheter was advanced into the PVL (Figure 8), but despite the "rail" created previously, the serpiginous track of the PVL lead to instability of the delivery catheter inside the PVL, and the procedure was converted to transapical access for better stability of the catheter system.

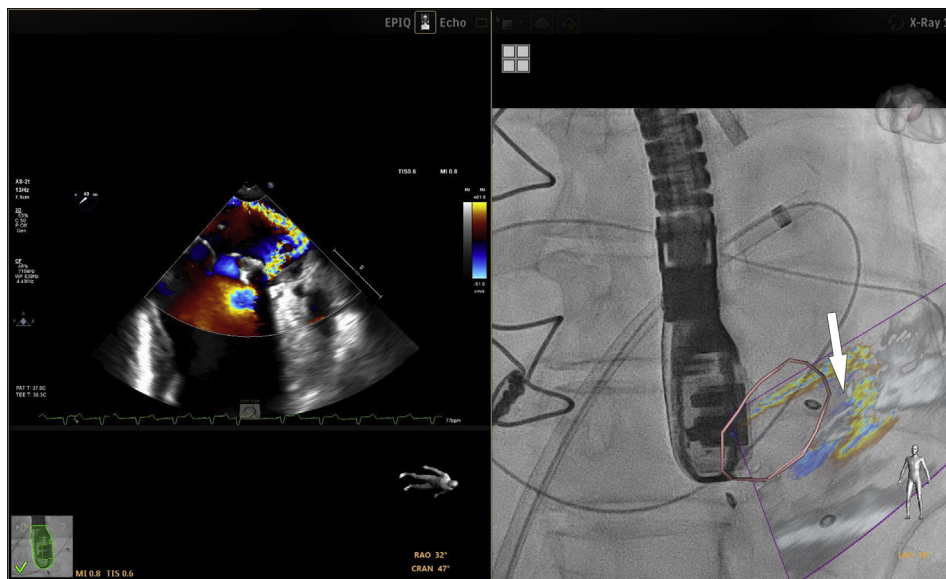
Figure 9 TEE imaging (*left*) showing severe PVL by color Doppler. Echo fusion images (*right*) showing the sheath across the atrial septum and origin of the PVL (*arrow*).

using HeartNavigator software allowing localization of the CT images in fluoroscopic space. Both echo fusion (Figure 9) and CT fusion (Figure 10) images were displayed simultaneously on separate screens to help guide the interventionalist during the transapical access.

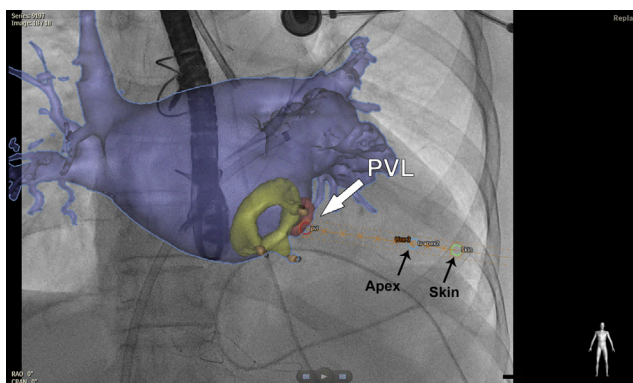
Figure 10 Gated cardiac CT image using HeartNavigator software showing recommended rib space and angle of approach for transapical access.

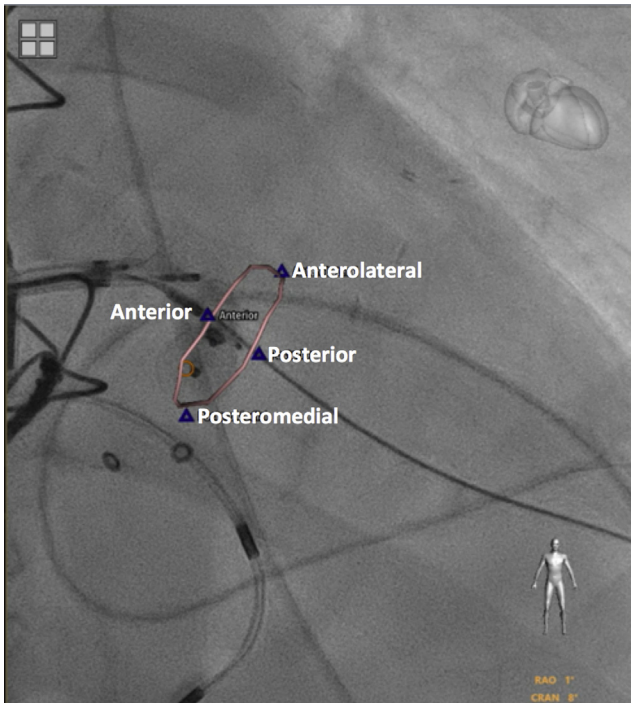
Figure 11 Portions of the mitral valve annulus labeled using EchoNavigator software.

The mitral valve annulus was labeled for orientation using EchoNavigator software (Figure 11).

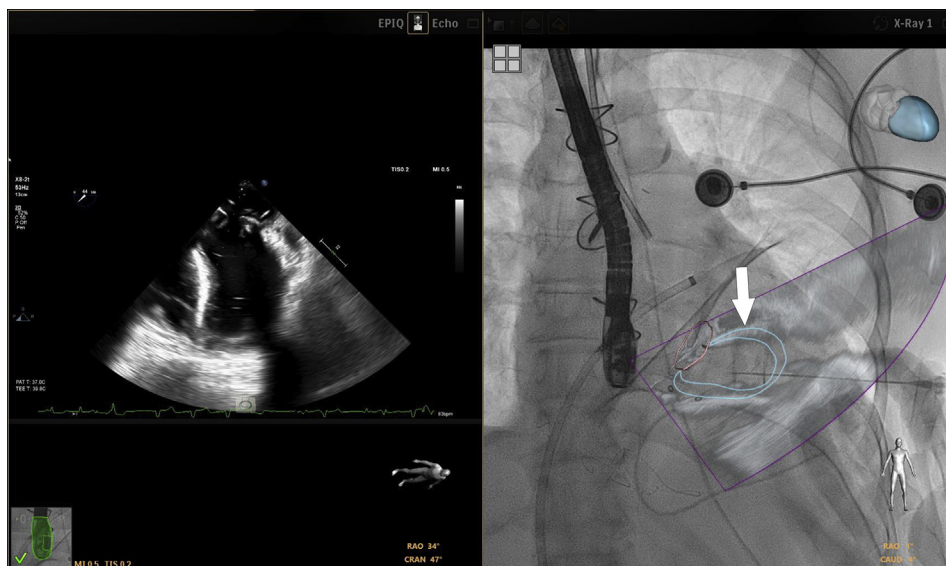
Figure 12 Echo fusion images in which the left ventricular endocardium (arrow) is outlined using EchoNavigator to help guide transapical puncture.

The correct rib space and angle of approach were identified, and a micropuncture needle was advanced into the left ventricle (Figure 12).

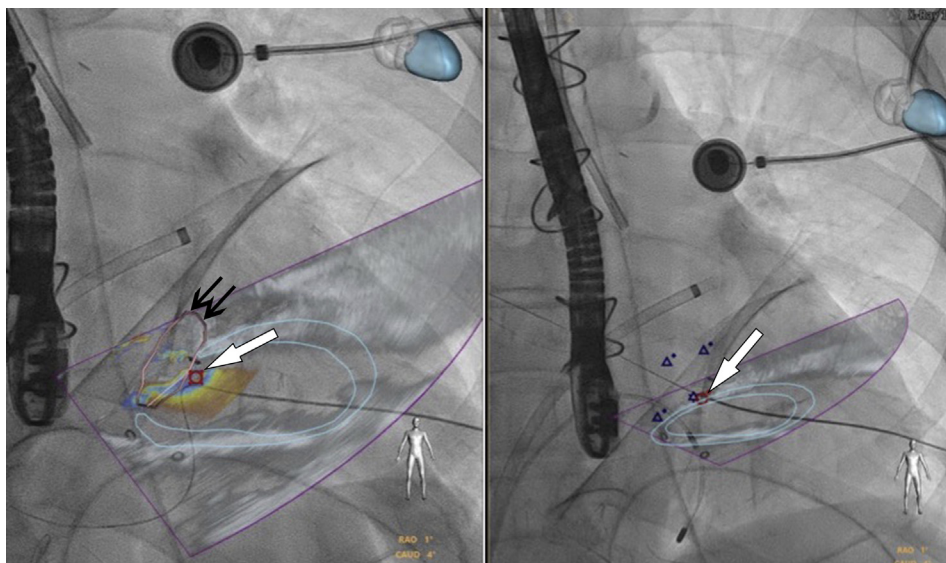
Figure 13 Echo fusion images showing (left) the outlined left ventricular endocardium and color Doppler to locate the PVL. A red marker (open circle) was placed at location of the defect using EchoNavigator software. (Right) A wire is seen passing at the location of the marker and into the PVL. Arrow indicates origin of PVL; double arrow indicates mitral valve annulus.

Using EchoNavigator software, a virtual marker was placed at the location of the PVL. A Neff wire (Cook Medical, Bloomington, IN) was passed through the micropuncture needle and guided through the PVL using TEE guidance (Figures 13 and 14).

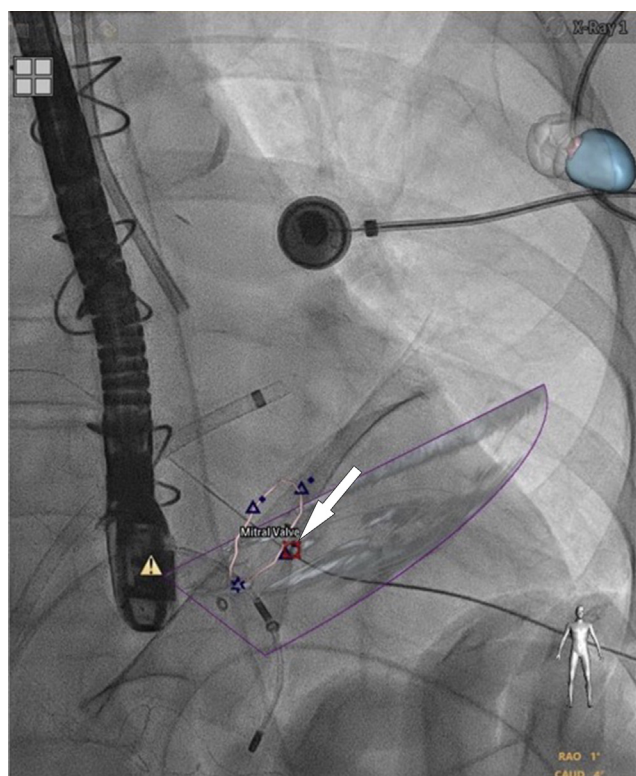
Figure 14 Echo fusion images in which the mitral valve annulus is marked (triangle) and a red marker (open circle) was placed at the origin of the PVL (arrow) using EchoNavigator software.

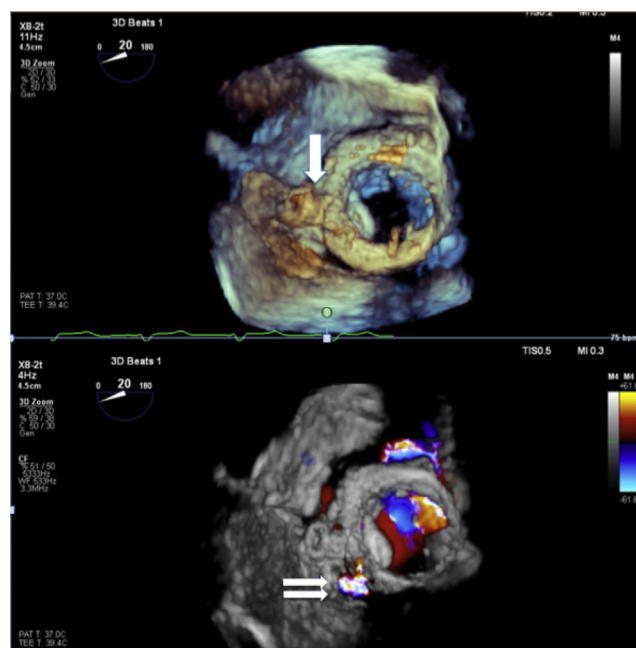
Figure 15 Three-dimensional TEE image of the PVL after placement of two Amplatzer Vascular Plug (AVP) II devices and one AVP IV (top, arrow) and trace residual PVL noted on color Doppler (bottom, double arrow).

A micropuncture catheter was then advanced over the wire into the left atrium. The wire was exchanged for a 260-cm Glidewire, which was snared through the transeptal sheath and exteriorized out into the femoral vein, creating an atrioventricular rail. Then a TorqVue delivery catheter (St. Jude Medical, St. Paul, MN) was advanced from the femoral vein across the PVL, and two Amplatzer Vascular Plug II (8 and 10 mm) devices and an Amplatzer Vascular Plug IV (8 mm) were advanced and deployed across the PVL (Video 2). Residual PVL was evaluated and determined to be trace to mild (Figure 15).

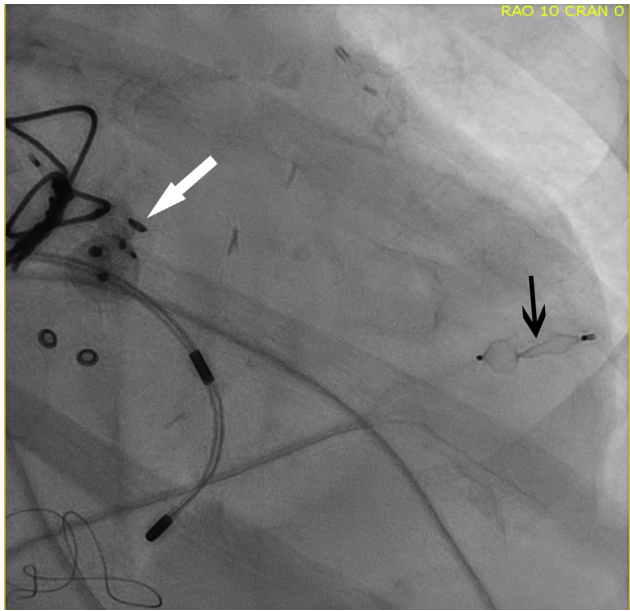
Figure 16 Fluoroscopic image showing closure of the left ventricular (LV) access site with an Amplatzer Vascular Plug (AVP) IV in the left ventricular apex. *Black arrow* indicates AVP IV closing LV apex access. *White arrow* indicates AVP II and AVP IV at the location of the PVL.

Transapical access was closed using an Amplatzer Vascular Plug IV and Surgiflo Hemostatic Matrix Kit (Johnson & Johnson, New Brunswick, NJ; Figure 16).

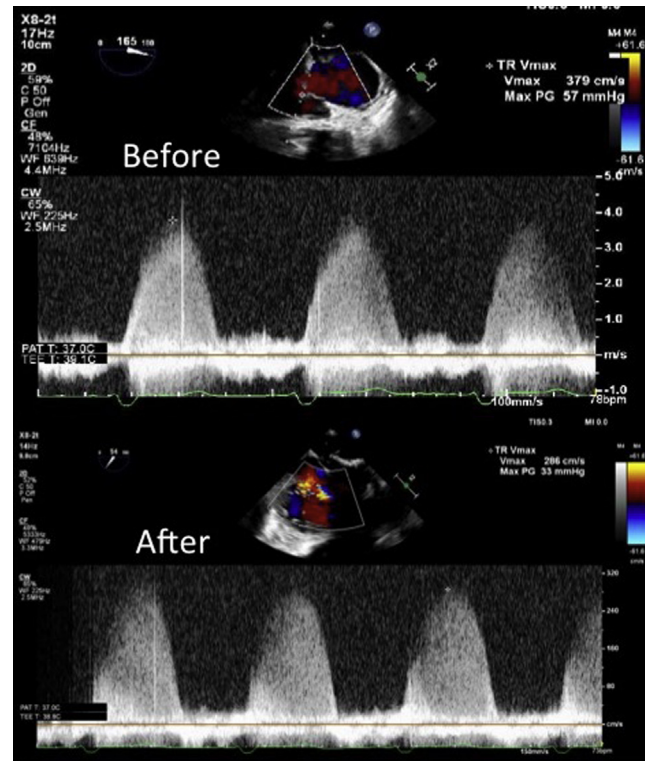
Figure 17 Reduction of estimated pulmonary artery systolic pressure was seen at the end of the procedure.

Improvement of estimated pulmonary artery systolic pressure (using peak tricuspid regurgitation velocity by Doppler) was seen, suggestive of improved hemodynamics (Figure 17).
