Case Report

Fracture of the Neck of a Modern Cementless, Titanium Femoral Stem

Emmanuel Gibon, MD, PhD^{*}, Justin T. Deen, MD

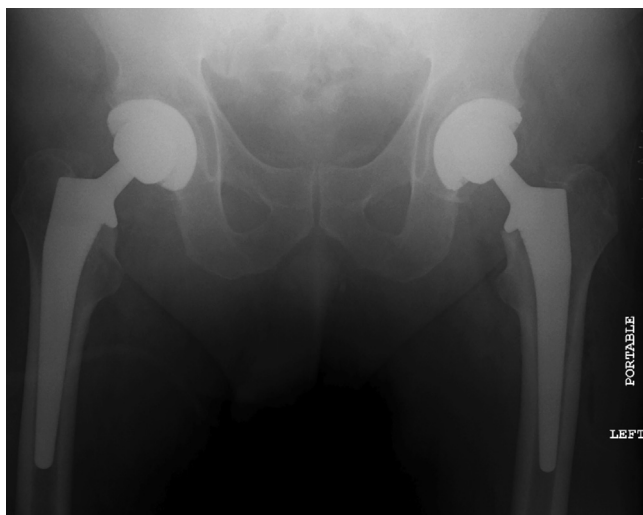
Figure 1. Anteroposterior view of the pelvis before failure. The left THA was performed in 2012.

A 68-year-old gentleman presented to our institution for evaluation of acute left hip pain, having previously undergone an uncomplicated left THA in 2012 via a direct anterior approach (Fig. 1).

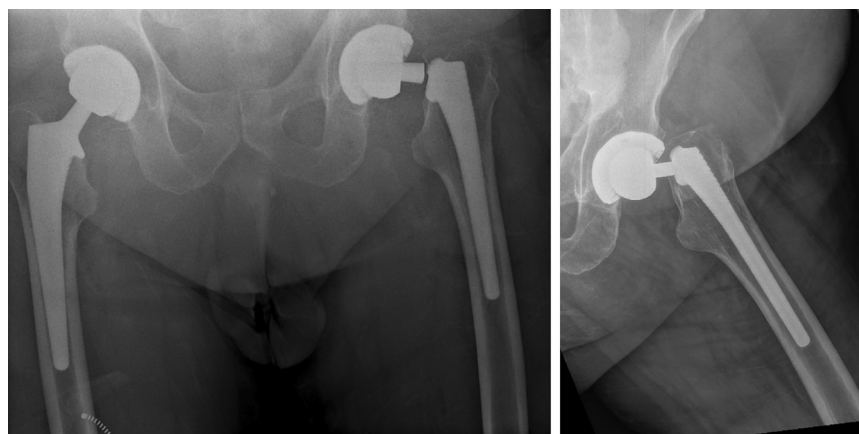
His plain radiographs showed a fracture of the midportion of the prosthetic femoral neck in an otherwise well-fixed Corail stem (Fig. 2).

Figure 2. Anteroposterior view of the pelvis (left) and lateral view of the left hip (right) at the time of the failure. Note the fracture of the midportion of the prosthetic femoral neck.

To conclude, as this is the first report of such a complication, our assumption is that this may be an isolated microscopic defect in the manufacturing, intrinsic integrity of the stem itself, or intergranular corrosion as was previously reported in other stems. Although the prosthesis was not evaluated microscopically, it was reported to the manufacturer.

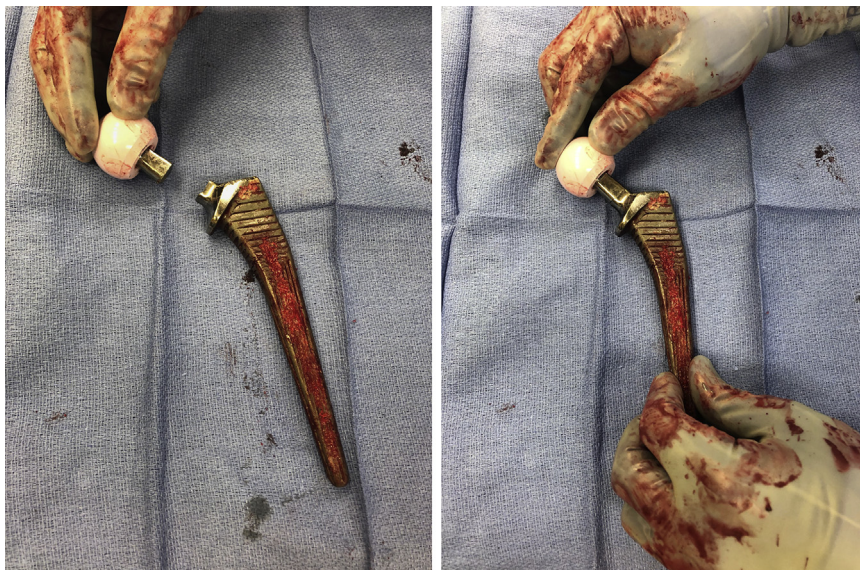
Figure 3. Intraoperative pictures of the broken stem. The midportion of the neck is broken with a transverse pattern.

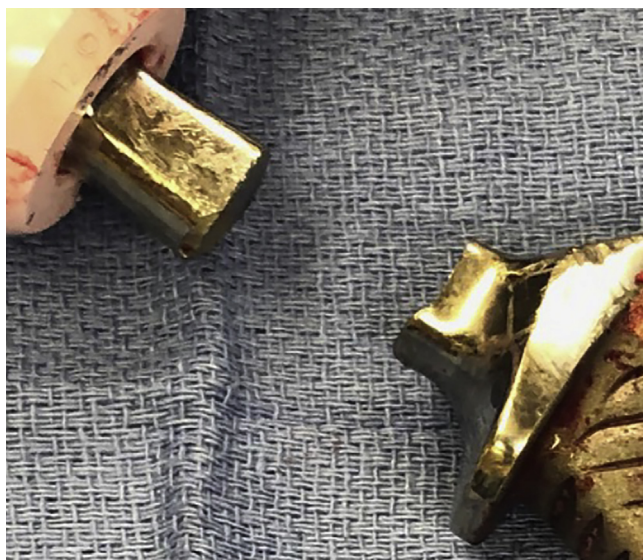
Figure 4. Zoomed-in view of the area of neck fracture.

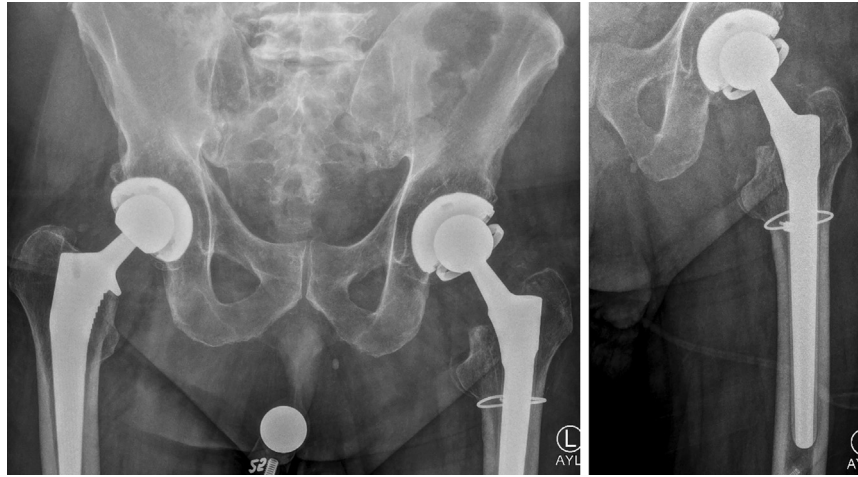
At the 6-week clinical follow-up, the patient was noted to be doing well with no changes in his radiographic examination (Fig. 5). His incision healed uneventfully, and his intraoperative cultures showed no growth.

Figure 5. Anteroposterior views of the pelvis and the left hip at 6 weeks after the revision surgery.

The femoral reconstruction was performed using a non-modular titanium tapered-fluted femoral component (Wagner SL femoral stem; Zimmer Biomet, Warsaw, IN) and a 36/+7mm Biolox delta ceramic head (Zimmer Biomet). A 36-mm constrained liner (ESc; DePuy) was also used in the setting of his complete hemiparesis.
