Article

Improving the Corrosion Resistance of Wrought ZM21 Magnesium Alloys by Plasma Electrolytic Oxidation and Powder Coating

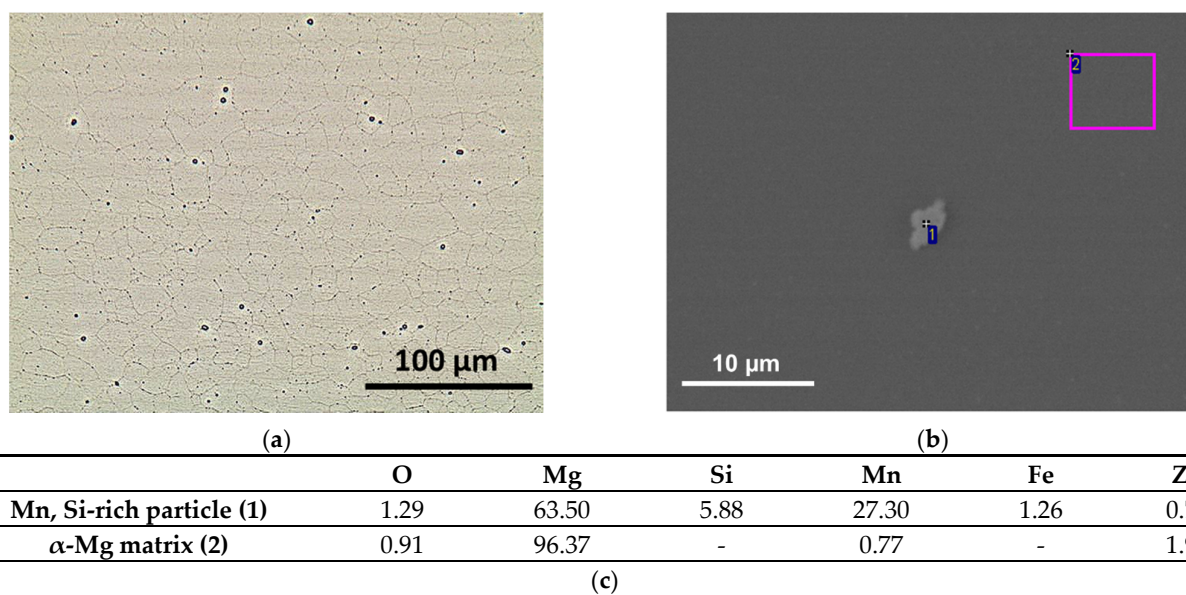
Figure 1. Microstructure of the ZM21 substrate: (a) optical image and (b) higher magnification SEM image with (c) EDS analysis (wt.%) of the unetched alloy.

Optical and SEM images showing the microstructure of the ZM21 alloy are shown in Figure 1a,b: a fully recrystallized microstructure was observed in the plane perpendicular to the extrusion direction. Equiaxed grains displayed an average size of $9 \pm 5 \mu\text{m}$ and a bimodal grain size distribution was observed, consisting of both relatively coarse grains ($15 \pm 4 \mu\text{m}$) and fine grains ($3 \pm 1 \mu\text{m}$), as already reported by other authors for ZM21 after extrusion [26]. Relatively small Mn,Si-rich particles ($<5 \mu\text{m}$, as shown by high magnification SEM image in Figure 1b, accompanied by localized EDS analysis results, Figure 1c) were also detected in the α -Mg matrix (with Zn and Mn in solid solution, as indicated by EDS data in Figure 1c). Mn,Si-rich particles also contained Fe, a common impurity in Mg alloys. Similar observations were reported for the same alloy in the extruded condition, also by Bian et al. [6]. The formation of the Zn-rich β phase was not observed, due to the balance between Zn and Mn in the alloy [27].

The small Mn,Si-rich particles described in Section 3.1 (Figure 1b) do not appear to have any significant influence on the overall growth of the PEO layer at this scale, and the ZM21 alloy basically responds to oxidation as a single phase material. As for the elements from the electrolyte, elemental maps show that Na-rich species are mostly located in the outer areas of the coating, while Si and P are more homogeneously distributed throughout the whole layer. The distribution of these elements in PEO layers is influenced by ionic mobility of different species, as discussed by Monfort et al. and Matykina et al. in [30,31].

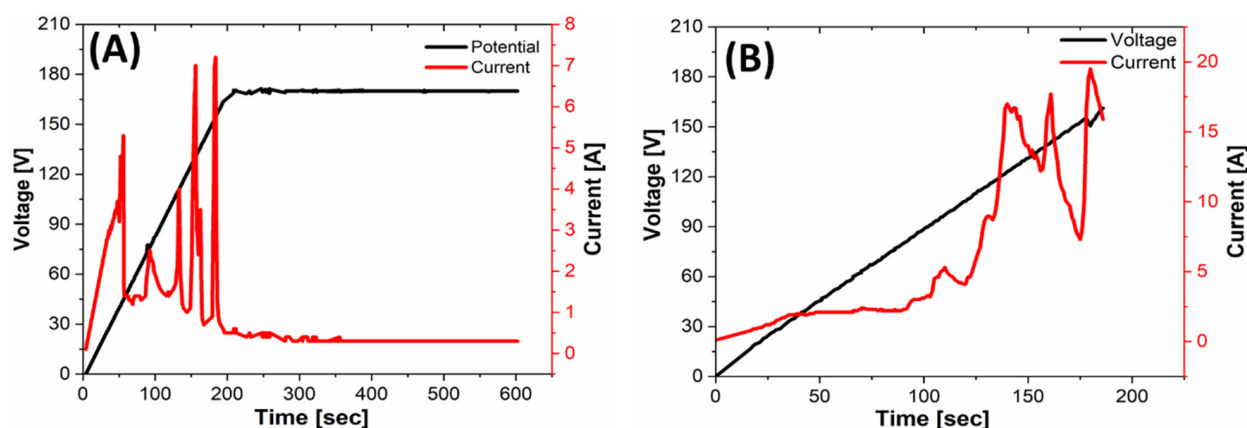
Figure 2. Potential (black) and current (red) curves as a function of the PEO processing time for the ZM21 sacrificial specimen (A) and for the ZM21 extruded profile (B).

The chronopotentiometric and chronoamperometric curves recorded during the PEO of the sacrificial samples (Figure 2A) showed a typical current profile characterized by randomly distributed peaks corresponding to discharge avalanches on the anodic surface. The current peaks did not exceed 7 A during the PEO of the sacrificial samples (Figure 2A). This induced lower energy dissipation and a better temperature control. During PEO of the extruded profiles (Figure 2B), the current peaked at 20 A, probably because of the higher anodic surface area. Correspondingly, a more intense sparking and gas evolution was observed, with significant electrolyte temperature increase, inducing the operator to interrupt the treatment at the beginning of the potential plateau. The discrepancy on the chronoamperometric profiles reported in Figure 2A,B can be ascribed to the different ratio of anodic to cathodic exposed area. This issue would deserve a dedicated development stage, which was out of the scope of this work.

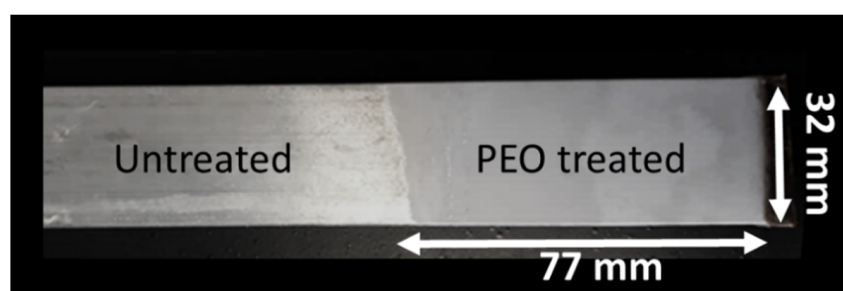
Figure 3. Representative image of a PEO-treated ZM21 extruded profile.

As shown in Figure 3, at visual examination the oxide film formed on the surface of the anodized ZM21 extruded profile appeared homogeneous.

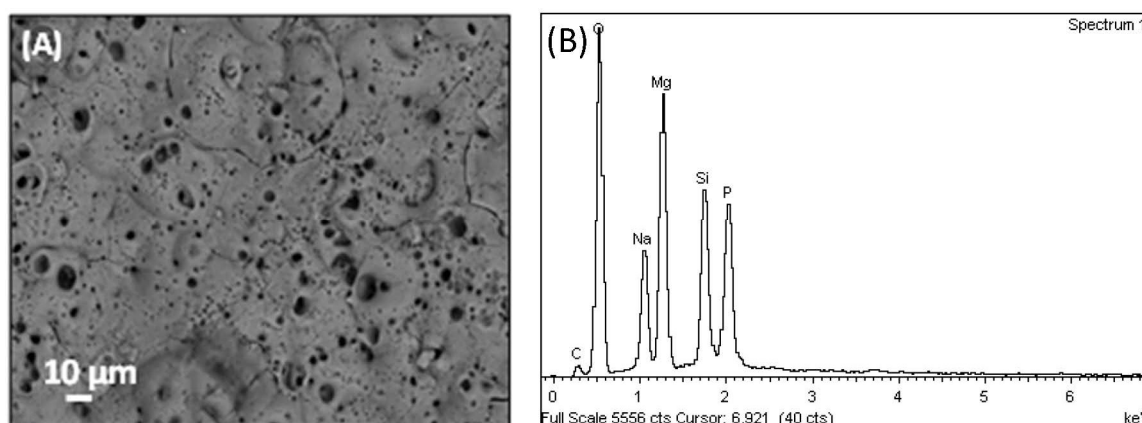
Figure 4. PEO-treated surface: (A) SEM image and (B) EDS surface spectrum of the oxide layer obtained onto a ZM21 sacrificial sample at 170 V, 188 s, 30 °C in 100g/L $\text{Na}_3\text{PO}_4 \cdot 12\text{H}_2\text{O}$, 20 g/L Na_2SiO_3 , 25 g/L $\text{Na}_2\text{B}_4\text{O}_7 \cdot 10\text{H}_2\text{O}$.

After anodizing, the surface of sacrificial samples exhibited a micrometric and sub-micrometric porosity; however, the typical cracks often resulting from PEO of Mg alloys [16] were not observed (Figure 4A). The EDS analysis of the surface (Figure 4B) revealed that the PEO layer contained O, Zn, Na, Mg, Si and P, with Zn and Mg from the ZM21 alloy and Na, Si and P incorporated from the electrolyte.

The surface morphology of PEO-treated profile and the corresponding cross-section image are shown in Figures 4A, 7 and 8, respectively. The surface morphology appeared rough and porous with typical craters generated by local discharge events occurring during the growth of the anodic oxide layer [15,29]. A few microcracks, derived from thermal stresses, and a pancake morphology, formed by molten oxide erupted from discharge channel and rapidly cooled by the electrolyte at the room temperature, were also observed

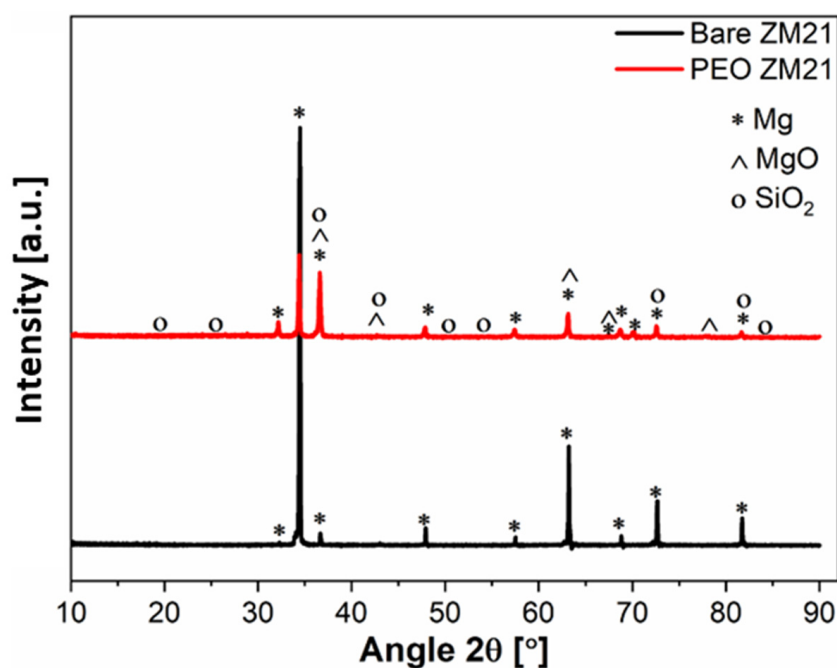
Figure 5. XRD pattern of the bare ZM21 alloy (black) and of the anodic film (red) obtained onto ZM21 at 170 V, 188 s, 30 °C in 100g/L $\text{Na}_3\text{PO}_4 \cdot 12\text{H}_2\text{O}$, 20 g/L Na_2SiO_3 , 25 g/L $\text{Na}_2\text{B}_4\text{O}_7 \cdot 10\text{H}_2\text{O}$.

XRD patterns shown in Figure 5 demonstrate that the PEO film consisted of a mixture of MgO and SiO_2 .

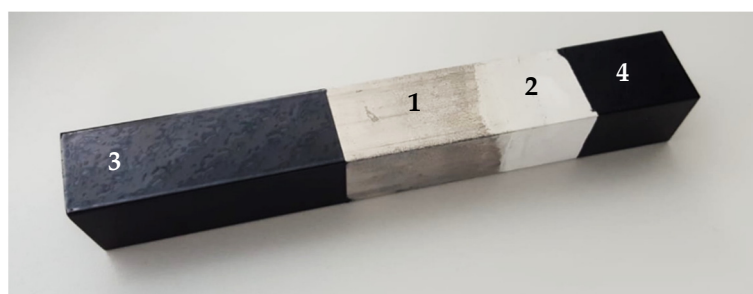
Figure 6. General view of extruded profiles ($30 \times 30 \text{ mm}^2$, length: 170 mm), with indication of the investigated conditions: (1) bare ZM21, (2) PEO-treated ZM21, (3) powder-coated ZM21, (4) PEO-treated ZM21 with powder coating top layer.

A general view of extruded profiles, with indication of the investigated conditions is shown in Figure 6: (1) bare ZM21 (reference), (2) PEO-treated ZM21, (3) powder-coated ZM21 (without PEO interlayer), (4) PEO-treated ZM21 with powder coating top layer.

Surface roughness parameters (R_a , R_q , R_z , R_t and R_{\max} according to [28], measured in the areas highlighted in Figure 6) are reported in Table 2.

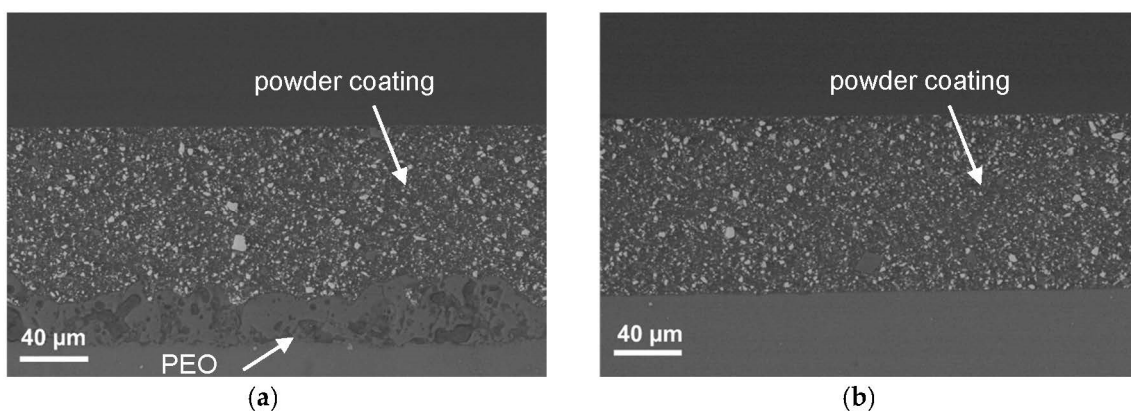
Figure 7. Cross-section BSE images of (a) PEO-treated and powder-coated ZM21 and (b) powder-coated ZM21 (without PEO interlayer).

The cross-section images (Figures 7 and 8) showed that the PEO layer/substrate interface is slightly undulated, due to local thickening of the anodic oxide following breakdown events [11]. The pores are unevenly distributed throughout the specimen cross-section and the average thickness of the film is about 30 μm . Typical discharge channels, pores and cracks, bigger and larger in the outermost region, were also observed. The characteristic anodic oxide morphology afforded mechanical interlocking of the powder coating top layer (Figure 7a), an important prerequisite for satisfactory bonding strength. Additionally, the deposition of the powder coating top layer allowed to obtain a smoother surface (as shown also by surface roughness data in Table 2), levelling out the rough PEO surface. The average thickness of the PEO layer was $39 \pm 4 \mu\text{m}$, while the powder coating top layer was $118 \pm 9 \mu\text{m}$ thick (Figure 7a,b), regardless the presence of the PEO interlayer (as expected, since the powder coating was applied in a single painting session). The coating thickness was fairly uniform in both cases (PEO layer alone and PEO with powder coating top layer). EDS analysis of bright spots in the BSE cross-section images of the powder coating showed the presence of Ba- and Ca-based compounds, typical inorganic fillers added to the powder coating top layer (such as BaSO_4 and CaCO_3).

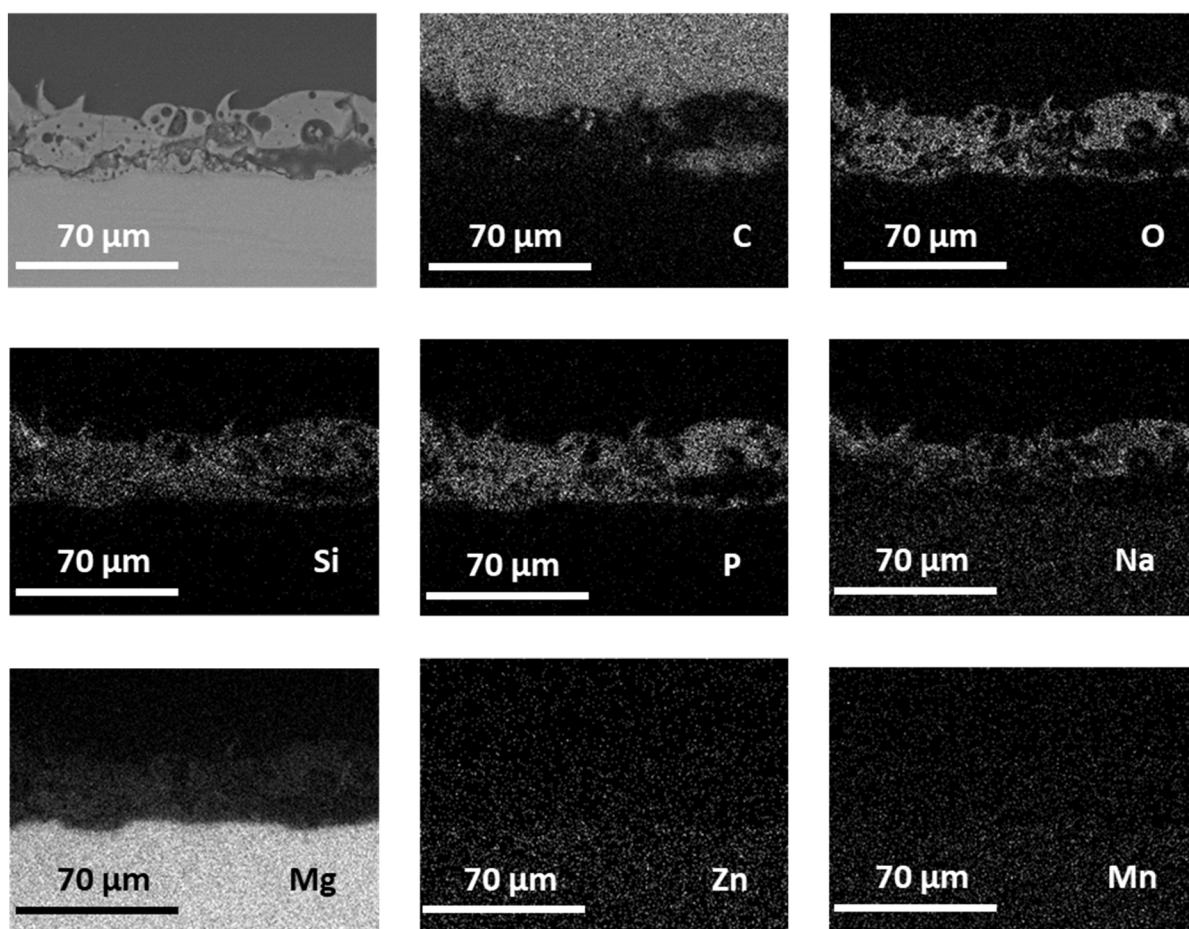
Figure 8. BSE image (top left) and X-ray EDS elemental maps of the PEO-treated ZM21 extruded profile (polished cross section; the presence of C is due to the mounting resin).

Elemental X-ray maps recorded by EDS on polished cross sections of PEO-treated samples (Figure 8) showed a homogeneous distribution of alloy elements (Mg, Zn, Mn) as well as of elements incorporated from the electrolyte (O, Si, P).

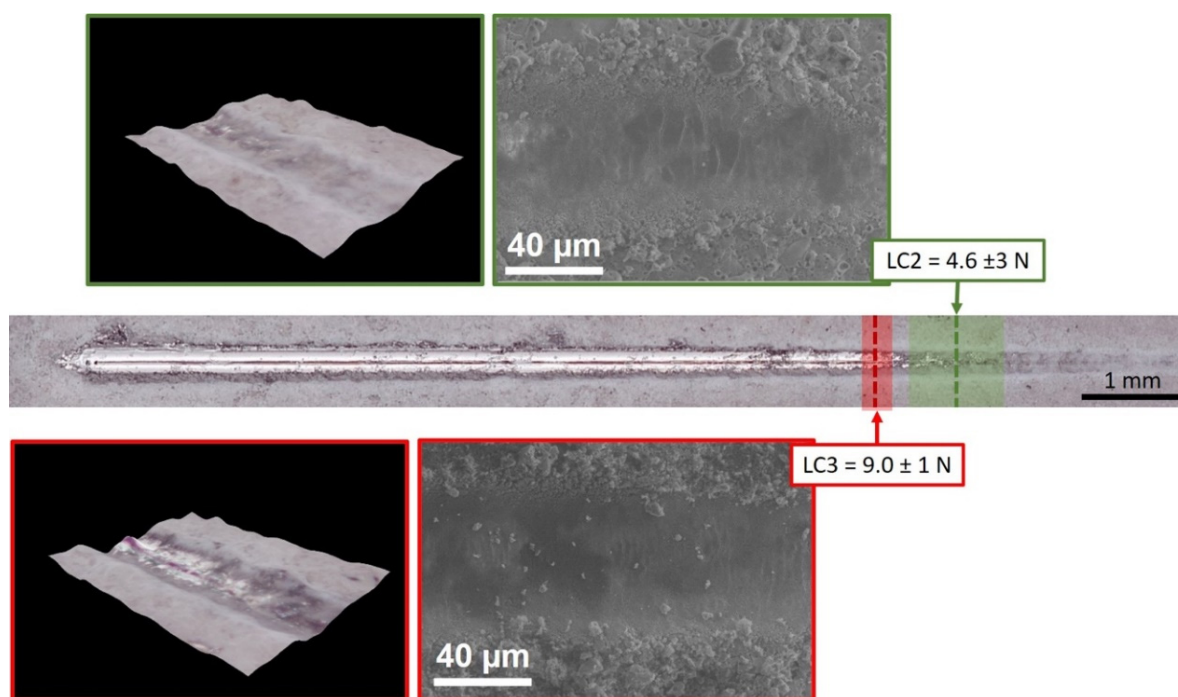
Figure 9. Overview of a representative scratch track on PEO-treated ZM21 extruded profiles (optical image), with indication of critical loads Lc2 (first coating detachment) and Lc3 (full delamination). Each critical load for adhesive failure of the PEO layer is accompanied by the corresponding SEM image (SE) and 3D-digital microscopy image of the scratch track (black background).

Representative images of scratch tracks with indication of critical loads Lc2 and Lc3 for adhesive failure of PEO layer, estimated according to ISO 20502:2016 [32] are reported in Figure 9.

The measured average value of Lc2, indicating when the coating detachment begins, and Lc3, corresponding to penetration of the coating to the substrate at the center of the track, were 4.6 ± 3 N and 9.0 ± 1 N respectively, comparable to those measured in a previous work on PEO-treated EV31A Mg alloy, where scratching was carried out in the same conditions [29]. Substrate and coating properties influence the failure mode during scratch testing [33]: PEO-treated Mg alloys can be considered as hard coating on soft substrate even though the hardness difference may not be notably high. Therefore, PEO layers were bent into the track as a consequence of substrate plastic deformation. The SEM image corresponding to Lc2 in Figure 9 (top right) shows buckling failures (cracks and patches of coating detachment) appearing in the scratch track, in the areas where the indenter movement generates pile-up deformation. After full delamination of the PEO layer, only substrate plastic deformation was observed, together with scattered micro-fragments from the anodic oxide (bottom right SEM image in Figure 9).

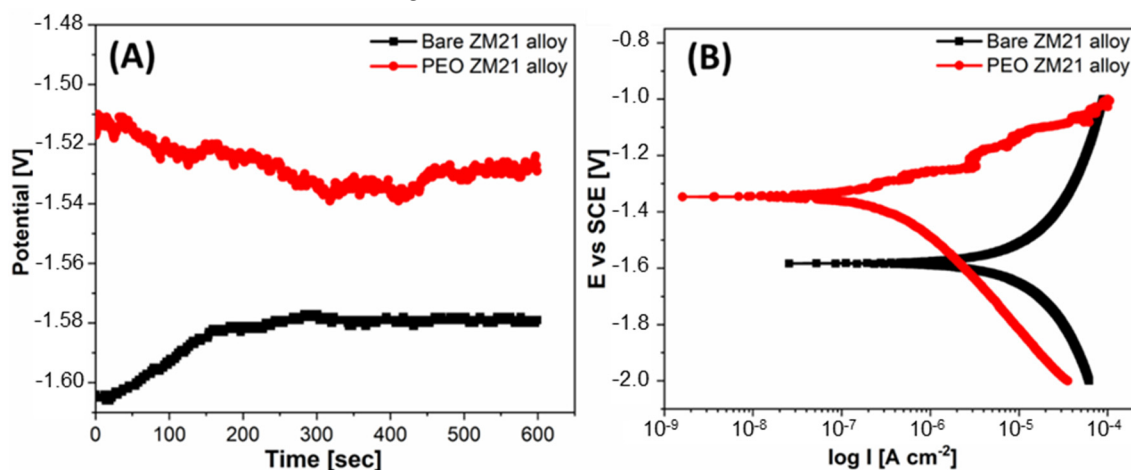
Figure 10. Open circuit voltage as a function of immersion time (A) and potentiodynamic curves (B) of ZM21 before (black curve) and after (red curve) PEO. Tests carried out in 3.5% NaCl aqueous solutions.

Corrosion tests were carried out on sacrificial specimens. Open circuit measurements in 3.5% NaCl solutions (Figure 10A) showed that the immersion potential of the anodized

According to the potentiodynamic tests (Figure 10B), after anodization the corrosion current density decreased by one order of magnitude, i.e., from $2.5 \cdot 10^{-8} \text{ A cm}^{-2}$ to $1.5 \cdot 10^{-9} \text{ A cm}^{-2}$ and the corrosion potential increased by about 300 mV, i.e., from -1.6 V vs. SCE (untreated ZM21 alloy) to -1.3 V vs. SCE (anodized alloy). Correspondingly, the polarization resistance of the alloy increased by two orders of magnitude after the PEO treatment, rising from about $9837 \Omega \text{ cm}^2$ to about $145,848 \Omega \text{ cm}^2$.

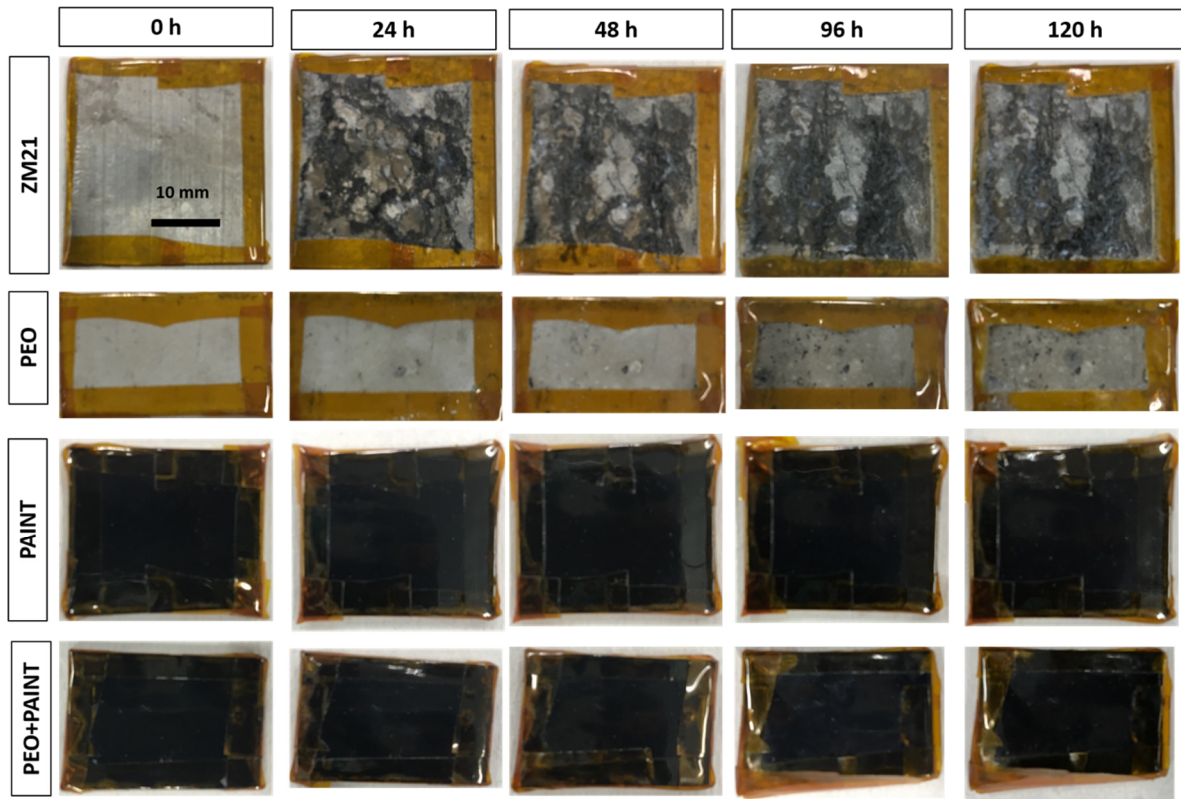
Figure 11. Visual observation of the samples before and during the NSS test.

The results of the visual inspection of the samples during and at the end of NSS test are reported in Figure 11. Already after a few hours of exposure (>6 h), ZM21 alloy exhibited corrosion products on the surfaces, indicating the high reactivity of this material in NaCl solution. At the end of the exposure, the reference ZM21 samples showed a strongly damaged surfaces characterized by the precipitation of uniformly distributed corrosion products, as highlighted in micrographs of Figure 12. The PEO-treated samples showed localized corrosion attacks for short exposure time (>6 h) that are clearly visible after 24 h. However, these corrosion attacks on PEO surfaces did not significantly evolve with time. This is probably due to the initiation of the localized corrosion attacks in correspondence with PEO treatment defects (e.g., porosity). In addition, corrosion products continuously precipitated inside the localized corrosion sites, mitigating the corrosion rate of the process. However, at a longer exposure time (>96 h), a localized acceleration of the corrosion process was observed with a consequently leaching of the corrosion products, as shown in Figure 12. Conversely, for both the painted samples, no corrosion attacks and/or painting damages were observed within the 120 h NSS test, indicating an increased performance for both the

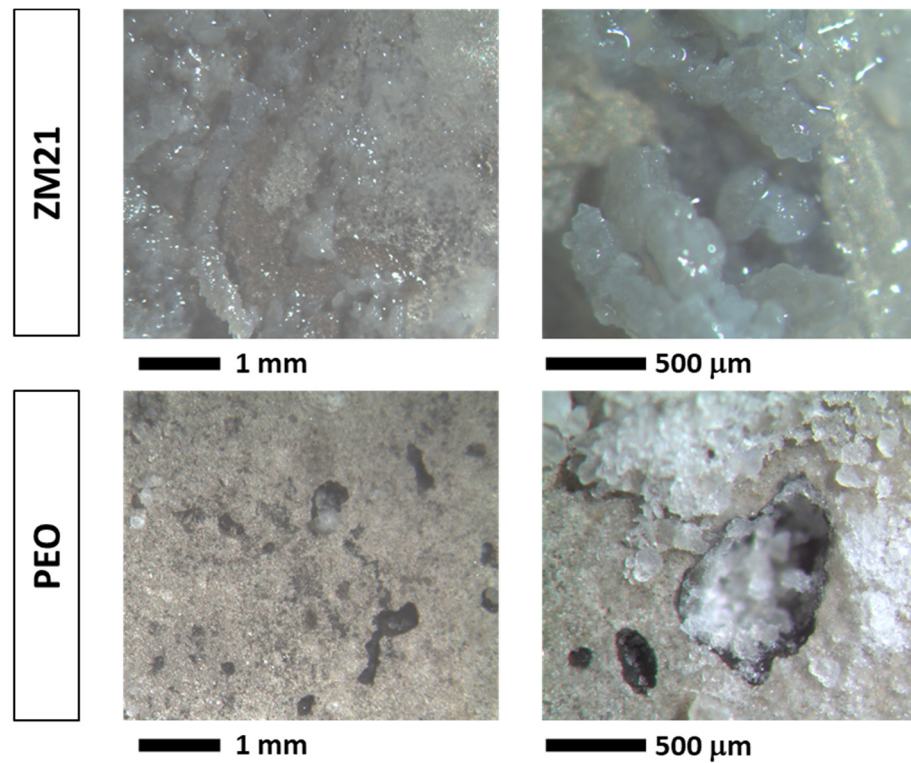
Figure 12. Macroscopic images of corroded surfaces (bare ZM21 and PEO-treated ZM21) at the end of the NSS test (120 h).

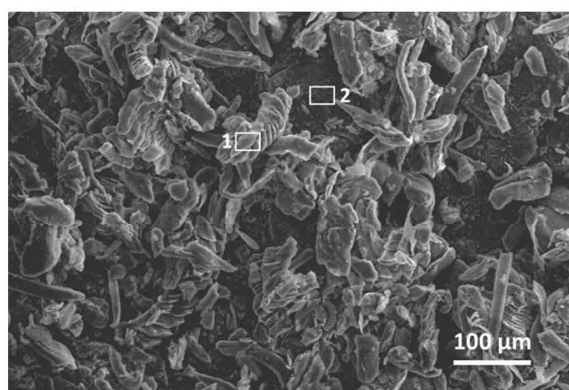
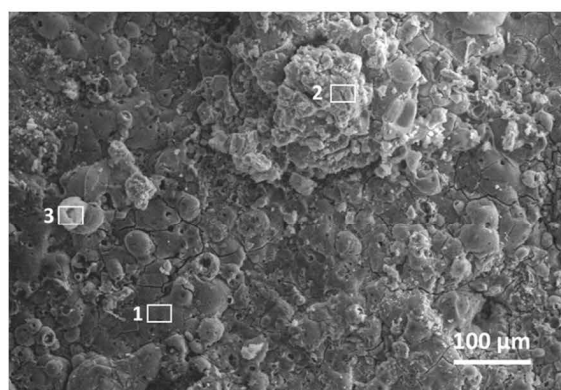
O	Na	Mg	Cl	Mn	Zn
1	28.1	0.4	68.9	0.1	0.7	1.8
2	56.1	4.3	36.7	2.1	0.2	0.6

O	Na	Mg	Si	P	Cl	Mn	Zn
1	60.4	5.3	17.8	7.7	7.2	0.6	0.3	0.7
2	63.7	5.0	16.9	7.0	5.3	1.1	0.3	0.7
3	66.7	4.5	17.4	5.5	3.5	1.8	0.3	0.3

Figure 13. SEM images (secondary electrons) and localized EDS analyses (wt.%) of corroded surfaces (bare ZM21 (a) and PEO-treated ZM21 (b)) at the end of the NSS test (120 h).

The corroded surface as well as the polished cross section of the bare and PEO-treated ZM21 were also analyzed by SEM/EDS at the end of the NSS test (120 h). Figure 13 shows the morphology of corroded surfaces and further demonstrates that the PEO layer contributed to limit the formation of corrosion products on ZM21: a more extensive formation of Cl- and O-rich crystalline corrosion products was observed on bare ZM21 (Figure 13a) than on the PEO-treated surface (Figure 13b). However, some localized corrosion attacks are also visible on the PEO-treated surface (areas 2 and 3 in Figure 13b), with increased amounts of elements from the aggressive environment (namely Cl and O) by comparison to the less corroded areas of the anodic oxide (area 1 in Figure 13b), which still retains its typical surface morphology with volcano-like features (as shown before corrosion by Figure 4A).

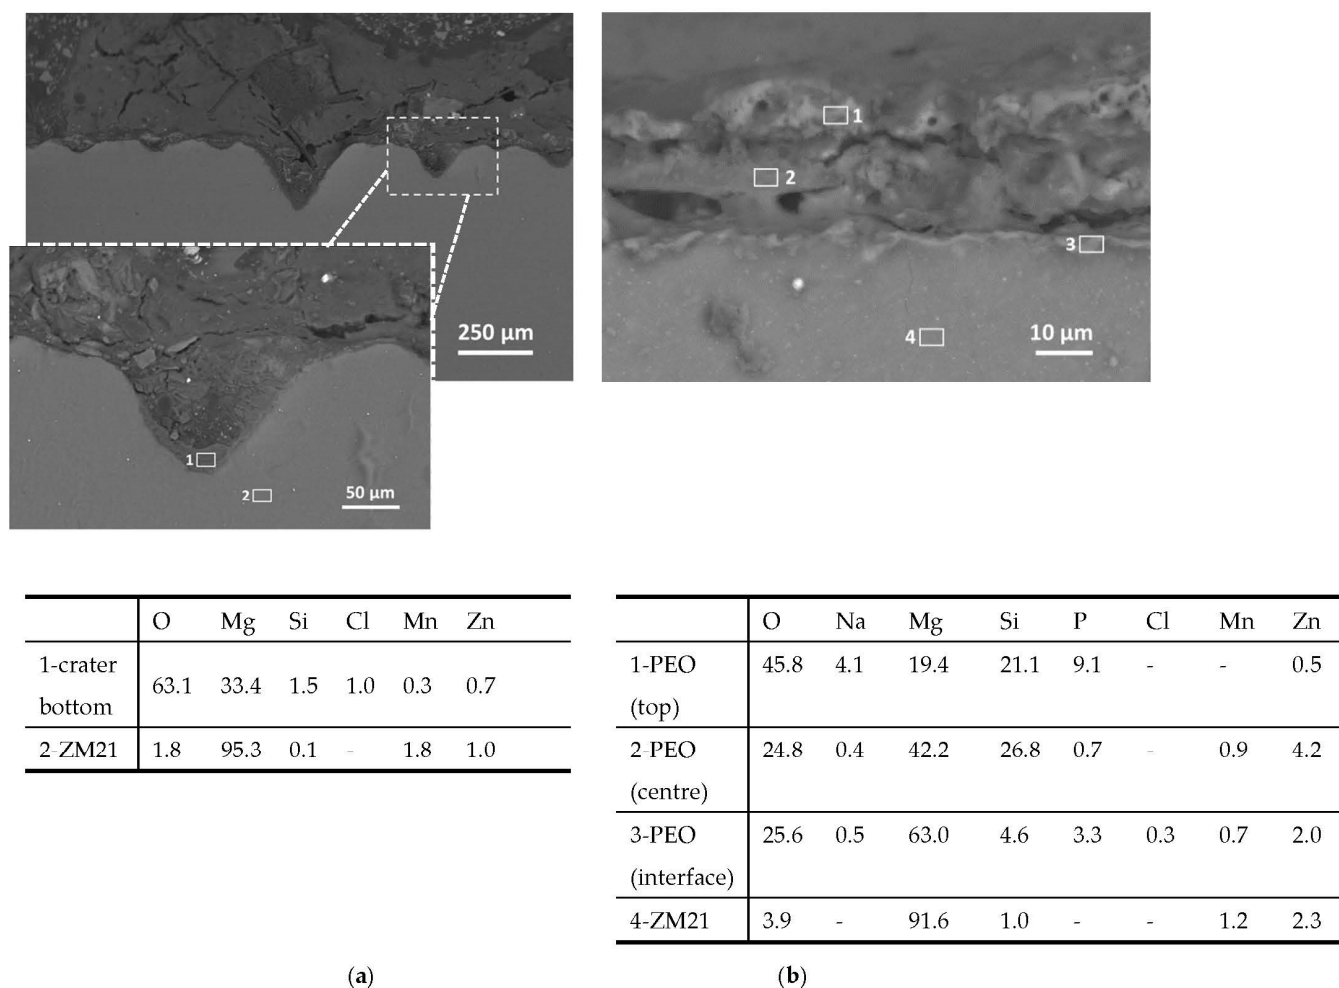
Figure 14. SEM images (backscattered electrons) and localized EDS analyses (wt.%) of polished cross sections through corroded samples (bare ZM21, with general view and high magnification detail (a) and PEO-treated ZM21, high magnification detail (b)) at the end of the NSS test (120 h).

Figure 14 compares the polished cross section of the bare and PEO-treated ZM21, showing that while the bare alloy underwent remarkable localized corrosion, with the formation of several craters (Figure 14a), the PEO-treated samples still showed the presence of the anodic oxide layer, even though with a slight increase of defects (cracks and pores), which favored the previously mentioned localized corrosion phenomena. Cl from the aggressive environment was always detected at the interface between the corrosion products and the alloy, as expected.
