Article

# An Experimental Study on Mechanical Properties for the Static and Dynamic Compression of Concrete Eroded by Sulfate Solution

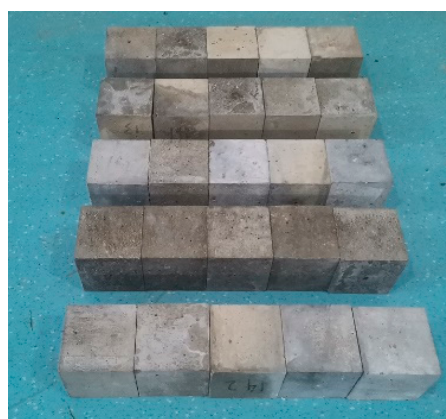
**Figure 1.** Concrete specimens eroded at different times.

For this test, Portland cement of 42.5 R P·O was one of the materials used to prepare the concrete test pieces, manufactured by Qinling Cement Group, Tongchuan, China, specific surface area:  $650 \text{ m}^2/\text{kg}$ , density:  $3.15 \text{ g}/\text{cm}^3$ , fineness: (80  $\mu\text{m}$  sieving residue) 7.6%; fine aggregate: sand from the Ba River, Xi'an, China, fineness modulus: 2.6, apparent density:  $2.44 \text{ g}/\text{cm}^3$ , bulk density:  $1.77 \text{ g}/\text{cm}^3$ ; coarse aggregate: crushed limestone, 15% of particle size 5–10 mm and 85% of particle size 10–20 mm, volume weight:  $2700 \text{ kg}/\text{m}^3$ . Cement content is  $495 \text{ kg}/\text{m}^3$ , coarse aggregate content is  $1008 \text{ kg}/\text{m}^3$ , fine aggregate content is  $\text{kg}/\text{m}^3$ , and water consumption is  $180 \text{ kg}/\text{m}^3$ . A “sand enclosed cement” method was adopted for the concrete test pieces in this test. After the concrete was mixed, its surface was covered with a film to cure it and prevent water evaporation. A cube specimen with a side length of 70 mm was prepared at room temperature ( $80 \pm 5\%$  in case humidity and  $20 \pm 3$  degrees in case of temperature). After 24 h of curing, the molds were removed, and the test pieces were transferred to the standard curing room for 28 d of curing. Then, the test pieces were taken out for the water to grind the sides with a stone grinding machine, so that the surfaces of the test pieces were flat and smooth. For the  $\text{Na}_2\text{SO}_4$  adopted in this test, at room temperature ( $20 \pm 3 \text{ }^\circ\text{C}$ ), the solubility in 100 g water is about 19.5 g and the mass fraction is about 16.3%. Therefore, the erosion solution used in this test was a  $\text{Na}_2\text{SO}_4$  solution with a mass fraction of 15%, and the solution was replaced every seven days, so that the mass fraction of the solution was maintained at 15% during erosion (as shown in Figure 1).

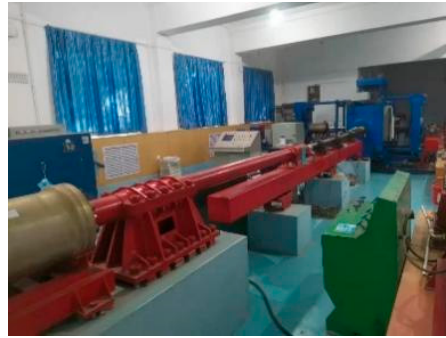
Figure 2. Triaxial static-dynamic comprehensive loading test system.

A self-developed true triaxial static–dynamic comprehensive loading test system (as shown in Figure 2) was adopted for this study. The system comprised of two parts. (1) The dynamic loading system (as shown in Figure 3), which is based on the split Hopkinson pressure bar (SHPB) device, and is equipped with a launching device, bullet, incident bar,

transmission bar, and absorbing bar. (2) The power system, which provides power for bullets through compressed gas for dynamic tests under different high strain rates, and is comprised of an air compressor, air reservoir, and gas channel (as shown in Figure 4). The data acquisition system consists of a speed acquisition system and strain acquisition system. The static loading system is controlled by an electronic grating system and can load in six directions, achieving a true triaxial test of concrete by changing the directions of the loads and loading rates.

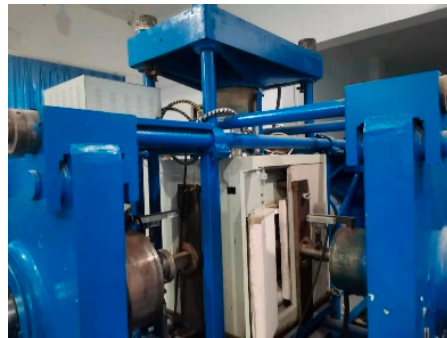
Figure 3. Dynamic loading system.

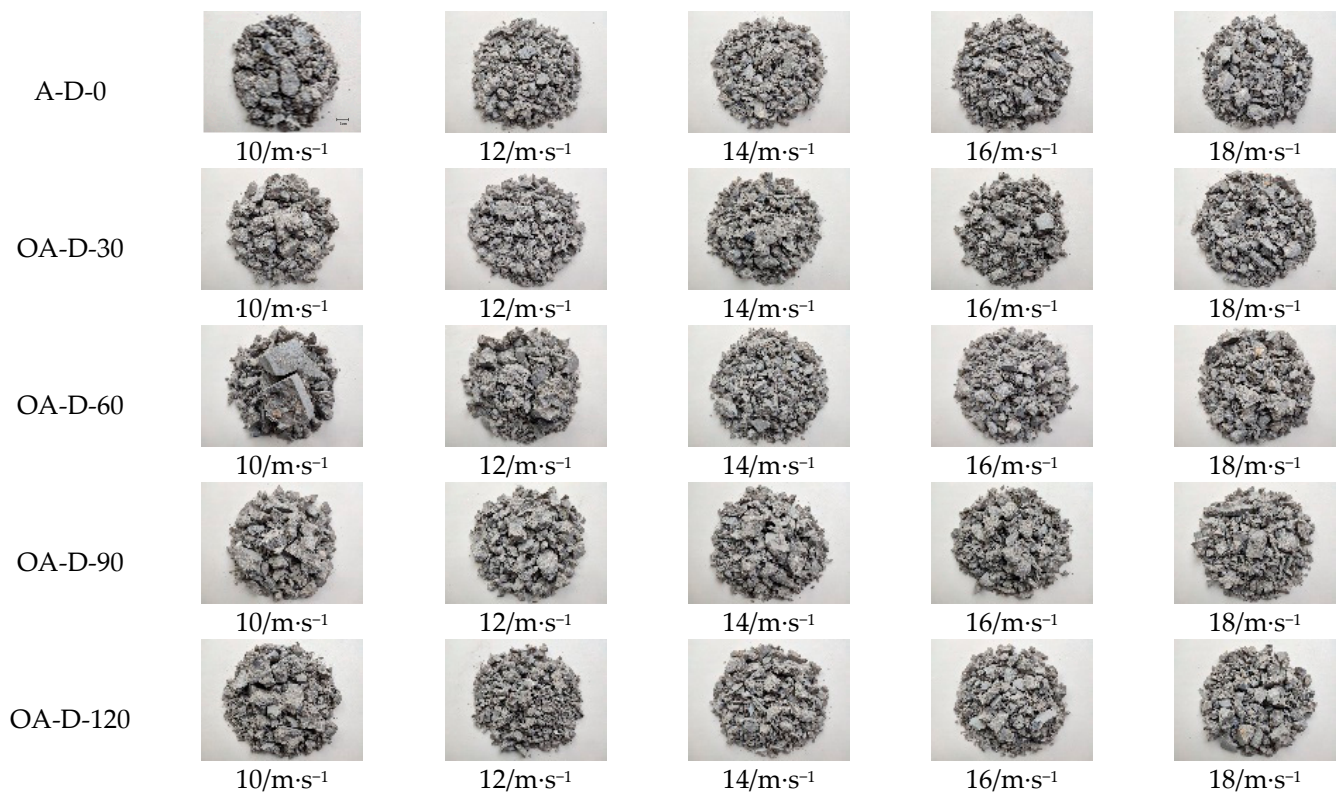
**Figure 5.** Impact failure modes of test pieces at different velocities.

The test pieces were damaged to different degrees under dynamic compression. Figure 5 shows the failure modes of the test pieces under different impact velocities Figure 5. The above failure mode diagram is scaled at a scale of 1:20 according to the actual size. At 0 d of immersion time, the failure mode was block failure with a small number of

fragments, but the bulk was relatively large for the fragments, and broken coarse aggregate appeared; at 30 d of immersion time, the fragments were more integrated than at 0 d, and the bulk of the fragments was clearly larger than at 0 d; at 90 d to 120 d of immersion time, the bulk of fragments from test pieces under dynamic load decreased, and the amount of debris increased. With the increase in impact velocity and a continuous increase in strain rate, the degree of damage to the test pieces increased, and the large fragments containing coarse aggregate at low velocities were gradually split into smaller blocks until the test pieces were broken into multiple fragments, and the amount of powdery substance gradually increased with the strain rate.

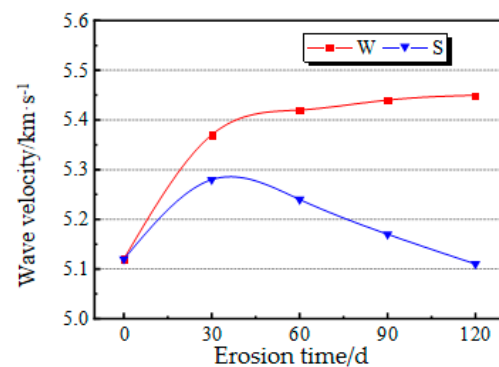
Figure 8. Changes in wave velocity with erosion time.

The experimental results of ultrasonic wave velocity of concrete after sulfate erosion are as follows: from 0 d to 120 d, the ultrasonic wave velocity of the W group is 5.12 km/s, 5.37 km/s, 5.42 km/s, 5.44 km/s, and 5.45 km/s, respectively. The ultrasonic wave velocities of the S group were 5.12 km/s, 5.28 km/s, 5.24 km/s, 5.17 km/s, and 5.11 km/s, and the relationship between the longitudinal wave velocity obtained by ultrasonic testing with erosion time is shown in Figure 8. Obviously, for the test pieces, the increasing trend

of longitudinal wave velocity with erosion time was like that of the static compressive strength. The transmission speed of ultrasonic wave in concrete reflects the structural strength and integrity of concrete itself. Usually, the wave speed is fast and the structure is intact and not destroyed, while the wave speed is slow when it is eroded. The wave velocity of the W group rose continuously, and the amplitude within 30 d after immersion was at its maximum, i.e., 76% of the total growth rate. In the W group, with the increase in soaking time, the wave velocity of concrete in pure water increased due to continuous hydration. The longitudinal wave velocity of the S group first increased and then decreased, peaking 30 d after submersion, and decreased continuously after then. At 60 d after submersion, the longitudinal wave velocity decreased to about the initial value, which was 93.76% of the wave velocity of the W group. In the S group, due to the dual influence of hydration of concrete and sulfate erosion, hydration played a dominant role in the 0 d and 30 d tests, so the wave velocity increased. When the erosion time exceeded 30 d, the sulfate erosion intensified, and the negative effect of concrete soaked in solution was greater than the positive effect of hydration, so the wave velocity decreased.

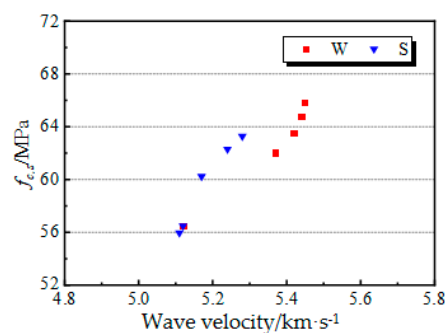
Figure 9. Relationship between longitudinal wave velocity and static compressive strength.

where  $a$  and  $b$  represent empirical coefficients. Figure 9 shows the relationship between the longitudinal wave velocity and static compressive strength of the test pieces.

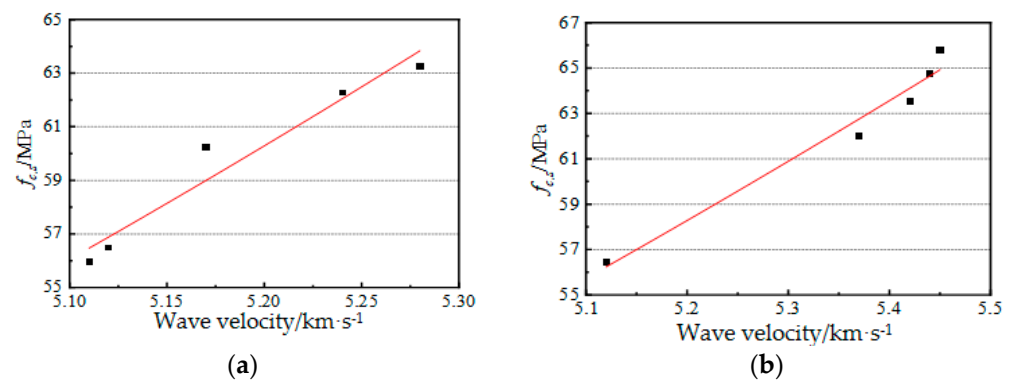
**Figure 10.** Fitting curve of the static compressive strength and wave velocity for the test pieces (a) the W group; (b) the S group.

The fitting results are shown in (6), and the relevant relation diagram is shown in Figure 10. The fitted correlation coefficient  $R^2 = 0.9679$  (the W group),  $R^2 = 0.9471$  (the S group). Thus, the correlation was high, and the fitting results were optimal.

$$\begin{cases} W : f_{c,s} = 1.316v_p^{2.299} (R^2 = 0.9679) \\ S : f_{c,s} = 0.123v_p^{3.748} (R^2 = 0.9471) \end{cases} \quad (6)$$

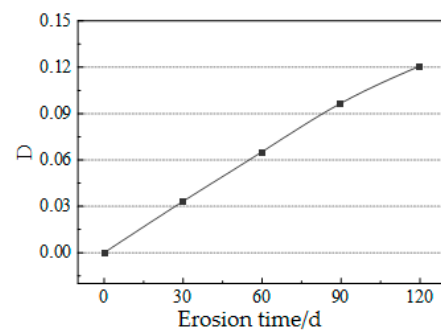
Figure 11. Damage variable of test pieces after sulfate attacks.

Concrete specimens are affected by the erosion of sodium sulfate solution, which mainly includes the erosion of sulfate and the continuous hydration of concrete. In order to separately analyze the influence of sulfate erosion on concrete, where  $\tilde{v}_p$ —the wave velocity of material in its initial state, and  $v_p$ —the wave velocity of material after damage. According to the Formula (9), the damage degree of material before any damage was 0, and the damage degree of material after any damage was 1. The damage curve of the test pieces (as shown in Figure 11) was drawn. Obviously, the damage degree of the concrete test pieces after undergoing sulfate attacks continuously increased with erosion time. When the erosion time was 120 d, the damage degree was up to 0.12.

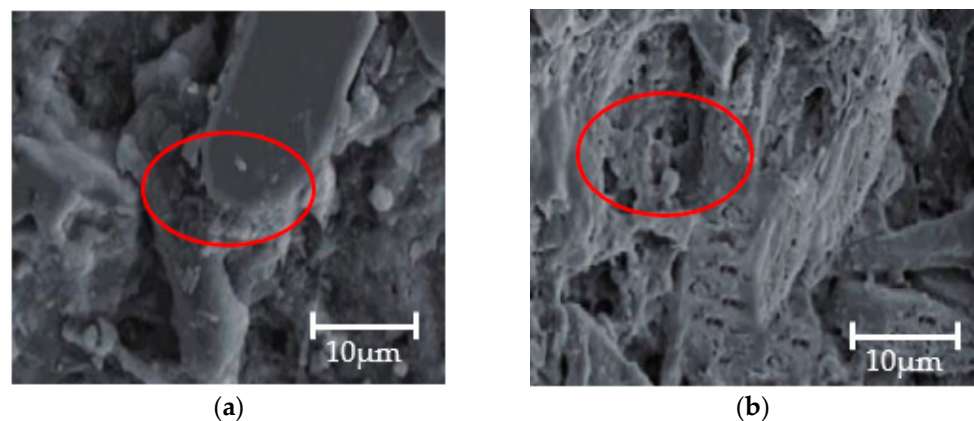
Figure 12. Microstructure of concrete after soaking (a) W group; (b) S group.

The acoustic velocity of the W group soaked in distilled water is the initial speed of the material, while that of the S subjected to sodium sulfate erosion is the speed after the material was damaged. The static mechanical properties and dynamic mechanical properties decreased to different degrees as the wave velocity decreased based on acoustic measurements. Figure 12 shows the microscopic morphology of specimens of the W group and the S group, respectively, at a magnification of 2000 times. It can be seen from the figure that, after the resoaking time reaches 120 d, a large amount of consolidation products of  $\text{Na}_2\text{SO}_4$  occurred between the skeleton and the pore bulk, and there were many consolidation products in the pores and increasing consolidation products amplify the defects. The static mechanical properties and dynamic mechanical properties decreased to different degrees as the wave velocity decreased based on acoustic measurements.
