Evaluation of the failure modes and load-bearing capacity of different surface-treated polyether ether ketone copings veneered with lithium di-silicate compared to polyether ether ketone copings veneered with composite: An *in vitro* study

Abhishek Kumar Gupta, Rekha Gupta, Shubhra Gill

Department of Prosthodontics, Crown and Bridge, Maulana Azad Institute of Dental Sciences, New Delhi, India

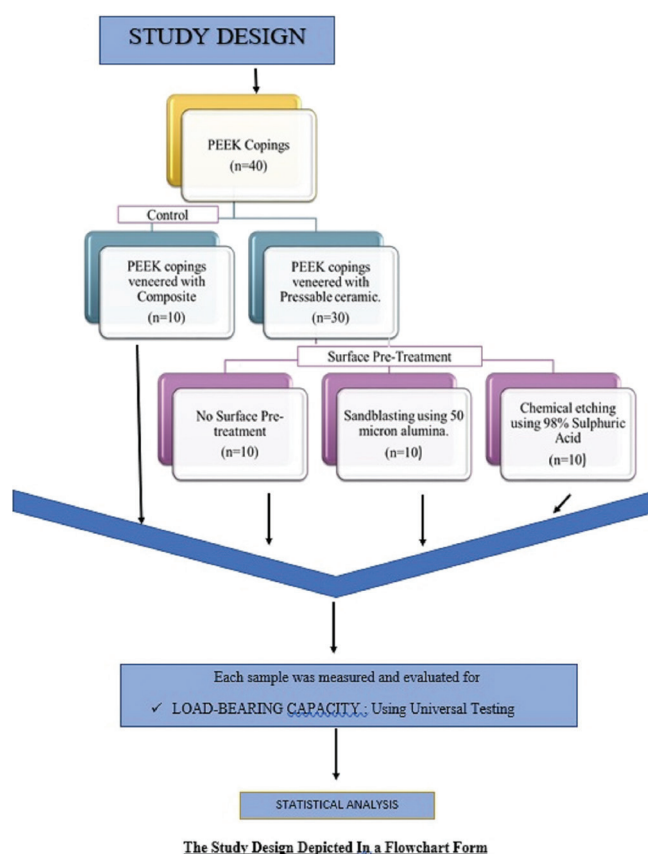
Figure 1: Study design, division of specimens according to different surface pretreatments, veneering composite resin, and lithium disilicate veneering

The PEEK FDPs were fabricated using rapid prototyping techniques (subtractive). This was followed by veneering with UDMA-based composite in case of 10 PEEK copings and lithium disilicate veneering on differently surface-treated 30 PEEK copings. To avoid confounding variables, the same milling machine was used for fabrication of all 40 PEEK FDP copings. The study design is shown in Figure 1.

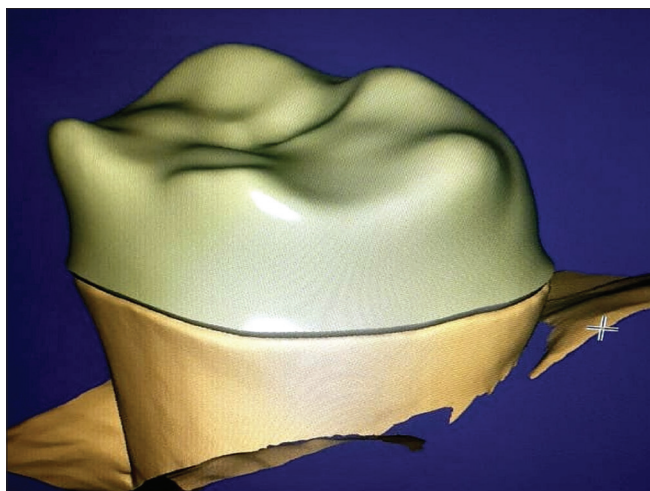
Figure 2: Computer-aided design designing of polyether ether ketone coping

The prepared typodont model was scanned using the Identica Hybrid Scanner, MEDIT. The scanning was done using 3-axis impression scanning technique to prepare the computerized die. The scanned data were thereafter sent to the DentalCam 7 software (VHF, Germany) [Figure 2]. This CAD data were used to design the required PEEK coping of 0.5 mm thickness. On the basis of the master design, the milling process was undertaken. The 4-axis milling process was carried out using the K4 milling machine (VHF, Germany). 40 standardized PEEK copings were milled using dry machining/milling. The PEEK dental disks (BIO-HPP, Bredent, Germany) with A2 shade were used.

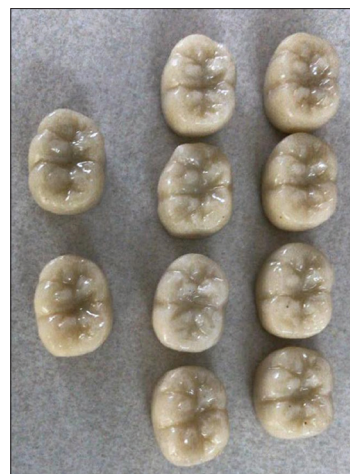
Figure 3: Composite veneered polyether ether ketone fixed dental prosthesis

model, a silicone index (Zetaplus, Zhermack, Italy) was created, enabling for a consistent and repeatable anatomic form fabrication. After utilizing the incremental method to apply the veneering composite resin on the PEEK coping, excess material was eliminated when the silicone mold was overlaid. The occlusal height of the composite was around 1–1.5 mm. Layering was followed by light polymerization for 180 s with bre.Lux power unit 2 (Bredent, Germany). The power unit makes use of full-range LED light with an in-built temperature control system. All the 10 samples of composite veneered PEEK were finished and polished and were stored in a dry environment [Figure 3].

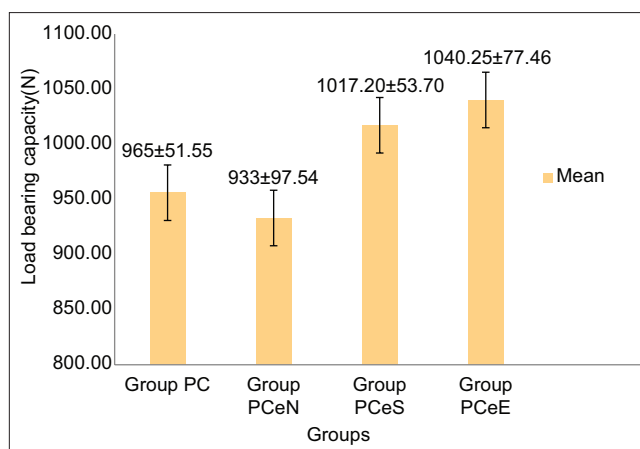
Graph 1: Bar-chart presentation of the results of the load-bearing tests (mean values and standard deviations) of different groups

The data were collected in Newton (N) for load-bearing capacity. Descriptive statistics (mean, standard deviation,) were computed for each group [Graph 1]. A one-way ANOVA analysis was used to test for significant differences between the groups, followed by a Bonferroni *post hoc* test (preset = 0.05). Statistical Package for the Social Sciences was used to do a *post hoc* power analysis (SPSS Inc. Chicago, IL, USA version 26). The level of significance was set at 5% ($P < 0.05$).

Table 1 shows the load-bearing mean, maximum and minimum values, and standard deviations for each group. The load-bearing capacity (in newtons, N) data were compared statistically using one-way ANOVA [Table 2] and the intergroup comparison of mean Load-bearing capacity was done in accordance to Tukey-HSD tests [Table 3]. The highest load-bearing capacity was recorded for lithium di-silicate veneered PEEK copings which were chemically etched with 98% sulfuric acid (Group PCeE: 1040.25 ± 77.46) followed by Group PCeS (1017.20 ± 53.70), then Group PC (965 ± 51.57) and least was for Group PCeN (933 ± 97.54). A significant reduction in load-bearing capacity was seen in Group PCeN ($P < 0.05$). The mean fracture load was significantly more among Group PCeE in comparison to Group PCeN ($P < 0.05$). No significant differences were seen in mean fracture load among groups PCeN and PCeS.

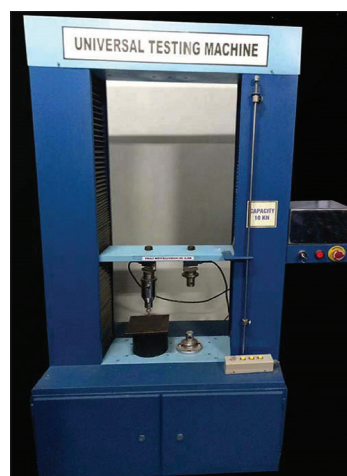
Figure 4: Universal testing machine used to measure load-bearing capacity for polyether ether ketone fixed dental prosthesis

Each PEEK veneered FDP was placed over the metal die and was loaded till a crack occurs. This was done using a Universal Testing Machine (model No: UNITEST-10, ACME) [Figure 4] which was attached to a connecting laptop, which had an in-built software (ACME, INDIA). The crosshead speed was 1 mm/min. A metal plunger with a diameter of 5 mm was then used to load the force into the central fossa of the occlusal surface of the crown. The amount of force was steadily increased from zero to a point where it abruptly decreased by more than 20 N. This sharp drop suggested that the sample had fractured. The force of fracture was calculated from the highest force up to the point of rapid decline. The location of cracks and fragmentation of core and/or veneering materials were also analyzed during the visual examination. The failures are of three types: cohesive

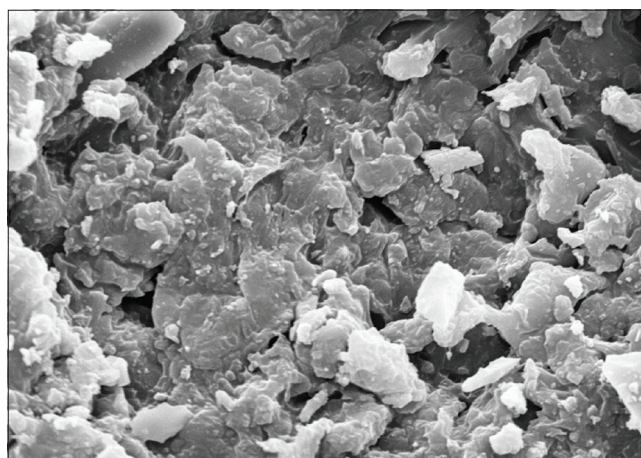
Figure 5: Surface topography: Untreated polyether ether ketone surface ($\times 5000$)

External surface of PEEK coping underwent pretreatments using 50 μ alumina and 98% sulfuric acid before luting it with lithium di-silicate Shell. The untreated PEEK surface [Figure 5] was kept as a control surface to analyze the characteristics after pretreatments. Distinct surface modifications were visible under an electron microscope with both the pretreatments. On PEEK's external surface, sandblasting with a particle size of 50 μ alumina resulted in an irregular surface that was more jagged in comparison to untreated PEEK coping. Chemical etching with 98% sulfuric acid resulted in a complex fiber network with a porous surface. At higher magnification, the H_2SO_4 resulted in a blister and porous surface [Figure 6]. This zone is accepted to form apparent tag formation with resin material.

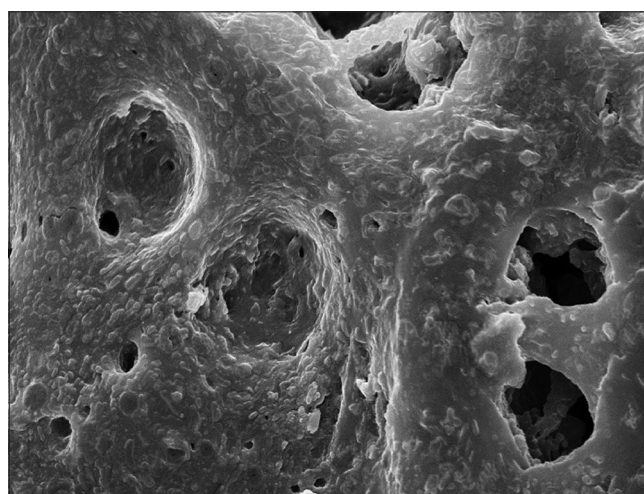
Figure 6: Surface topography: Etched with 98% sulfuric acid (x5000)

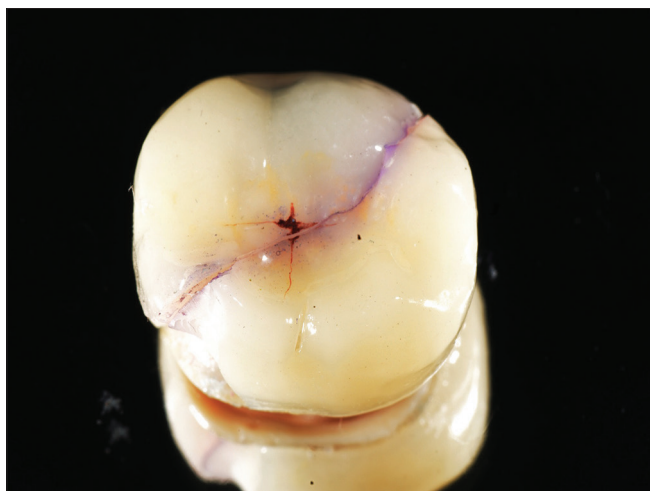
Figure 7: After fracture load measurements. Adhesive failures between polyether ether ketone framework and veneering lithium di-silicate

- All the samples in PEEK FDPs in Group PC suffered adhesive failures pertaining to marginal ridge area [Figure 7]
- Composite chipping was seen in three composite veneered PEEK FDP's out of ten, with detachment of veneering material
- In lithium di-silicate veneered PEEK FDPs, all the samples suffered adhesive failures with detachment

In case of lithium di-silicate veneered FDPs, an interesting fact has been observed that after the fracture of veneering material, the remaining lithium di-silicate gets deboned from the PEEK substructure. This finding was mostly seen in Group PCeN. In this group, no etching or surface treatment of PEEK coping was done, resulting in low bonding between PEEK and lithium di-silicate shell. Therefore, they too had devastating adhesive failures. The location of fracture in lithium di-silicate veneered PEEK is mostly along the central fossa of mandibular first molar.

The highest loads are concentrated in the central fossa resulting in shear stresses along the lateral surface of PEEK substructure. These shear stresses cause debonding of lithium di-silicate and fracture of veneering material.
