Cadaveric Study Validating In Vitro Monitoring Techniques to Measure the Failure Mechanism of Glenoid Implants Against Clinical CT

ABSTRACT: Definite glenoid implant loosening is identifiable on radiographs, however, identifying early loosening still eludes clinicians. Methods to monitor glenoid loosening in vitro have not been validated to clinical imaging. This study investigates the correlation between in vitro measures and CT images. Ten cadaveric scapulae were implanted with a pegged glenoid implant and fatigue tested to failure. Each scapulae were cyclically loaded superiorly and CT scanned every 20,000 cycles until failure to monitor progressive radiolucent lines. Superior and inferior rim displacements were also measured. A finite element (FE) model of one scapula was used to analyze the interfacial stresses at the implant/cement and cement/bone interfaces. All ten implants failed inferiorly at the implant-cement interface, two also failed at the cement-bone interface inferiorly, and three showed superior failure. Failure occurred at of $80,966 \pm 53,729$ (mean \pm SD) cycles. CT scans confirmed failure of the fixation, and in most cases, was observed either before or wit

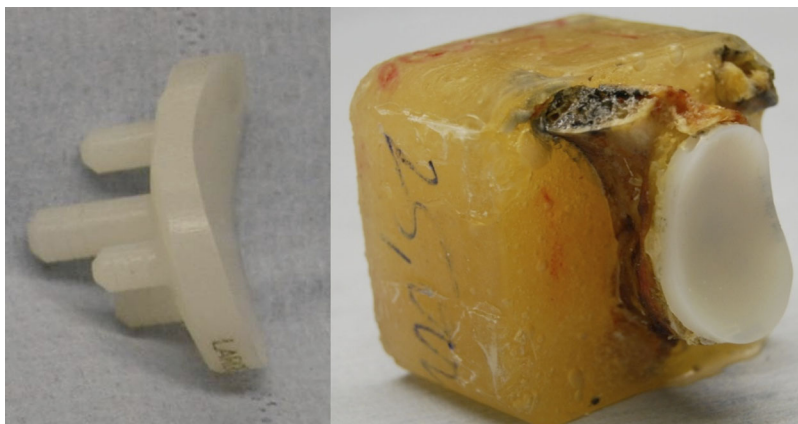
Figure 1. Curved-back cemented glenoid implant (left). Cadaveric scapula cemented and potted for testing (right).

The ten scapulae were implanted with a commercially available glenoid implant, an Aequalis all-polyethylene, curved-back, pegged design (Tornier Inc., Grenoble, France) (Fig. 1). Three small, six medium and one large glenoid with radial curvatures of 27.5, 30, and 32.5 mm, respectively, were implanted by an experienced shoulder surgeon (T.G.). The soft tissue and labrum were excised. The glenoid surface was reamed, removing the cartilage layer, and care was taken to maintain the subchondral layer. The glenoid implants were cemented using Simplex[®] bone cement (Stryker Europe,

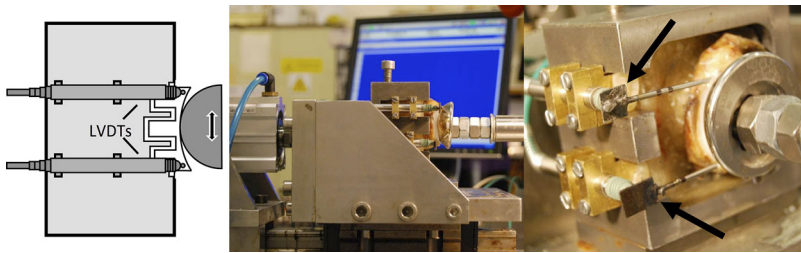
Figure 2. Mechanical glenoid fixation loosening cadaveric test (middle), which is also shown as a schematic (left). Reference pins (arrows) were used to monitor horizontal rim displacement using LVDTs attached directly to the specimens (right).

Montreux, Switzerland). The scapulae were cut to size using an Exakt 310 CP diamond-tipped high precision saw (Exakt Technologies Inc., Oklahoma City) and cemented using Simplex[®] bone cement into the specimen holder. Care was taken to ensure the correct seating of the glenoid component with no tilt (Fig. 1). Two holes were drilled into each glenoid implant to accommodate a 2 mm diameter rod at the superior and inferior edge of the glenoid, 2.5 mm from the corresponding rim. The two rods were prepared as reference points to measure the corresponding rim displacements via two displacement transducers (LVDTs) (Fig. 2).

The scapulae were cemented into the specimen holder and tested using a testing rig compliant to the ASTM standard F2808-17.¹⁶ A compressive horizontal load of 750 N was applied throughout. A 24 mm humeral head manufactured by the implant company was used to articulate onto the implants for all specimens. Thus, the three glenoid sizes; small, medium and large, corresponded to a radial mismatch of 3.5, 6, and 8.5 mm, respectively. The specimens were tested without a water bath at room temperature, and the scapulae and joints were kept wet via a water spray. LVDTs were attached directly to the specimen and horizontally aligned to measure horizontal rim displacement at the superior and inferior rim via reference pins inserted at the implant rim edge as specified by the standard¹⁶ (Fig. 2). The rim displacements were measured every 2000 cycles without stopping the test with visual failure as the primary outcome measure. Every 4000 cycles the vertical head displacement was readjusted to maintain the testing loads.

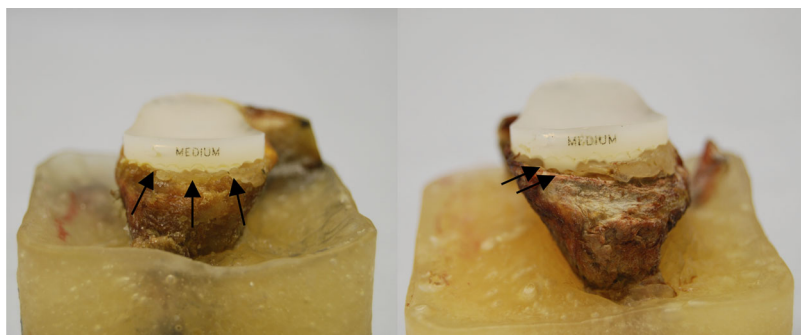
Figure 3. Failure definition: “partial failure” as inferior rim distracts away from cement (left) and “failure” as inferior pegs visible (right).

During testing, failure visually was defined in two stages (Fig. 3), initial failure was indicated by visible distraction of the inferior glenoid rim from the cement or bone substitute

block. Partial failure was defined as the point when the inferior pegs were visible during inferior rim distraction, where the test was stopped. Partial failure is referred to in the following text as failure. Superior bone crushing was defined by visible embedding of the superior implant rim or bone fracture and superior failure was defined as visible distraction of the superior rim. “CT partial failure” was defined as a radiolucent line between the implant rim and the cement and the bone or between the cement and bone (Fig. 4). “Complete failure” was defined as a radiolucent line reaching the inferior pegs in the CT images. Microscopic images were compared to the final CT image.

All ten implants visibly failed except one, which only partially failed (Fig. 3) where the test stopped after 200,000 cycles. Six failed exclusively at the implant-cement interface, two failed both at the implant-cement and cement-bone interface and two failed superiorly due to cortical bone failure (Fig. 4). Implant failure occurred between 16,300 and 122,500 cycles, with a mean (\pm SD) of $80,966 \pm 53,729$ cycles. The earliest specimen to fail had previously been identified as partially sclerotic. The partially failed implant was stopped at 200,000 cycles, although some superior and inferior implant-cement distraction was observed and CT scans revealed initial good implant seating. All final CT scans confirmed failure, which were observed visually (Fig. 5), however, in three specimens it was difficult to identify which interface loosening was apparent either visually or with CT. No significant difference was found between the three radial mismatches with respect to cycles to failure.

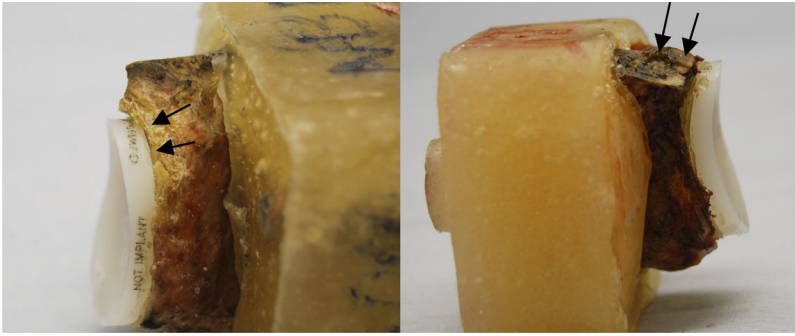
Figure 4. Superior failure-rim distracts away from cement (left) and bone crushing-bone fracture or implant embedding (right).

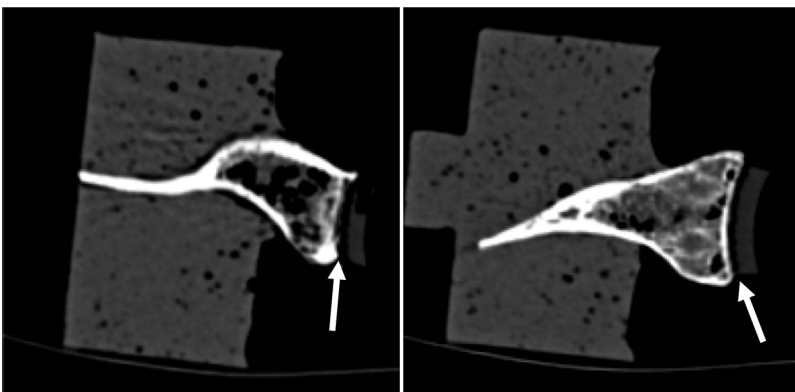
Figure 5. CT slices of the transverse plane showing an example of superior (left) and inferior (right) failure at the implant-cement interface in a specimen.

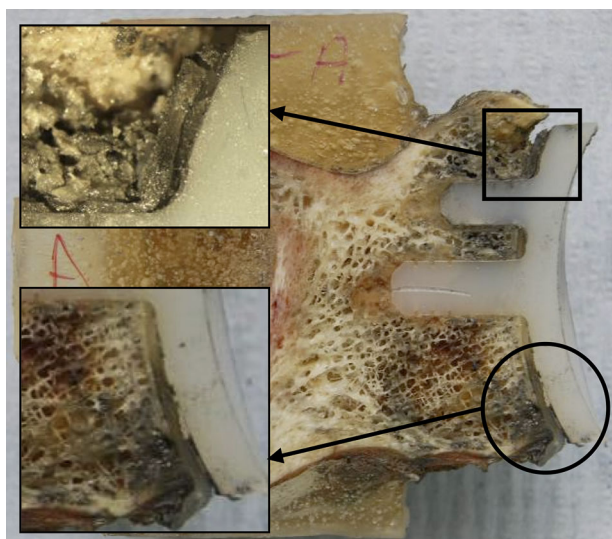
Figure 6. Cross-sectional slice of same specimen as CT after failure. Note: inferior failure of the implant-cement (circle) and superior bone crushing (square).

The visual examination of the sectioned specimens confirmed clear failure at the implant-cement interface and superior bone crushing, as was observed from

inspection of unsectioned specimens (Fig. 6). The microscopic study revealed the cement thickness varied from 0.5 to 1.5 mm and was cracked in three specimens at one of the peg junctions where bending stresses had been experienced. There were no other apparent cement fractures anywhere else. In one case, the implant completely detached at the implant-cement interface, the cement embedded in the peg grooves was still intact.

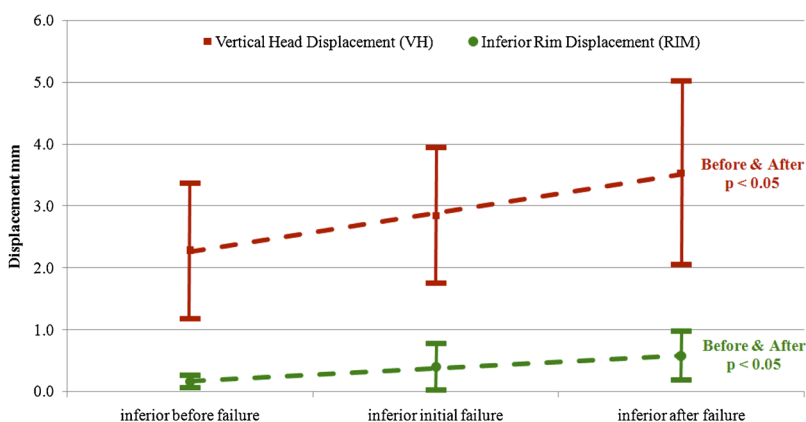
Figure 7. Positive correlation between vertical head displacement ($p < 0.05$) and inferior rim displacement ($p < 0.05$) with visual failure.

Inferior rim displacement and vertical head displacement both increased with observed failure (Fig. 7). The positive correlation between vertical head displacement before failure and at failure was statistically significant ($p < 0.05$). This was also true for the inferior rim displacement ($p < 0.05$). The mean vertical head displacement (\pm SD) before and after failure was 2.3 ± 1.1 and 3.5 ± 1.5 mm, respectively.

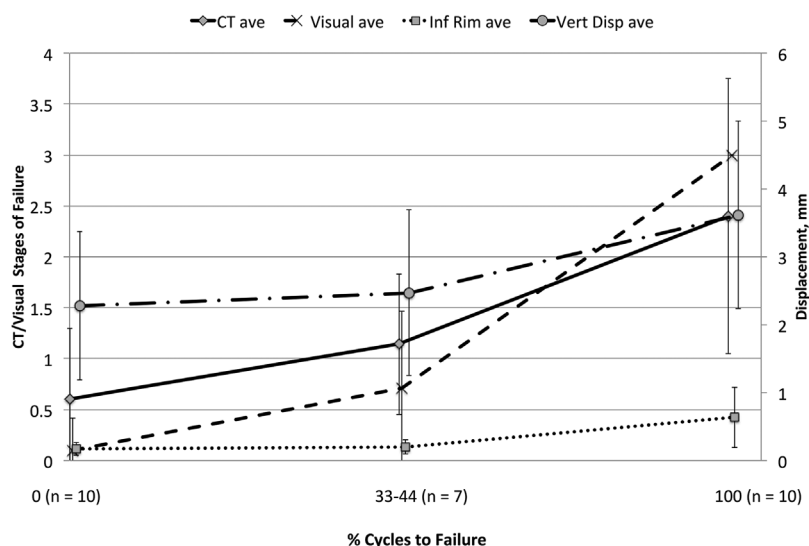
Figure 8. A plot of the mean clinical CT failure* and qualitative visual measures* with quantitative inferior rim and vertical head displacement against cycles to failure, normalised to a percentage. The plot shows correlation between displacements with CT and visual failure. *No failure, 1; partial failure, 2; and failure, 3.

All four failure measures: Clinical CT, qualitative visual, quantitative vertical head, and quantitative inferior rim displacement, positively correlated with cycles to failure (Fig. 8 and Table 1). On average, failure was identified in clinical CT images before visual failure was observed (Fig. 8). This observation was found in 8/10 shoulders. In the remaining two shoulders, CT and visual failure were observed together in one and visual failure observed first in the other.

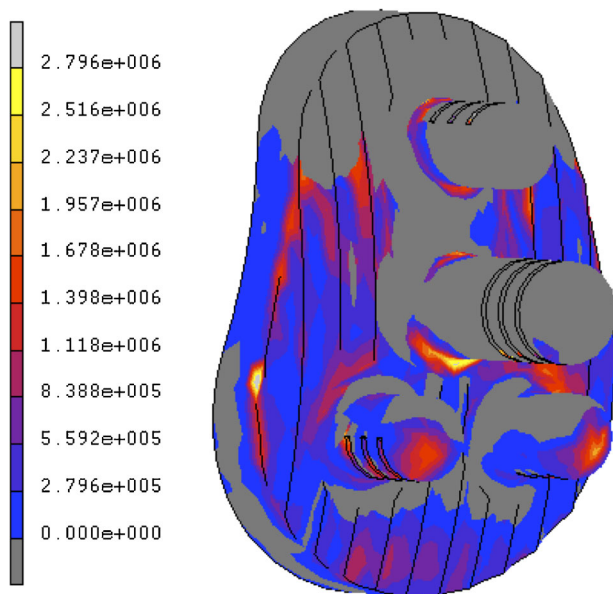
Figure 10. Tensile normal contact stresses at the implant/cement interface. Note: peak stresses at the inferior edge and pegs reaching up to 1 and 2.5 MPa, respectively.

The implant/cement interface normal stress predicted by the FE model showed superior compressive stresses and inferior tensile stresses. Tensile peak stresses were found at the base of the pegs (2.5 MPa) and peaked at the inferior edge of the implant (1 MPa).

Although the sample size was small, all ten cadaveric scapulae tested failed inferiorly at the implant-cement interface, and two of these also failed at the cement-bone interface. No specimen failed at the cement-bone interface alone, however, superior bone crushing was also observed clearly in three specimens. The CT scans indicated failure at the observed interface in seven cases and was able to detect failure before or with visual failure in nine specimens. All in vitro measurements correlated with CT failure, with quantitative rim displacement and head displacement both showing a significant increase from no failure to failure ($p < 0.05$) (Fig. 7). The FE model showed peak tensile loads at the inferior rim and at the base of the inferior pegs. Unpublished work in our laboratory have found implant/cement interface strengths at between 0 and 1 MPa for smooth implant surfaces, placing the peak tensile stresses within the failure range, thus possibly corroborating the experimental findings (Fig. 10).
