Research article

Role of local town planning authorities in building collapse in Nigeria: evidence from Enugu metropolis

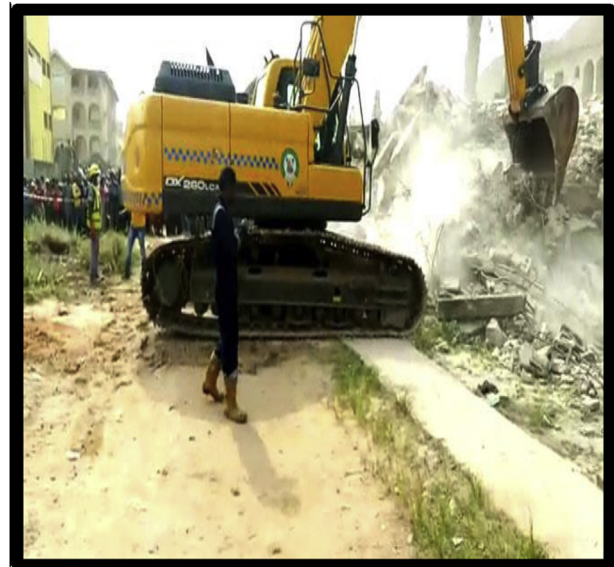
Figure 3. The collapsed building project in under controlled demolition in Lagos State.
Source: Authors' (2020).

enforcement of building regulations by the Town Planning Authorities and poor maintenance culture [41, 42]. For examples, the findings of the Lagos State Emergency Management Agency on the collapse of a 3 storey residential building under construction at Ugochukwu Omeja Close off Alasepe Street/Community Road off Ago Palace Way, Okota Lagos State Shown in Figures 2 and 3 that collapsed on 17th January, 2020 (see Figure) revealed that the primary cause of the collapse was poor supervisory role of Planning Authority, while the secondary cause of the collapse was linked to poor workmanship and the use of substandard building materials.

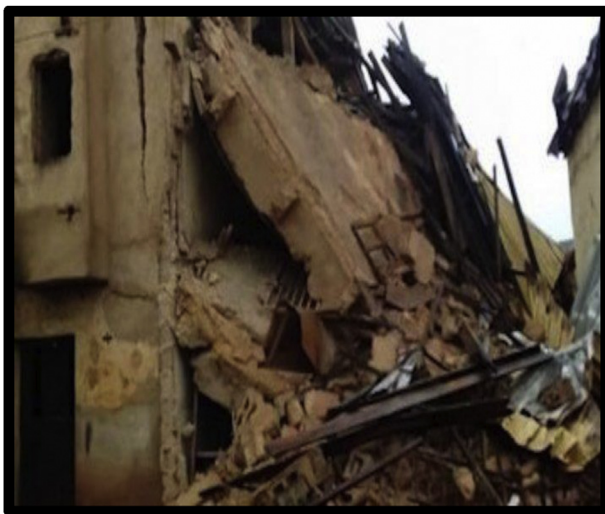
Figure 2. The collapsed building project in under controlled demolition in Lagos State.
Source: Authors' (2020).

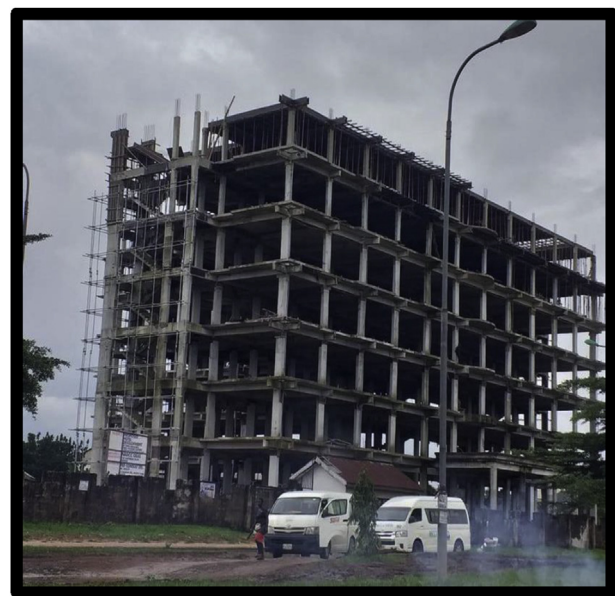
Figure 4. 8-storey hotel building before collapse in Owerri Metropolis Imo State.
Source: Author (2020).

Similarly, the preliminary reports of the panel of investigation comprising the Owerri Capital Development Authority (OCDA) and the Nigerian Institute of Architects (NIA) on the collapse of a 8-storey hotel building under construction located along Musa Yar' Adua Drive, Owerri, Imo State shown in Figures 4 and 5 that collapsed on 30th April, 2020 resulting in 40 fatalities, identified the primary cause of the collapse as non-adherence to construction drawings, poor supervisory role of planning authority and secondary cause of the collapse to be the use of substandard building material and structural failure.

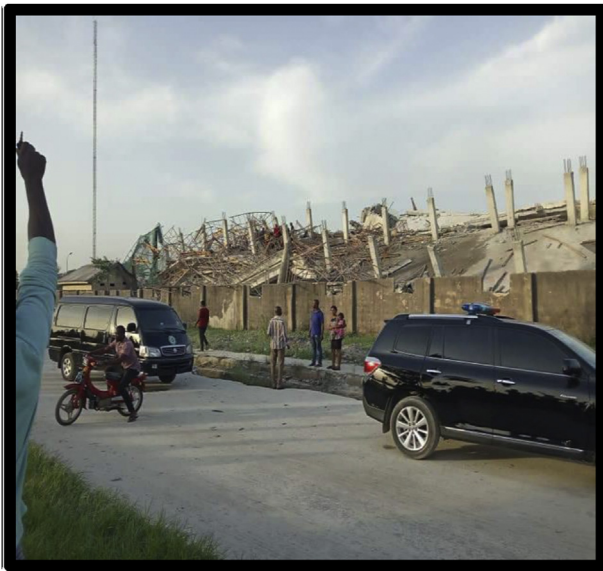
Figure 5. 8-storey hotel building after collapse in Owerri Metropolis Imo State. Source: Author (2020).

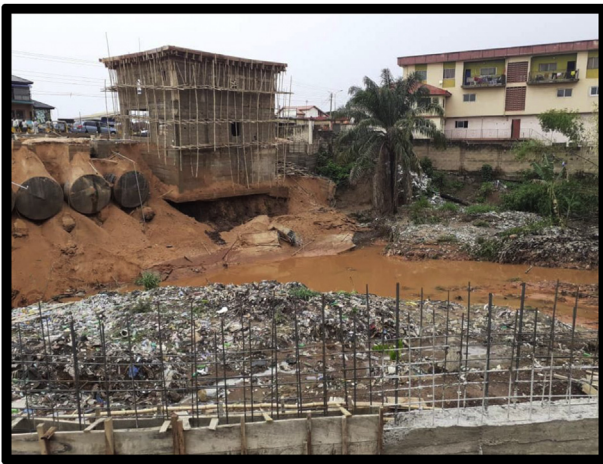
Figures 7, 8, 9, and 10 show the pictures of the case study of the gas station under construction along O'Connor Street, Enugu Metropolis that collapsed in April 2020. According to the investigative panel comprising the Enugu Capital Development Authority (ECDA) and the Nigerian Institute of Architects (NIA) revealed that although no fatalities was recorded, the main causes of the collapse of the building were the lack of building approval (no development permit was issued to the developer), poor supervisory role of planning authority and corruption. The secondary causes of the collapse were linked to heavy rainfall and location of the building along storm water channel.

Figure 7. The building project on water ways along O'connor Street, Enugu. Source: Authors' fieldwork (2020).

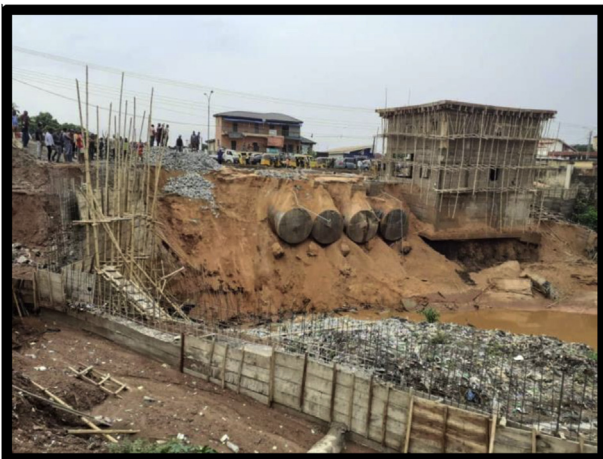
Figure 8. The building project on water ways along O'connor Street, Enugu. Source: Authors' fieldwork (2020).

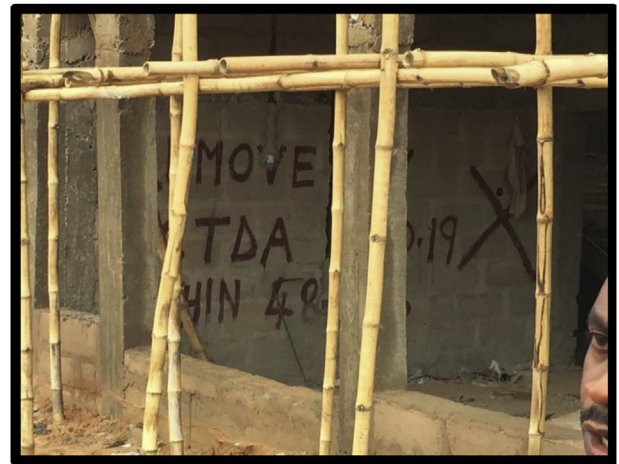
Figure 9. The building project mark of stop work order by ECDA along O'connor Street, Enugu. Source: Authors' fieldwork (2020).

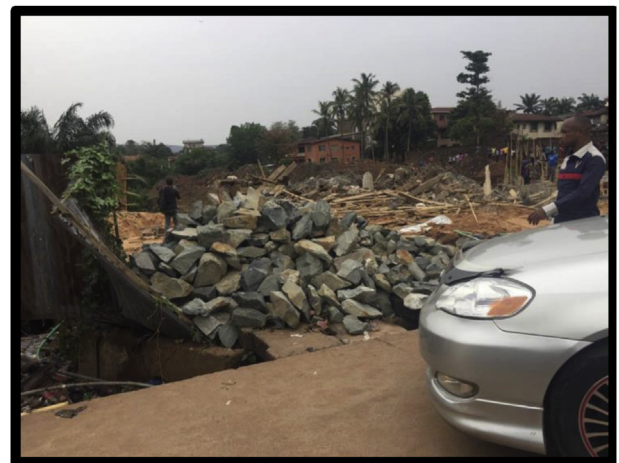
Figure 10. The debris of collapsed site along O'connor Street, Enugu. Source: Authors' fieldwork (2020).
