CASE REPORT

TRAUMA AND RECONSTRUCTIVE UROLOGY

An uncommon situation of kidney perforation with a ureteric stent

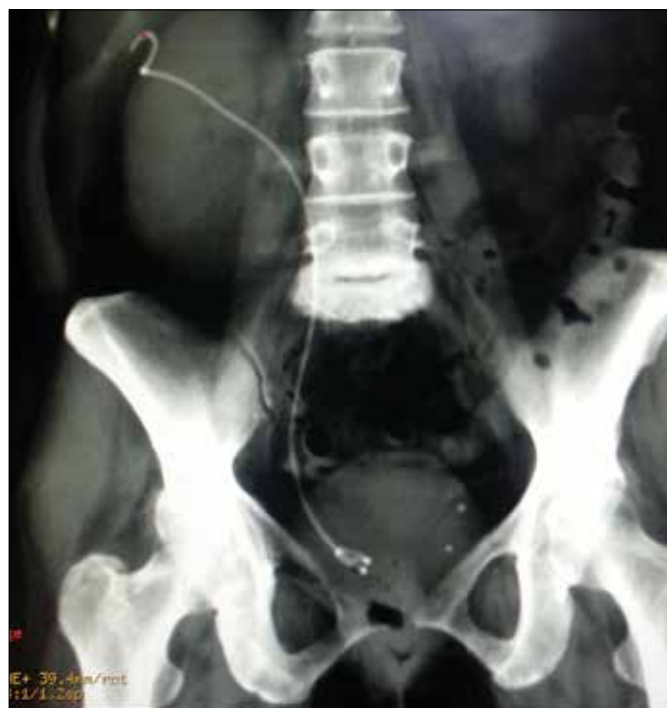
To evaluate the cause of fever the patient was referred to this center. A CT scan was ordered, which revealed an extrusion of the upper end of the double J stent outside the renal parenchyma (Figure 1). A review of prior X-rays of the patient revealed the same finding, wherein the upper end of the stent was

Figure 1. CT scout image showing the proximal tip of the stent localized outside the outline of the right kidney.

The stent was removed cystoscopically. A retrograde pyelogram showed a normal ureter; hence no stent was reinserted. The patient was put on broad spectrum antibiotic cover for 14 days post operatively.

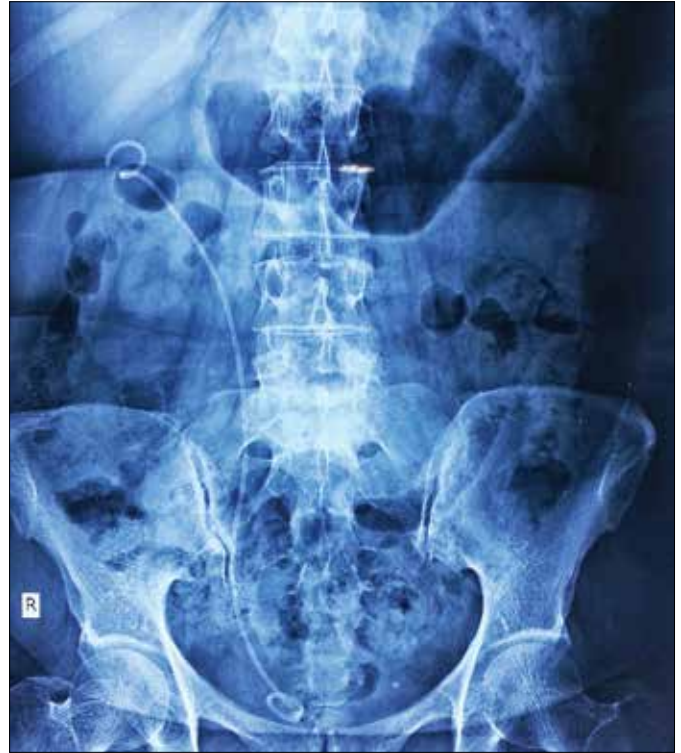
lying outside the renal outline (Figure 2). This fact was apparently missed earlier.

Figure 2. KUB x-ray showing extruded DJ stent.

that the loop was not in a tight loop and the tip of the stent was far away from the axis of the stent, pointing to extra pelvic location of the renal end of the stent. The urinary tract infections were possibly on account of transgression of parenchyma by the stent, since removal of the stent resulted in cure.
