Proximal Femoral Nail Mechanical Failure: A Case Report and Biomechanical Study

Abstract

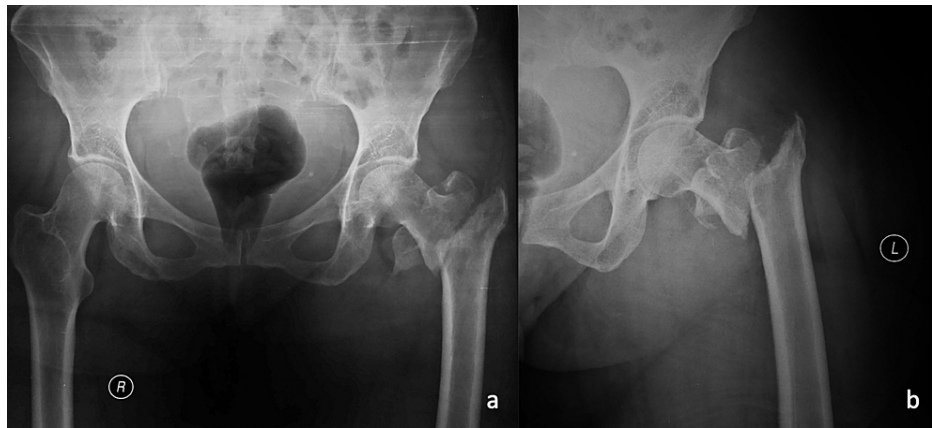
FIGURE 1: Anteroposterior pelvis (a) and lateral left hip (b) x-rays.

A 50-year-old female with a body mass index (BMI) of 19,5 was transferred to the Emergency Department after a fall from a standing height. She sustained a displaced pertrochanteric fracture (AO A2-2B) of her left hip (Figures 1a, 1b). Her past medical history was significant for hypertension and thyroid dysfunction. On post-admission day three, the patient underwent surgical fixation of her left hip on a fracture table. A proximal femoral nail (KFN, Königsee Implantate, Allendorf, Germany) of 125° Caput-Collum-Diaphyseal (CCD) angle was implanted. A hip screw of 80 mm length was used and distal locking was achieved by means of a 34-mm distal screw-in dynamic mode (Figures 2a, 2b). Postoperatively, the patient was mobilized with weight-bearing as tolerated and was discharged from the hospital on postoperative day 4. Screening for osteoporosis and vitamin D levels was scheduled but she was lost to follow-up.

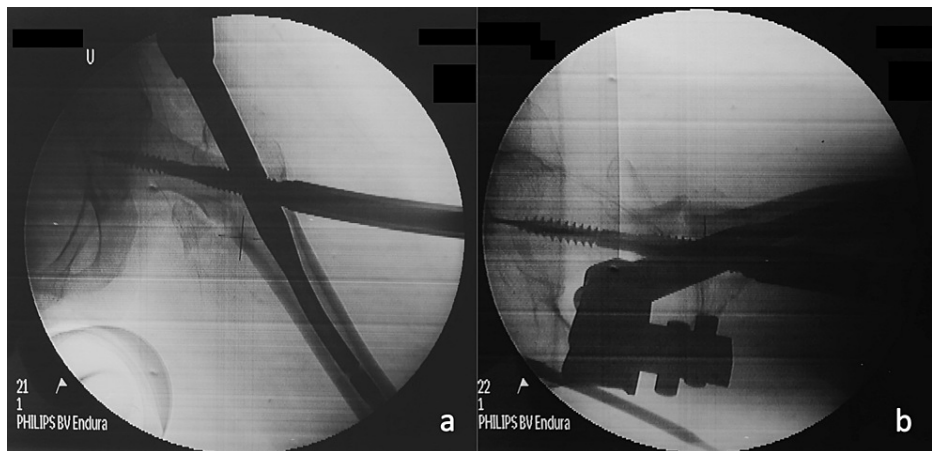
FIGURE 2: Anteroposterior left hip (a) and lateral left hip (b) intra-op fluoroscopy.

After scrutinizing our immediate postoperative x-rays, one could argue that there was a slight malreduction on the lateral view (Figure 2b). However, the tip to apex distance (TAD) was within acceptable limits (Figures 2a, 2b). After discharge, the patient was lost to follow-up and presented only nine months later with the fixation failure. The patient's compliance with postoperative instructions was questionable. Moreover, her mental status did not allow her to clearly describe or recall any preexisting pain or injury that caused the new incident. The selection of hemiarthroplasty versus total hip arthroplasty in this 50-year-old patient was decided, taking into account the patient's mental and functional status as well as her poor compliance. A hemiarthroplasty was considered to be a more stable [17] and viable solution.

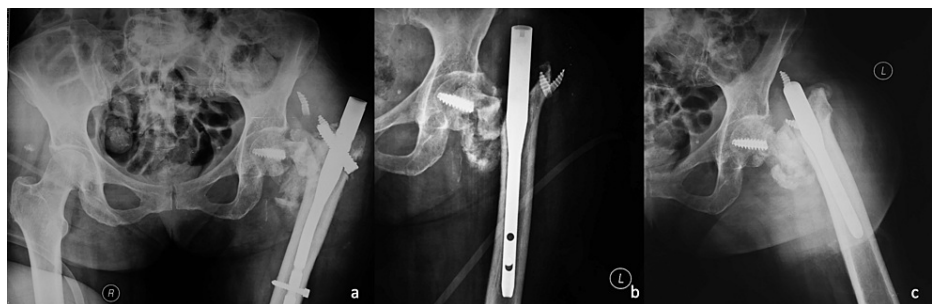
Nine months after the primary operation, the patient was transferred again to the emergency department, reporting pain and inability to bear weight on her left hip without reporting clearly what happened. X-rays (Figures 3a-3c) revealed multifragmented implant and fixation failure. Blood tests (C-reactive protein, erythrocyte sedimentation rate, and white blood cells count), in order to rule out infection, were all within normal limits.

FIGURE 3: Anteroposterior pelvis (a) and lateral left hip (b,c) x-rays after implant failure.

On post-admission day 4, a revision operation took place. With the patient in the lateral decubitus position, an extended Hardinge approach was performed. Broken implant was removed and a left hip cemented hemiarthroplasty was done (Figure 4). Cultures of tissue samples taken intraoperatively were negative. The

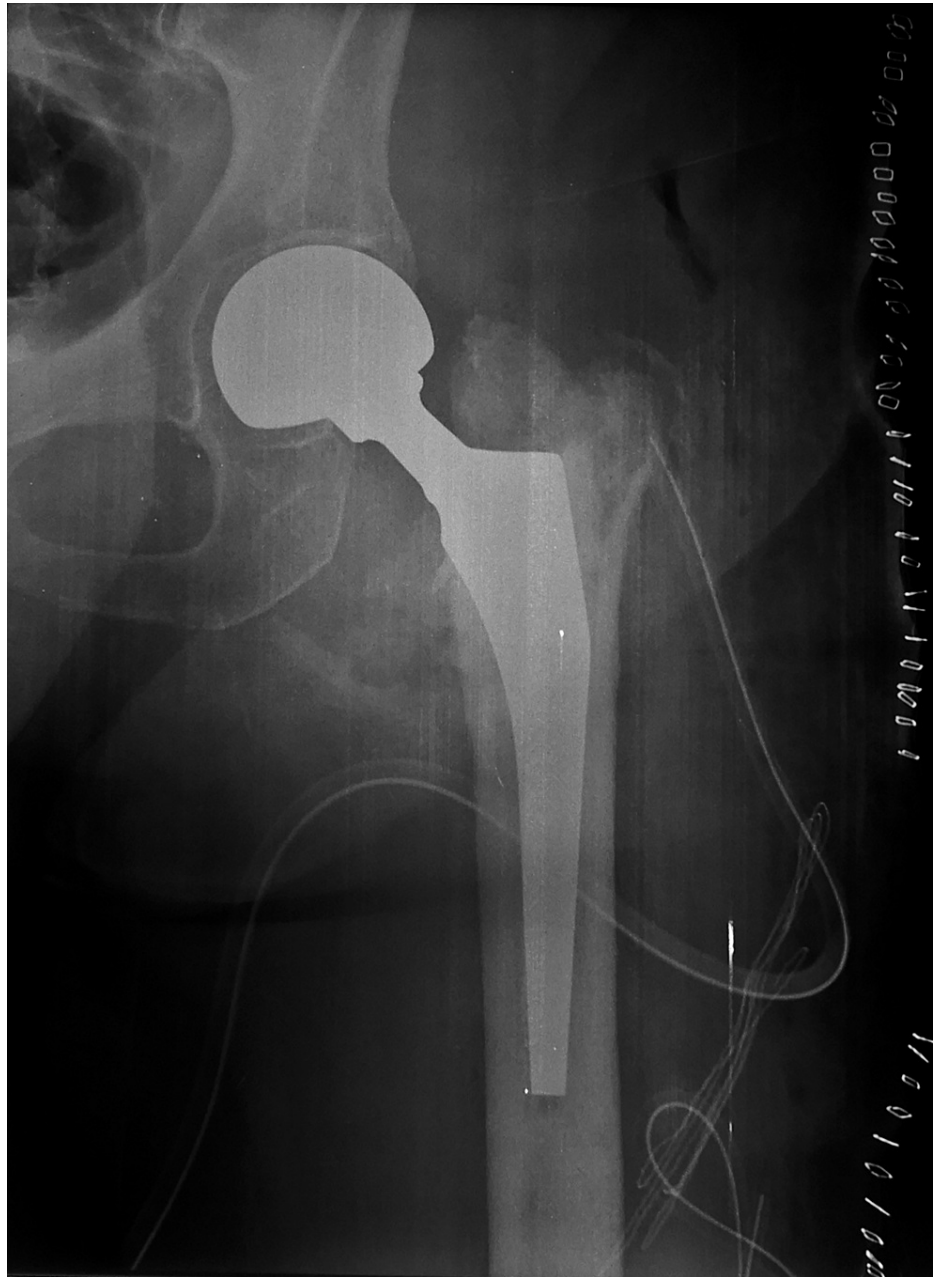
FIGURE 4: Cemented left hip hemiarthroplasty.

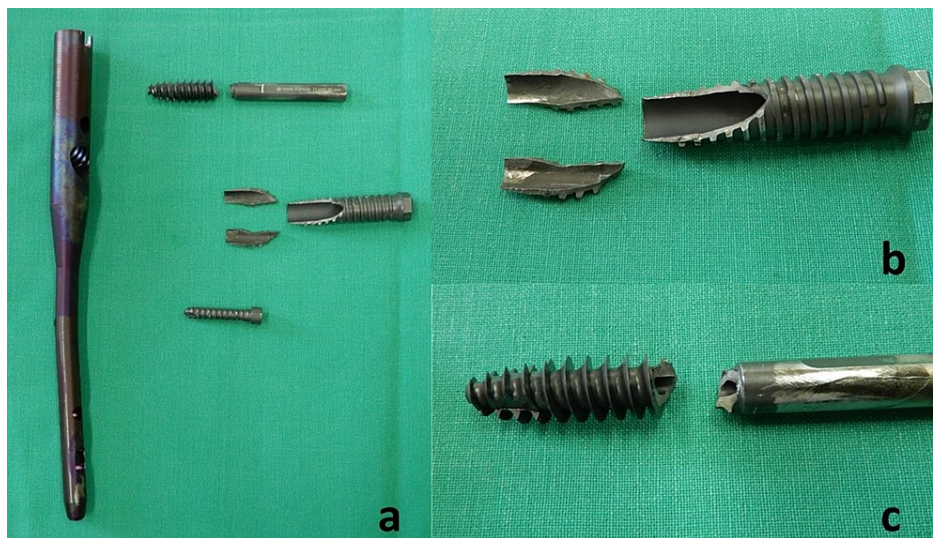
FIGURE 6: Broken implant (a), broken sleeve detail (b), and broken hip screw detail (c).

The status of the broken implant that was removed from the patient was assessed via fractography in order to determine the fracture mechanism that led to the catastrophic failure of the KFN assembly. As it can be seen in Figure 6, both the hip screw and the hip screw sleeve failed catastrophically. A first visual macroscopic examination of the debris revealed rough fractured surfaces of uniform texture. There was not any sign of neck formation, which would indicate plastic deformation, and the resulting fracture faces matched almost perfectly. Most of the material prior to fracture was recovered; however, some very small pieces were missing further pointing to a brittle (sudden) failure.

pathology exam reported calcified tissue debris and fibrosis (Figure 5). Broken implant (Figures 6a-6c) was sent to mechanical engineering laboratory for fractographic analysis. The patient came back for new radiologic evaluation one month postoperatively (Figure 7) and was again lost to follow-up thereafter.

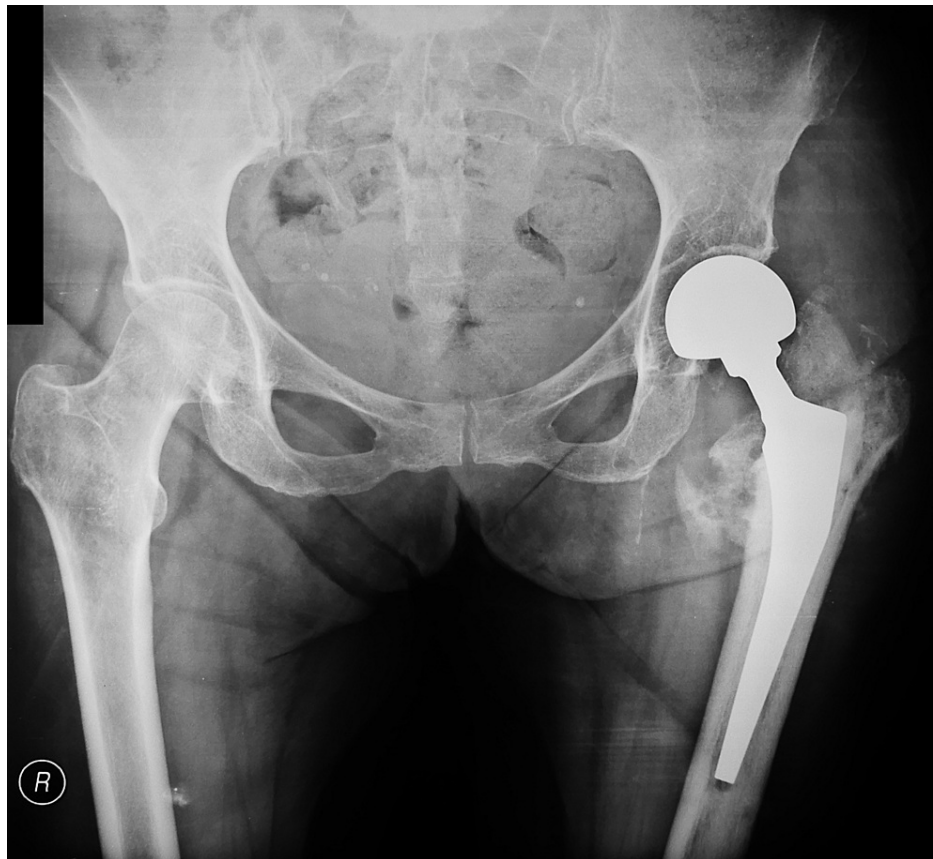
FIGURE 7: Anteroposterior pelvis x-ray, one month postoperatively.

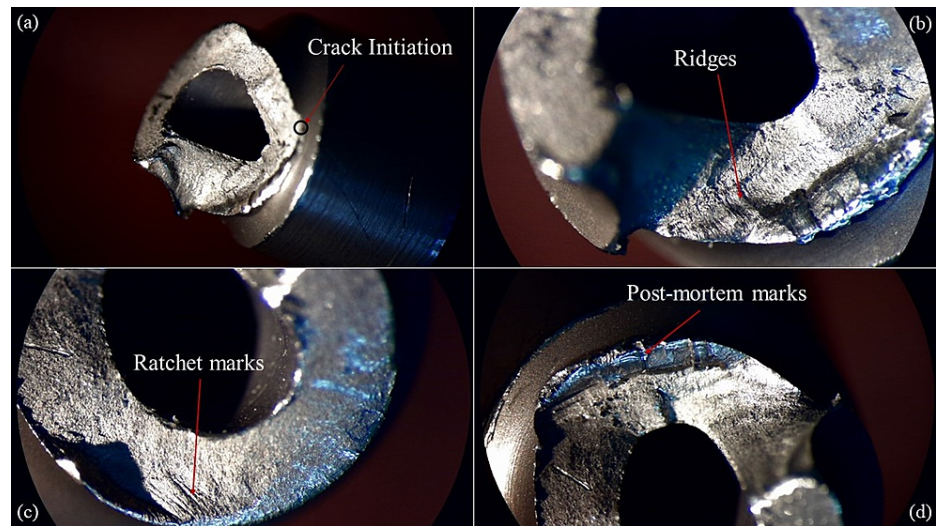
After preliminary visual examination of the fracture surfaces, a comprehensive fractographic analysis followed using a stereoscope (Leica MZ6, Leica Microsystems, Germany). The fracture surface of the broken hip screw (Figures 8a-8d) was selected for the analysis. In the same figure, representative photographs of the fracture surface in 30x magnification are presented. A thorough examination of these images was expected to reveal the cause of the fracture in detail and provide evidence regarding the cause of failure (either overloading or fatigue).

FIGURE 8: Photographs (a-d) of the broken hip screw fracture surface in 30x magnification (stereoscope).

Figure 8a presents an overview of the fracture surface, which is apparently not perpendicular to the axis of the hip screw. The crack initiation point was located near the start of the thread, where a change in diameter was present and therefore stress concentration was expected to occur. The crack propagated at an inclination of 50-55 degrees in respect to the screw axis until it reached the first thread, from where it followed the thread helix until the screw failed completely. Given the nature of the loads that the screw should withstand to retain the hip and after examining the characteristics of the crack's initial direction and propagation, the conclusion was drawn that the screw failed under combined bending and torsional loading.

Figures 8b, 8c present some characteristic types of fracture lines that they were found on the examined fracture surfaces. Ratchet marks and ridges mainly indicate step-like progression of the crack and occur parallel to the direction of crack growth [17,18]. Although they are common in both brittle and fatigue fractures, in the latter they coexist in most cases with beach marks, which appear as coaxial arcs centered at the crack initiation point and form during the stable crack growth phase. In the examined fracture surface no beach marks can be identified. The only visible marks on the surface are indicated in Figure 8d and cannot be attributed to fatigue loading since the surface locally is considerably rough and the crack initiation point is located near their left end. They are most probably post-mortem (i.e., occurred after failure) marks created from localized asperity contact of the failed surfaces in the body of the patient in the period between screw failure and the KFN debris removal operation. Furthermore, the absence of any sign of chemical action on the failed surfaces (i.e., calcification, corrosion, oxidation) strengthens the hypothesis of sudden failure due to overstressing.

In conclusion, the fracture was caused due to the combined action of bending and torsion. The absence of beach marks and the uniform roughness of the fracture surface combined with the absence of chemical attack exclude the possibility of fatigue failure. In addition, the absence of plastic deformation features, such as shear leaps, and the fact that the fracture surfaces match almost perfectly exclude the possibility of ductile fracture. Consequently, based on the above fractographic analysis, the failure of the screw is attributed to an abrupt brittle fracture due to overloading.

After evaluating the fixation failure and patient status, questions regarding possible fracture nonunion, implant fatigue failure, potential implant defect, or a new high load incident, e.g., fall from height, arose and needed to be answered. We decided to proceed with a thorough biomechanical analysis. Fractography is a validated method for describing the cause of mechanical failure [18-20]. A scanning electron microscope could be a useful adjunct in our study but was not available. The analysis documented an abrupt brittle fracture due to sudden overloading as the cause of mechanical failure. Thus, our major concern of implant manufacturing defect or damage during implantation was ruled out.
