Case Report

Failure of the Femoral and Tibial Components Following Anterior Cruciate Ligament Injury After Robotic-Assisted Bicruciate-Retaining Total Knee Arthroplasty

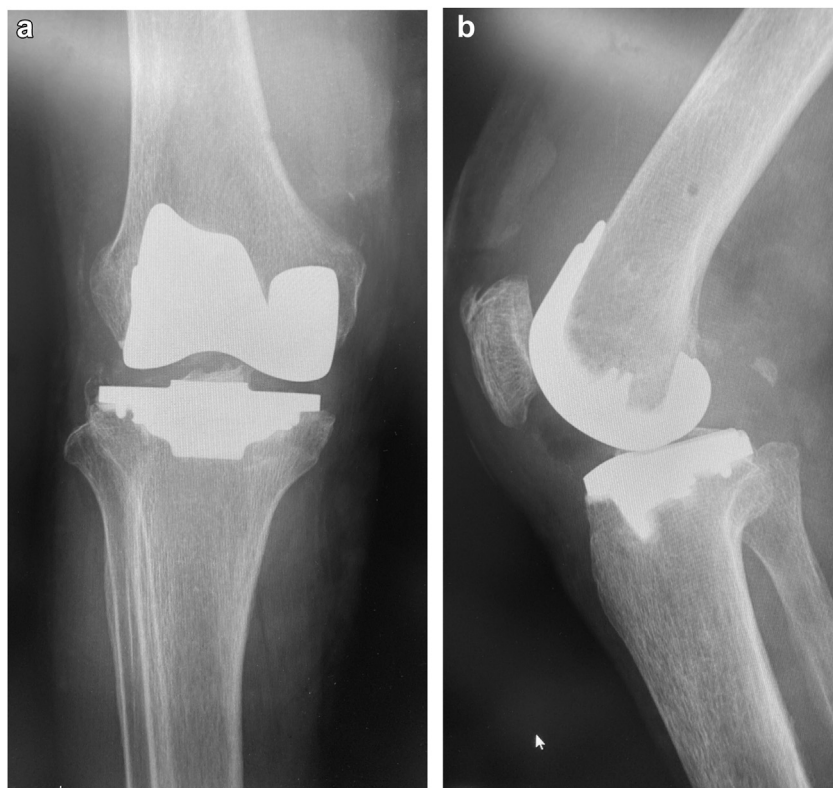
Figure 1. Postoperative plain radiographs after robotic-assisted bicruciate-retaining total knee arthroplasty. (a) Antero-posterior view; (b) lateral view.

A 70-year-old female farmer with body mass index of 21.5 kg/m² and bicompartamental knee osteoarthritis (Fig. 1) underwent RA TKA (CORI, Robotic Surgical System, Smith & Nephew, Plymouth, MN) with a BCR prosthesis (Journey II XR, Smith & Nephew, Inc., Memphis, TN) (Fig. 1). The patient had no preoperative pain and was able to farm without hindrance. At 8 months after surgery, the patient fell while working in agriculture and sustained injury due to valgus loading of the knee joint, internal rotation, and adduction of the hip joint, that is, knee in.

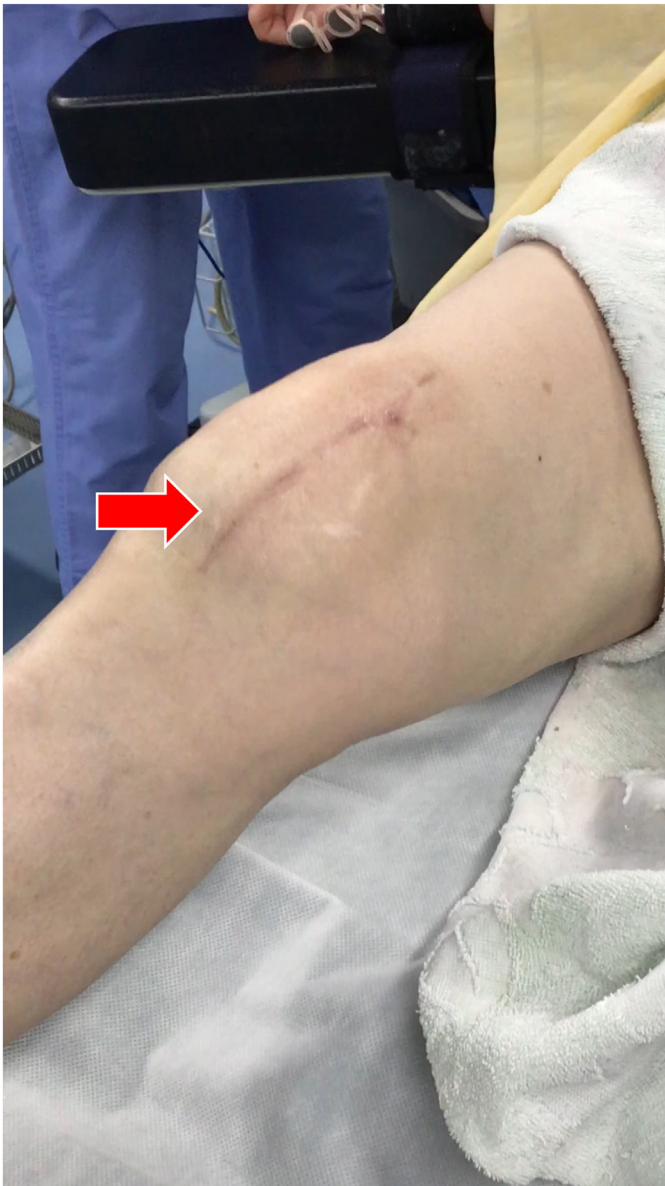
Figure 2. Crepitus on the lateral side of the skin incision with flexion (red arrow).

months after surgery. Clinical findings included joint effusion with dark brown blood, crepitus with flexion (Fig. 2), positive anterior drawer sign, and anterolateral rotatory instability. Range of motion (ROM) was assessed from 5 to 90 degrees. Plain radiographs of the right knee showed the metal line sign associated with the shapes of the femoral and tibial components and thrust of the femoral component in the medial direction (Fig. 3).

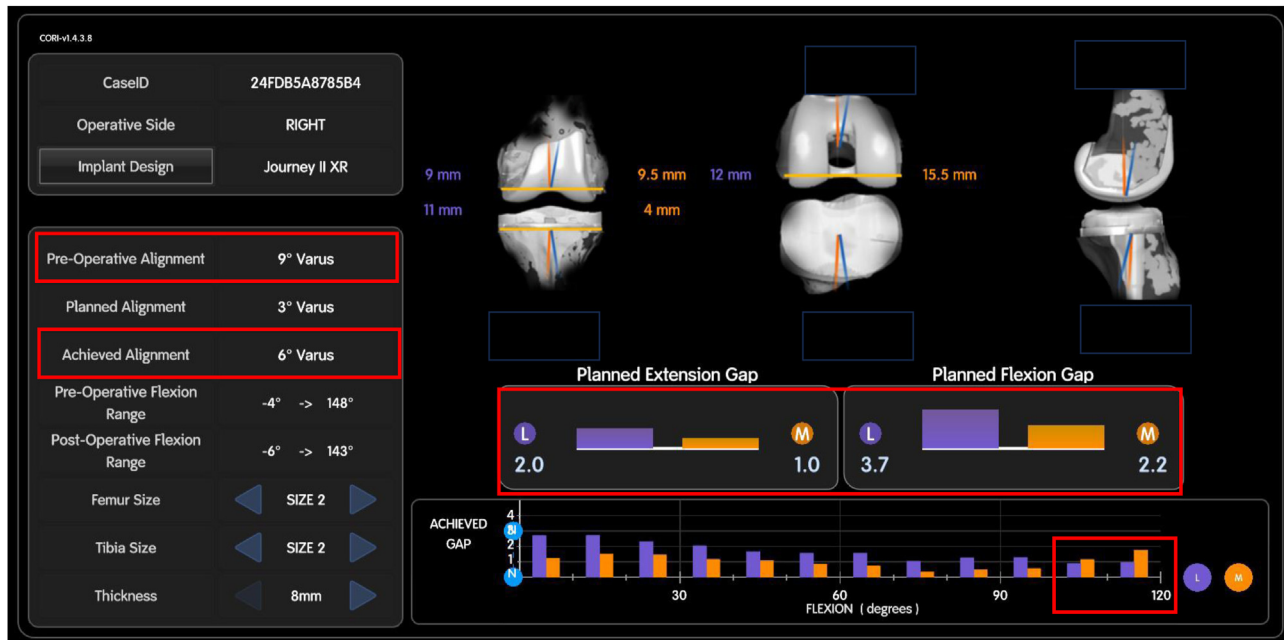
Figure 8. Intraoperative gap assessment and component alignment. Preoperative HKA angle of 9 degrees varus improved to postoperative HKA angle of 6 degrees varus, corresponding to undercorrection. Gaps were assessed intraoperatively: medial joint gap (MJG) of 1.0 mm and lateral joint gap (LJG) of 2.0 mm in extension, and MJG of 2.2 mm and LJG of 3.7 mm. From extension to 100 degrees of flexion, MJG was smaller than LJG, consistent with physiological laxity. However, from 100 degrees of flexion to deep flexion, MJG was larger than LJG, indicating medial laxity.

< LJG) from 0° to 140° of flexion results in improved postoperative patient ROMs with Journey II XR prosthesis using conventional jig-based technique and a balancer [17]. Therefore, with the RA surgical technique, component alignment and osteotomy volume were determined with consideration of soft tissue balance in reference to these findings. In the present case, intraoperative gap assessments were MJG of 1.0 mm and LJG of 2.0 mm in extension and MJG of 2.2 mm and LJG of 3.7 mm. From extension to 100° of flexion, MJG was smaller than LJG, consistent with physiological laxity. However, from 100 degrees of flexion to deep flexion, MJG was larger than LJG indicating medial laxity (Fig. 8). The preoperative hip and knee angle (HKA) improved from 9 degrees of varus alignment to 6 degrees of varus alignment after surgery (Fig. 8). Determining component alignment based on this patient's soft tissue balance resulted in undercorrection of the postoperative HKA, while the MJG resulted in a concern for medial loosening with deep flexion.
