Application of material from used car tyres in geotechnics—an environmental impact analysis

Aleksander Duda¹, Małgorzata Kida², Sabina Ziembowicz² and Piotr Koszelnik²

This work begins with a literature-based discussion of the hazardous-waste problem represented by car tyres as hazardous waste, along with possible ways in which they might be utilised or managed. The impact of the material on the environment is characterised in the process, not least in the context of pollutants leached to the aquatic environment. Input in terms of new research results concerns the impact on water and soil of material from used car tyres being used in geotechnics. Specifically, tyre bales comprising 100–140 car vehicle tyres compressed into a lightweight block and secured by galvanised steel tie wires running around the length and depth of the bale, were researched, having been immersed in basins with alkaline and acidic water following initial preparation and pre-washing. The aim was to in some sense simulate—respectively—conditions in which rain and surface/ground water are involved, or else acid rain. To do that, the tyre bales were placed in the water for 120 days, with emerging leachate analy

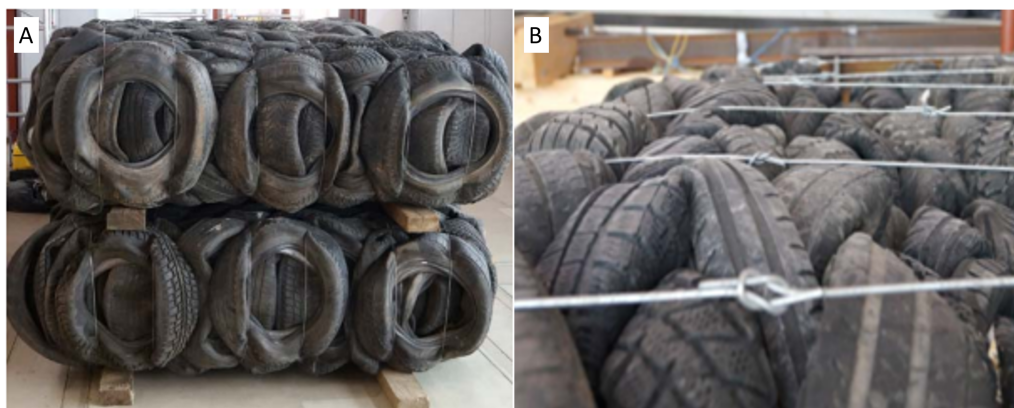
Figure 1 Tyre bales used in research. (A) General view of tyre bale. (B) Detail of connection wires.

The pressing and packing of tyres has represented a response to the obligation that the input of tyre-related components be reduced, also given the increasing risk that the tyres present at dumps might self-ignite. Tyre bales considerable potential for use in construction, particularly where their low density and ease of handling give them an advantage. Tyre bales used in the experiment comprised 135 whole waste passenger-vehicle tyres compressed into a lightweight block with the weight of around 1,000 kg and the density of circa 500 kg/m³. Each bale contained only one type and size of tyres. The bales were produced according to PAS 108 (*PAS: 108, 2007*) in a tyre baler capable of compressing whole tyres to reach the density not lower than 420 kg/m³. The bales measured approximately 1.30 × 2.05 × 0.75 m and were secured by six galvanized steel tie wires running around the length and depth of the bale (*Fig. 1*). Apart from tyre bale dimensions -slightly modified to facilitate transport - the remaining PAS 108 (*PAS: 108, 2007*) production requirements, i.e., compressing force, density (mass/volume ratio) and number and tension of steel tie wires, were fulfilled.

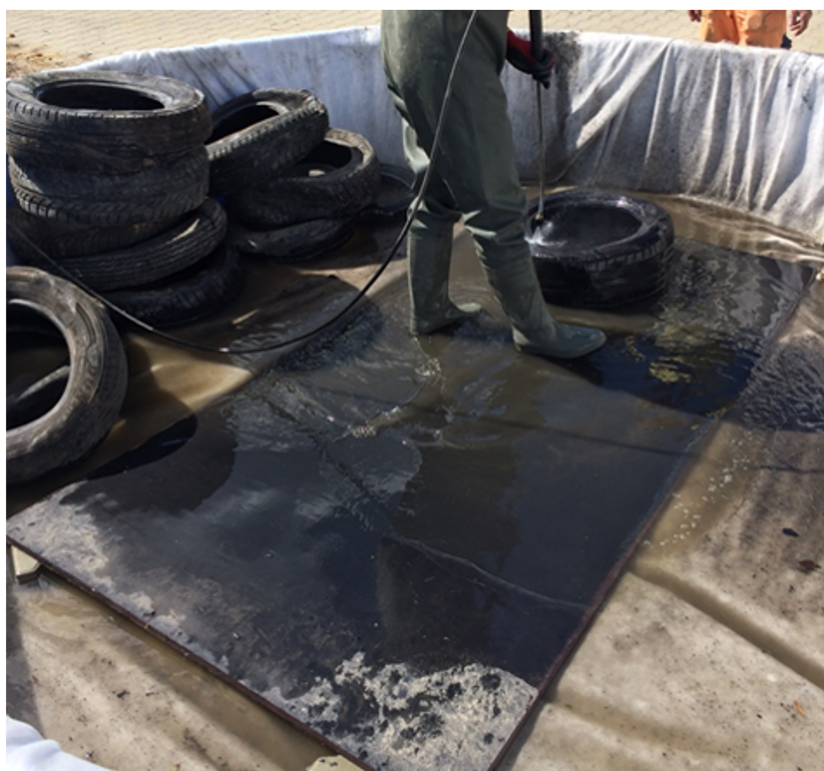
Figure 2 Stage I: washing tyres intended to perform tyre bales; testing leachate.

The environmental testing of tyre bales proceeded in stages. Stage I saw the tyres from tyre bales washed with tap water (WW) (*Fig. 2*), with both the collected leachate (M) and inputting water made the subject of physico-chemical analyses. The used tyres involved were obtained from a tyre store and not cleaned preliminarily in any way. In Stage II of the testing, washed tyre bales were placed in two separate pools (*Fig. 3*), i.e., one filled with tap

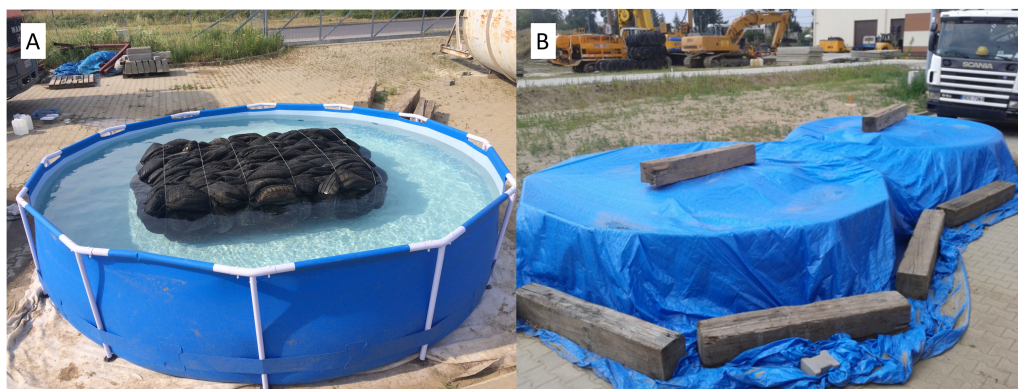
Figure 3 Leachate test trial. (A) Tyre bale in test pool. (B) Test trial protected against atmospheric influences.

water at pH 8.71 and a second acidified to pH 3.87. The goal was for the first pool to mirror conditions in which rain and surface/ground water is present, while the second simulated situations of acid rain.

The tyre bales were left immersed for 120 days, with sampling on days 0, 21, 68, 99 and 120. Based on the reviewed literature and previous experience in site contamination, factors
