Management of Broken Dental Implant Abutment in a Patient with Bruxism: A Rare Case Report and Review of Literature

Abstract

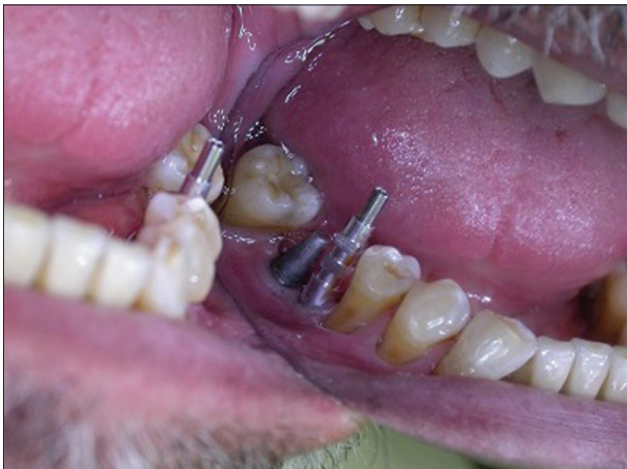
The impression post for the open tray and the fabricated abutment for the 3.3 and 4.8 mm diameter implants, respectively, were inserted in parallel direction [Figure 4]. A pick-up impression was taken, an Narrow Neck CrossFit (NNC) cementable titanium abutment, with a height of 5.9 mm was selected for 3.3 mm diameter implant, and the fabricated abutment was inserted into the cast and to be sure in a parallel direction. Laboratory procedures as well as fabrication of a single metal framework for porcelain-fused-to-metal cemented crown were conducted [Figure 5]. The NNC cementable titanium abutment screw was tightened into 3.3 mm diameter implant, and the fabricated custom-made abutment was cemented into the 4.8 mm diameter implant using resin cement. Delivery of the final restoration included confirmation that proximal contact allowed the patient to perform normal oral hygiene procedures using dental floss and the occlusal scheme for all molars was evaluated to ensure a firm-centric contact [Figure 6]. A postoperative photograph and radiograph were taken after cementation to confirm the seating of the two-implant supported molar restoration at the time of delivery. Oral hygiene instructions were reinforced, and the importance of periodic recall visits was emphasized. A maxillary acrylic resin occlusal guide was provided for long-term stability in this case due to the patient's history of bruxism. Radiographic evaluation has indicated a stable periodontal condition with little or no bone loss associated with the osseointegrated implants. The

Figure 4: Impression post and fabricated abutment were inserted

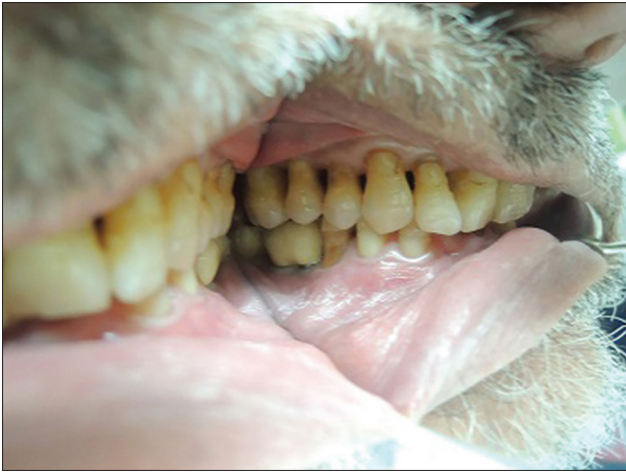
Figure 6: Delivery for the final restoration
