## Influence of surface preparation on fracture load of resin composite-based repairs

Agustín-Panadero R, Mateos-Palacios R, Román-Rodríguez JL, Solá-Ruiz MF, Fons-Font A. Influence of surface preparation on fracture load of resin composite-based repairs. J Clin Exp Dent. 2015;7(1):e80-3.  
http://www.medicinaoral.com/odo/volumenes/v7i1/jcedv7i1p80.pdf

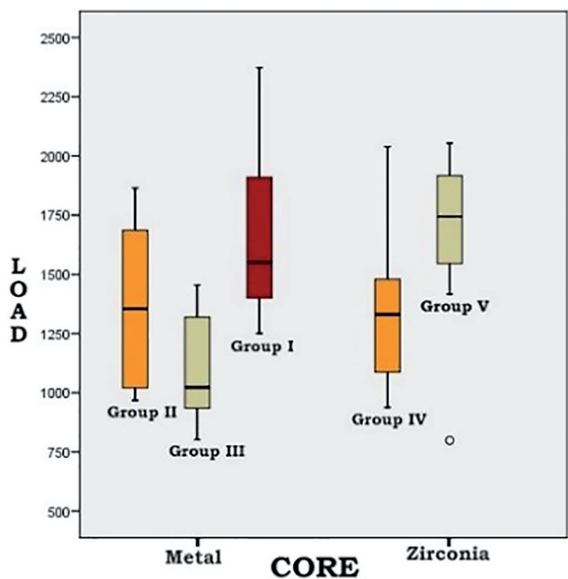
**Fig. 1.** Box plot shows the distribution of fracture resistance values in relation to crown core material and surface preparation.

Repaired ceramic-fused-to-metal crowns obtained mean final fracture values of 1372.4N, Group I (diamond bur + HF) obtaining the highest value (1667.2±394.3N). Bonferroni bivariate contrast analysis revealed that mean fracture resistance was significantly higher for Group I than for Group III (silica-coated) (1094.3±212.6N) ( $p= 0.001$ ). However, no evidence was found of higher fracture resistance in Group I than Group II (air-particle abrasion) (1355.6±333.8N)( $p=0.137$ ). No statistically significant differences were found between Group II (air-particle abrasion) and Group III (silica-coated) ( $p=0.275$ ) (Fig. 1).

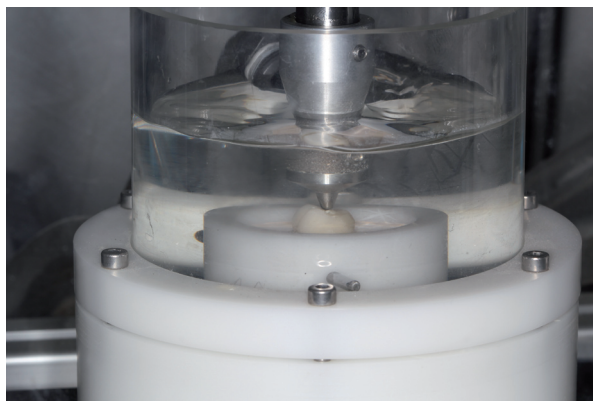
**Fig. 3.** Sample undergoing dynamic loading and thermocycling.

When the samples had been repaired, they were subjected to dynamic loading in a chewing simulator (SD Mechatronik, Chewing Simulator CS-4. Mechatronik GmbH, Feldkirchen, Germany); they received 120,000 cycles with loads of 80N and 2Hz frequency with a vertical displacement of 2mm. They then underwent thermocycling (Thermocycler 2000, Heto-Holten A/S, Allerød, Denmark) for 6000 cycles with temperature changes between 5°C and 55°C every 30 seconds. When the samples had been fatigued, they were subjected to load testing (Shimadzu model AG-X plus) until the point of fracture, registering the final fracture values in Newtons (N), as well as the type of fracture produced.

Although crowns with zirconia cores showed a tendency for samples repaired with silica-coating to obtain higher final fracture values (1660.2±361.6N, compared with an overall mean fracture resistance of 1517.8N), no significant differences were found between these samples (Group V) and samples treated with air-particle abrasion (Group IV: 1375±362.9N) ( $p=0.067$ ) (Table 1) (Fig. 2). Observing the type of fracture produced, all in vitro mechanical failures were found to be adhesive fractures (Fig. 3).

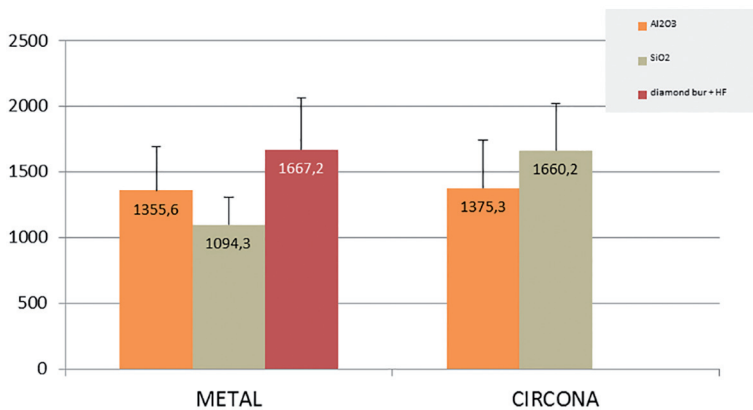
**Fig. 2.** Mean fracture resistance (N) in relation to crown core material and surface preparation.
