## Technical note

# The preventive effect of hydrocolloid dressing to prevent facial pressure and facial marks during use of medical protective equipment in the COVID-19 pandemic

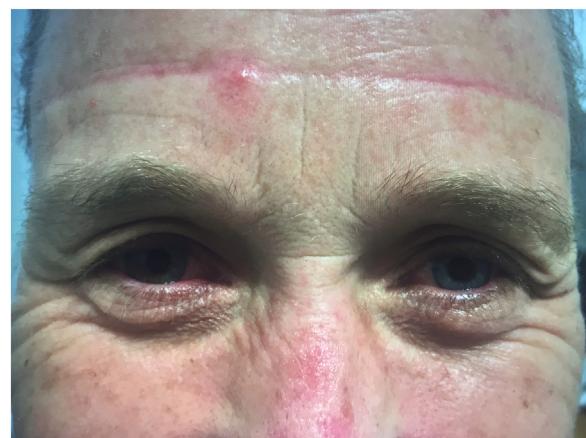
Fig. 1. A distinctive red line can be seen on this nurse's forehead from where her protective equipment pressed down on her face, and an erythematous zone in the nasal dorsum.

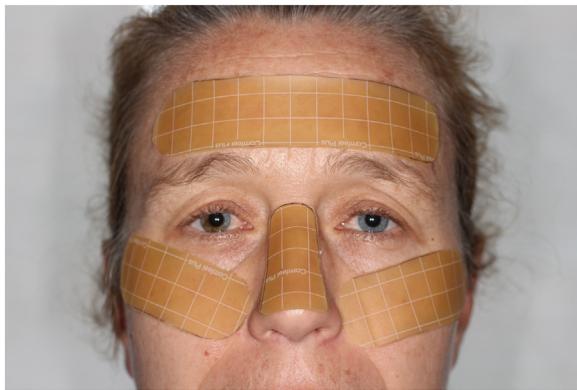
Fig. 2. This nurse has hydrocolloid on her cheeks as well as her forehead to stop her protective outfit from rubbing and causing pain.

After the hydrocolloid dressing has been trimmed the adhesive dressing is then placed over the skin of the nasal dorsum, cheeks and forehead, covering the area where the mask and protective glasses will rest (Figs. 2 and 3).

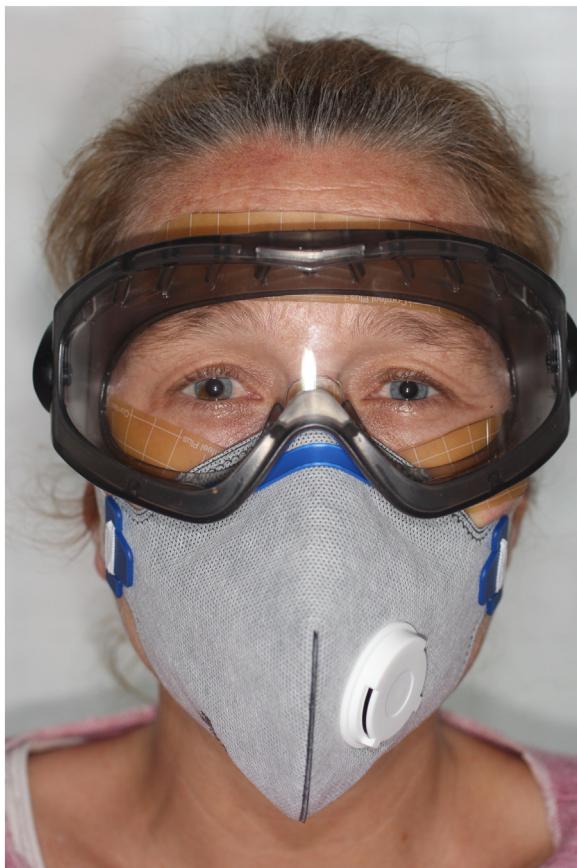
Fig. 3. The protective equipment adapts perfectly to the facial surface and the skin on which both the mask and glasses rest. It is completely protected.

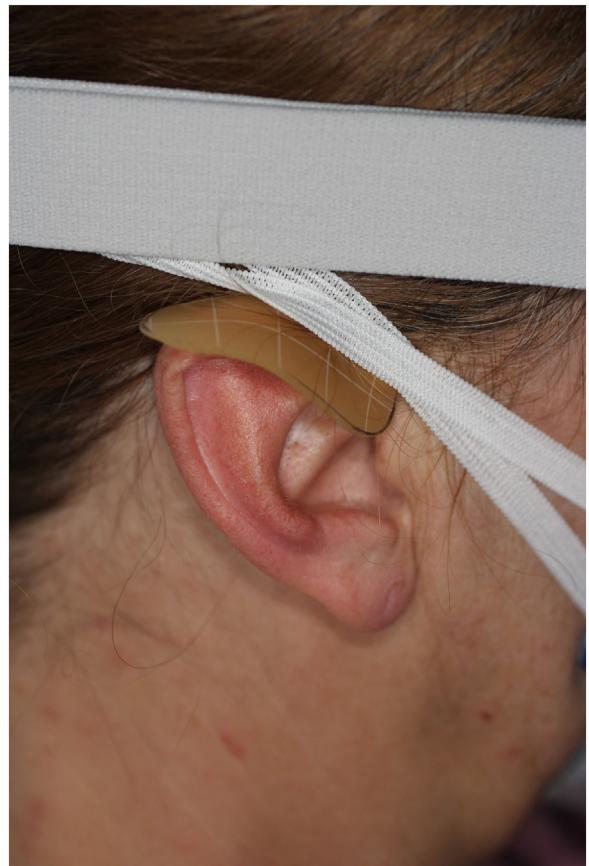
Fig. 4. The areas of the root of the auricular helix must especially be covered by the hydrocolloid to avoid skin injury.

A particularly damaged and painful location despite daily use of the strips of for the masks and the elastic band straps of protective glasses and screens with cranial support are the areas of the root of the auricular helix. We will also apply

a hydrocolloid dressing to measure friction in these areas (Fig. 4).
