Fracture resistance of polyetheretherketone, Ni-Cr, and fiberglass postcore systems: An *in vitro* study

Hossein Pourkhalili¹, Donya Maleki²

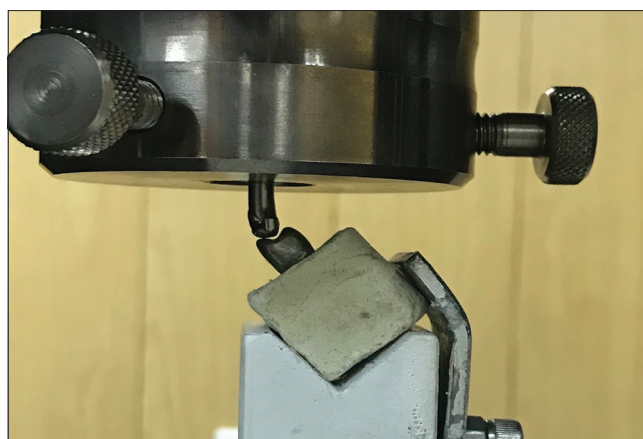
all the specimens were tested with a universal testing machine (STM-250, Santam, Tehran, Iran). A 4-mm spherical indenter was positioned to load the force in the central fossa of the teeth with an angle of 135 degrees to the long axis with a speed of 0.5 mm/min until a visual or an auditory fracture occurred [Figure 1]. The applied force being recorded at MPa had a drop at this moment in the force-time diagram. Eventually, the fracture pattern was checked with radiography and confirmed objectively by cutting the acrylic resin boxes using burs. Six patterns occurred:

Figure 1: Specimen setting on the universal testing machine.
