Case Report

Dislocation of a McMinn-Like Prosthesis with Distinctive Metallosis and Fracture of the Os Ilium

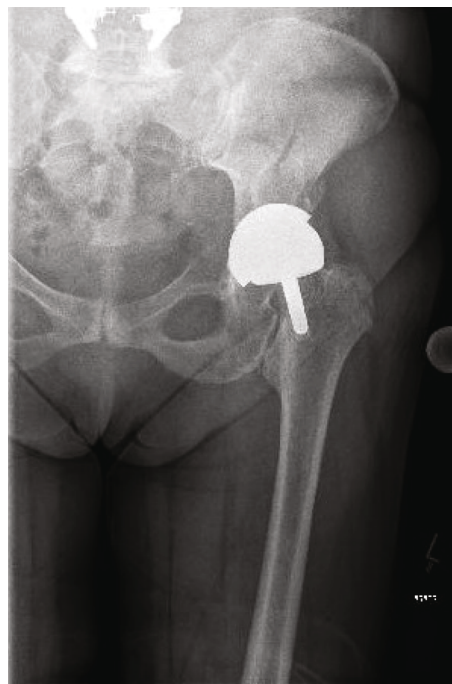
FIGURE 1: Initial X-ray of the fracture. After a stumble fall, the patient presented herself to an orthopedist. An anteroposterior X-ray of the pelvis was conducted and showed a fracture of the pelvis with a dislocation of the prosthesis.

The patient contacted our outpatient clinic because she had tripped over the stairs in her house. Afterward, she had constant and severe pain in the hip. The resident doctor conducted computed tomography (CT) and native x-rays on the hip to reveal the affected part (Figures 1 and 2). The CT showed the full extent of an acetabular fracture and the extension to the iliac bone. Since the fall, the patient has been immobilized on two forearm walking aids and dependent on regular painkillers, taking paracetamol 3 grams a day.

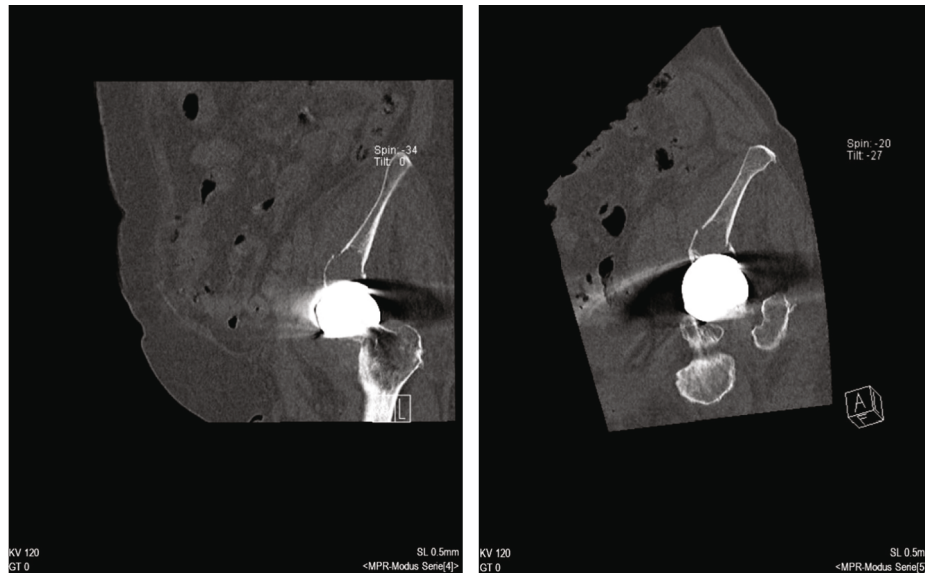
FIGURE 2: Preoperative CT of the pelvis. (a) shows the large osteolysis in the sagittal plane. (b) is the corresponding coronal plane of the patient's left hip.

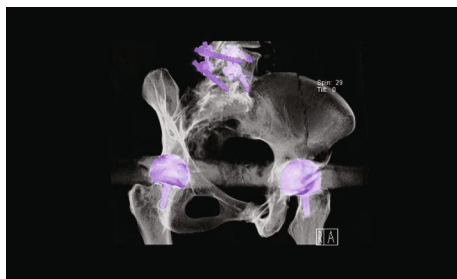
FIGURE 3: CT volume rendering of the pelvis. The reconstruction of all CT planes gives an overview of the fracture of the Os ilium and the extent of the cyst.

Pronounced osteolysis is observed in the femoral neck. The anterior edge of the cup was no longer visualized for osteolytic reasons. The ilium, the pubis, and the sciatic bone were lined with pronounced osteolytic linings (Figure 3). Surprisingly, in the case of osteolytic ilium fracture, no relative movement of the ileum is observed, showing that the pelvis osteosynthesis treatment could be dispensed. The acetabulum was debrided, and the metallosis was shown here at the smaller pelvis, carefully and extensively debrided (Figure 4).

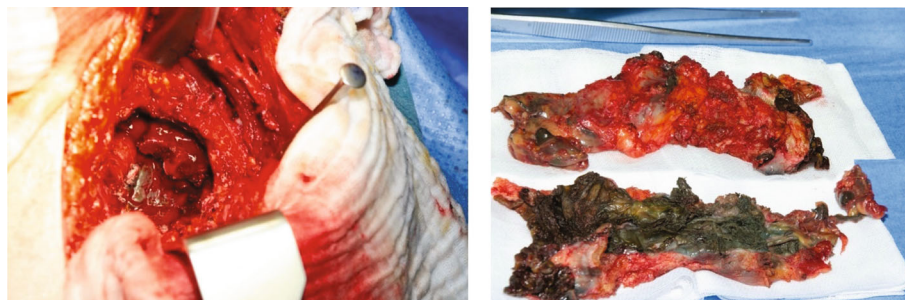
An anteroposterior X-ray of the pelvis was performed for the operation and the prosthetic components. A senior orthopedic surgeon with more than 10 years of experience in THA performed the operation in the right lateral position via a posterior approach to the hip. Intraoperatively, the abrasion granuloma was already fused with the fascia lata and encompassed the entire proximal and middle femur. The sciatic nerve has grown with the granuloma over almost 20 cm. After the joint had opened, copious amounts of black discolored synovial fluid were emptied. The entire joint presented itself as metallosis.

FIGURE 4: Metallic pseudotumor. (a) shows the intraoperative metallosis with pronounced osteolysis. (b) shows the resected metallic tissue after a complete surgical debridement.

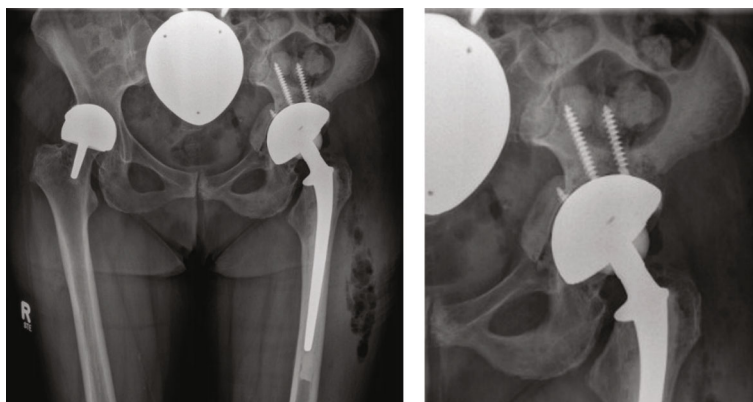
FIGURE 5: Surgical reconstruction after implantation of a cemented THA. (a) is an anteroposterior X-ray of the pelvis that shows the postoperative situation. On the left side, the patient carries a McMinn-like prosthesis without any symptoms or functional deficits. In (b), the bony acetabular reconstruction is observed. The cup was fixated with three screws to increase rotatory stability.

Two femoral heads from the inhouse bone bank were prepared for the construction. Two larger bone lids were shaped as a pan-base plastic, partially replaced the anterior pillar, and splinted in the acetabulum. The larger defects were filled with the remaining bone, resulted in a relatively stable bony bed. Then, a Trabecular Metal Acetabular Revision Shell (Zimmer Biomet, Warsaw, IN, USA) with an outer diameter of 60 mm was inserted, screwed into the dorsal of the abutment with 4 screws. An Endo-Mark III cup (Waldemar Link GmbH, Hamburg, Germany) 49/32.5 mm

was cemented into this. Carried out is the femoral implantation of a Lubinus Classic Plus shaft (Waldemar Link GmbH, Hamburg, Germany), size 4, 126° CCD angle, 150 mm long (Figure 5).

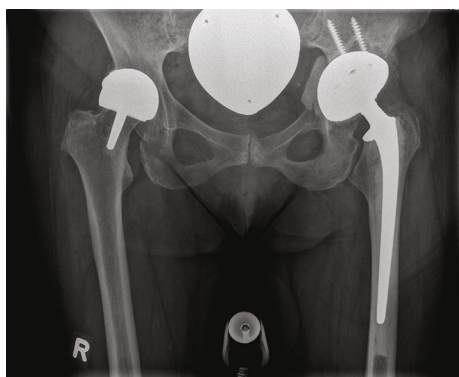
FIGURE 6: Follow-up X-ray 6 months after surgery. The anteroposterior view of the pelvis shows the correct placement of the implants and a bony healing of the Os ilium.

In the follow-up examination 6 months after surgery, the patient mobilized herself freely and with full weight bearing on the left leg (Figure 6). Function of the left hip was within physiological range.
