The impacts of human-induced disturbances on spatial and temporal stream water quality variations in mountainous terrain: A case study of Borcka Dam Watershed

Mehmet Özalp^{a,*}, Saim Yildirimer^b, Esin Erdoğan Yüksel^c

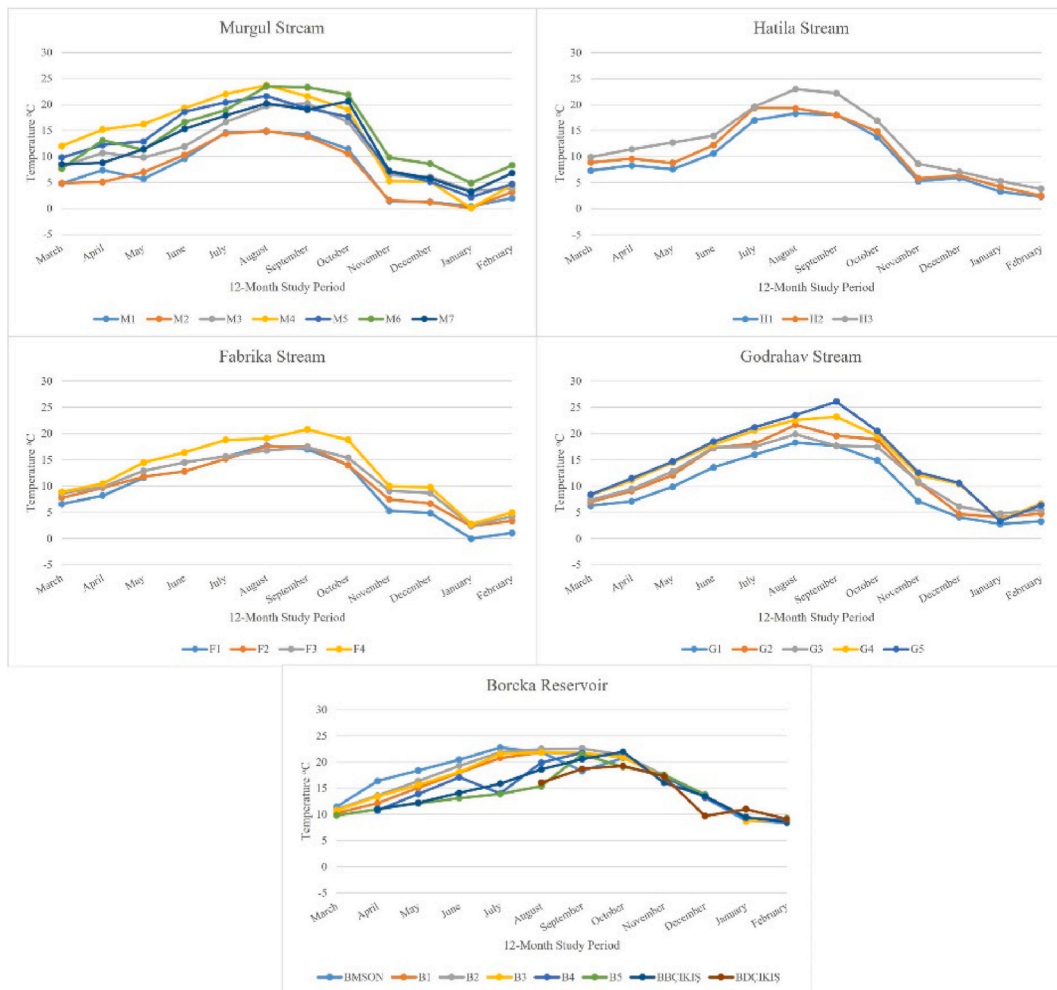
Fig. 8. Annual water temperature changes for the streams of Murgul, Hatila, Fabrika, and Godrahav and for the reservoir of Borcka Reservoir.

average stream water temperatures were close to each other with no significant differences among the four streams, significantly higher water temperature values -as expected-were detected for water in the reservoir (15.5 °C), (2). Here, the fact that the reservoir area absorbed more heat because of its large surface area and a stagnant water regime might be the main reason for this outcome. In addition, as is seen in Fig. 8, it was clear that the water temperature at the first sampling points (in higher elevations) was lower than at the sampling points close to the river mouth of each catchment, as stated by Hamid et al. [15].

This was expected because while the elevations of the first measurement points were 1495 m, 800 m, 1100 m, and 880 m for MSC, HSC, FSC, and GSC, respectively, the average elevation of the last measurement points (close to the reservoir) in the streams was ranging between 167 m and 195 m (Fig. 8). Similarly, In the bordering watershed (the Eastern Black Sea), measurements made only at the output points (close to sea level) of 11 streams yielded higher water temperatures ranging from 13.95 °C in Firtına Stream to 16.83 °C in Pazarsuyu Stream [36]. When evaluated in the scope of Surface Water Quality Regulation of Turkey, the temperature values of the stream waters in our project area were classified as “High-Quality Waters (1st Class) since their values are generally below 25 °C [31].

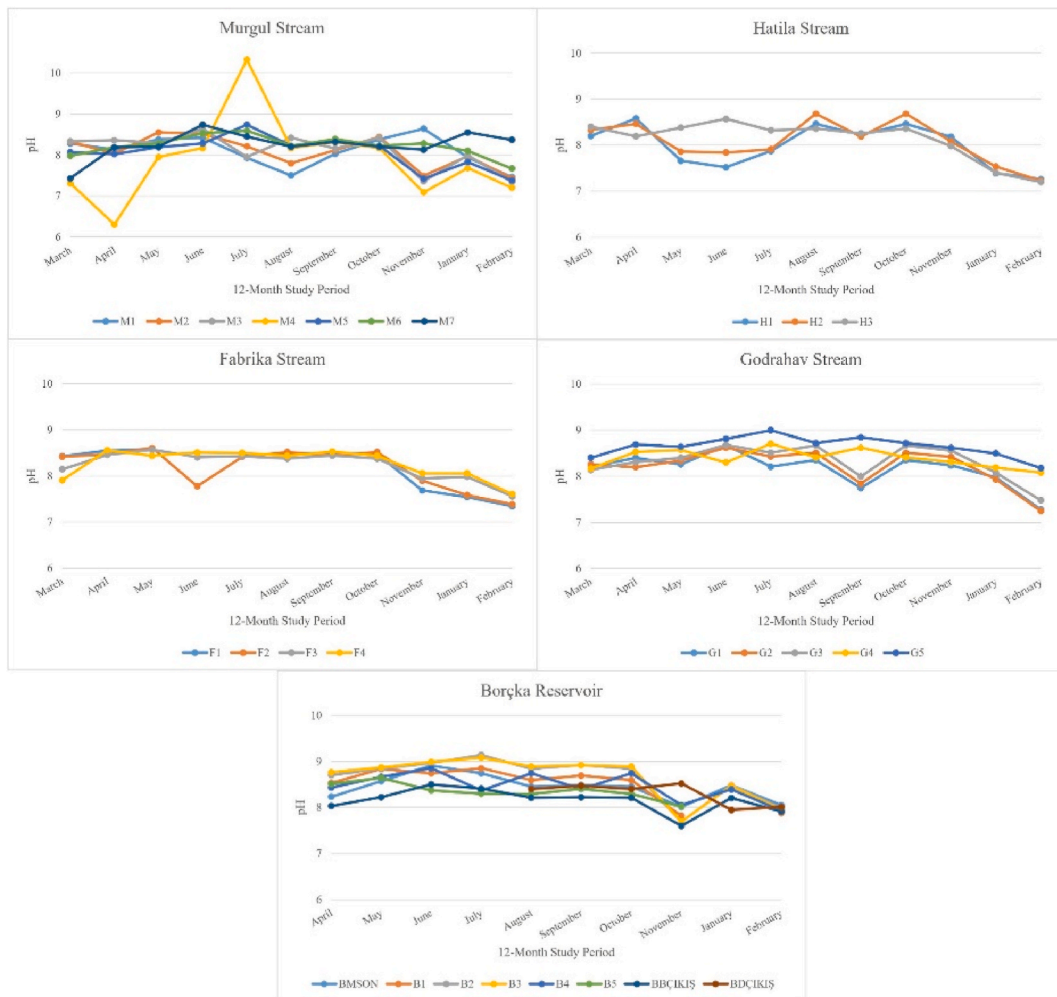
Fig. 9. Monthly changes of pH values for the streams of Murgul, Hatila, Fabrika, and Godrahav and the reservoir of Borcka Dam.

The monthly changes in pH values of both the stream and the reservoir waters in the study area are given in Fig. 9, while the ANOVA results are shown in Table 2. According to the Surface Water Quality Regulation and the World Health Organization, in general, pH values ranging between 6.5 and 8.5 are ideal for both natural and drinking waters [31,37]. As for the current study, when all the mean pH values of waters in all the streams and the reservoir were evaluated, it was noticed that the waters had a mild-alkaline characteristic with pH ranging from 8.11 to 8.44 (Table 2). In other words, Fig. 9 shows that there was no significant change in pH values because they all show a parallel trend from the source to the river mouth. However, statistical tests revealed that the reservoir waters had a substantially higher mean pH value (8.44) than the other four stream waters (Table 2). The M4 of Murgul Stream has the lowest (6.3) and highest (10.3) pH readings of all the sampling stations.

The main reason for both of these extreme pH values at M4 can be directly associated with the copper mine that has been operated within the higher parts of the Murgul Catchment since the 1950s, releasing wastewater to surface and groundwater resources from the mining activities (Fig. 2). In another study conducted in Murgul Catchment, similar findings were reported with the lowest (2.7) and the highest (10.8) pH values along the stream branches near the mining area [38]. Overall, when the data in Table 2 is evaluated, it is seen that the quality of stream water in all catchments of this study was generally in good condition (within the 1st class) with respect to pH, except for some measurements for M4 sampling point related with the mining area. In a study that was conducted to determine the water quality in the Kargı Stream of Antalya, pH values were measured between 7.03 and 9.4, and average values were reported to be between 7.87 and 8.26 [39]. For example, in this study, the annual average pH values were found to be between 7.5 and 8.5 as the pH values of the productive waters reported in the literature.

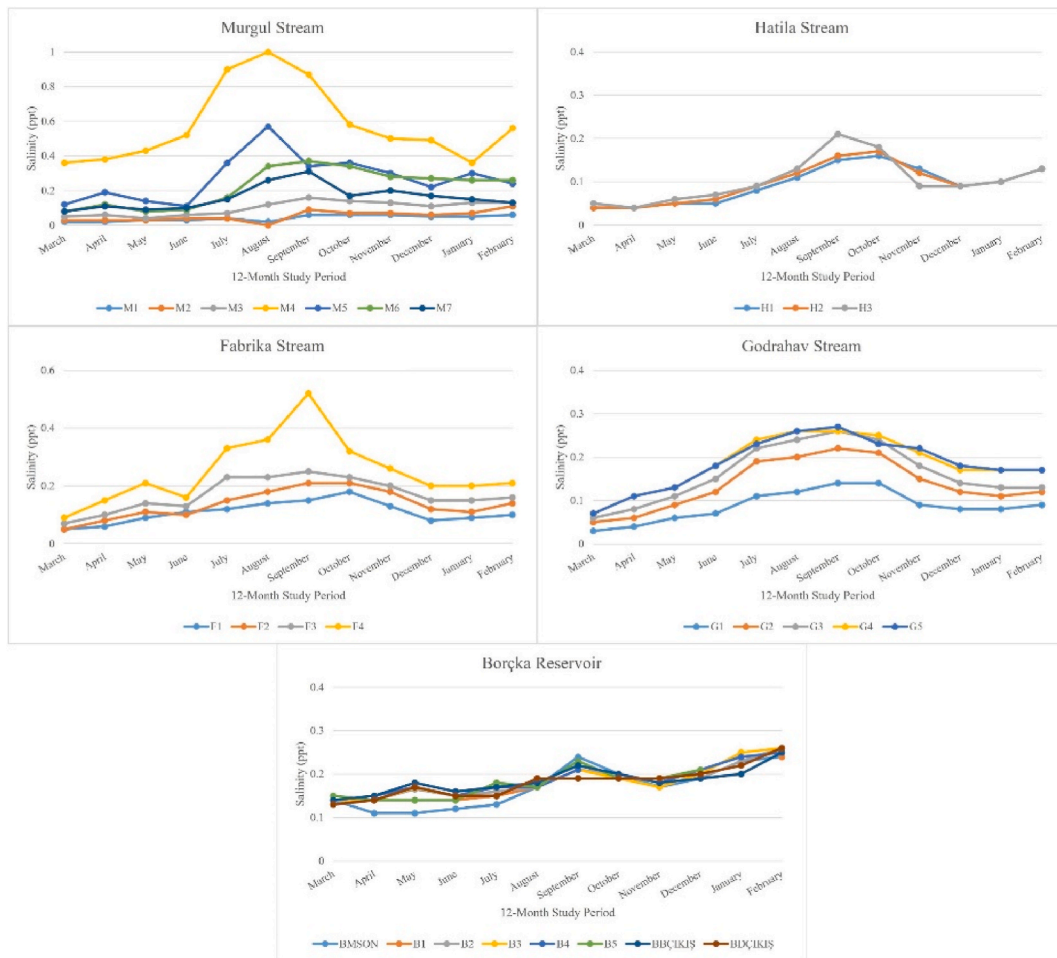
Fig. 11. Monthly changes of salinity values for the streams of Murgul, Hatila, Fabrika, and Godrahav and the reservoir of Borcka Dam.

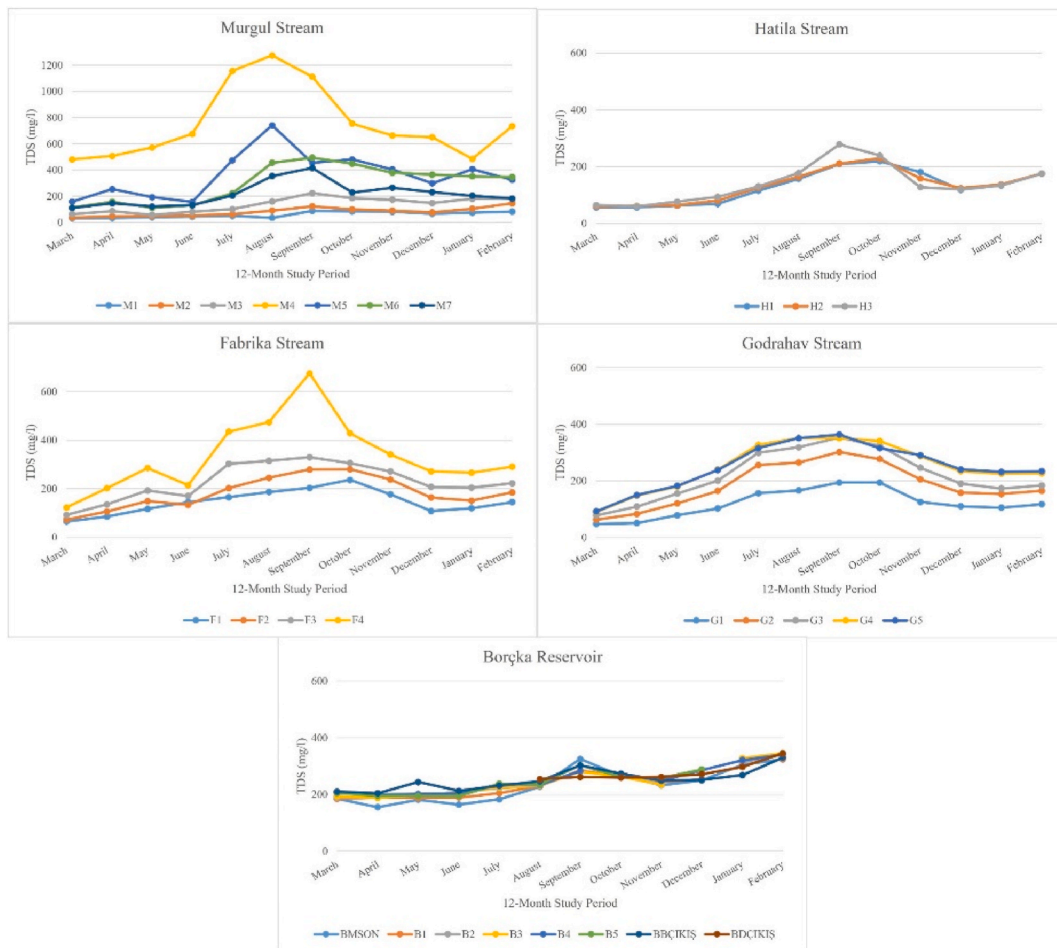
Fig. 12. Monthly changes of TDS values for the streams of Murgul, Hatila, Fabrika, and Godrahav and the reservoir of Borcka Dam.

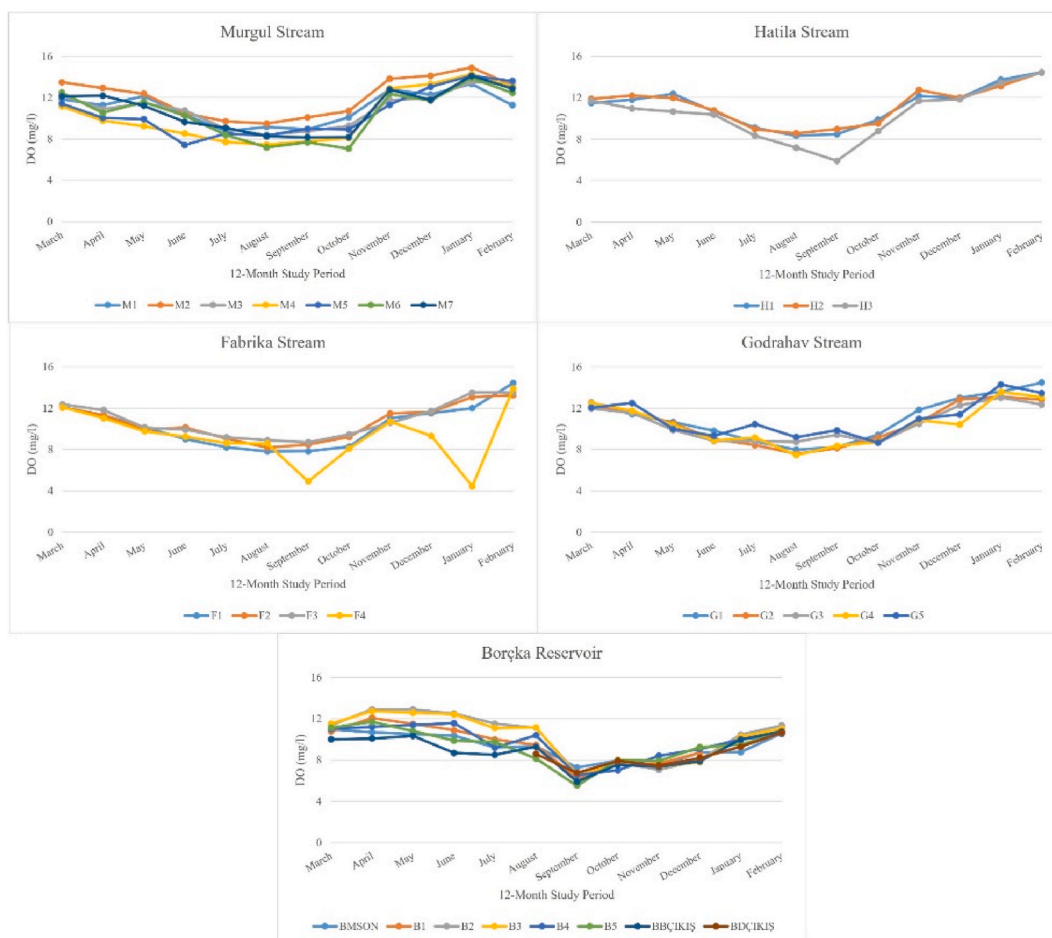
Fig. 13. Monthly changes of DO values for the streams of Murgul, Hatila, Fabrika, and Godrahav and the reservoir of Borcka Dam.

The major reason for the lower DO values in Fabrika Stream can be closely related to the anthropogenic wastes possibly causing DO levels to be impaired since the FSC consists of most of the settlement areas of Artvin city center and some agricultural lands; thus, the waters within this catchment receives significant amounts of both sewage (raw and treated, human and nonhuman) and agricultural runoff [1]. However, it can be concluded that according to the "Regulation on Surface Water Quality", the stream waters in the study area should be considered as "1st Class" (High-Quality Waters) with respect to the mean DO values since they were generally over >8 mg/L [31]. Also, it is known that the dissolved oxygen saturation varies inversely with salinity and temperature; similarly, it was seen that there was a tendency to decrease in dissolved oxygen amounts with increased temperature, particularly in the summer months of the study period (Fig. 13).

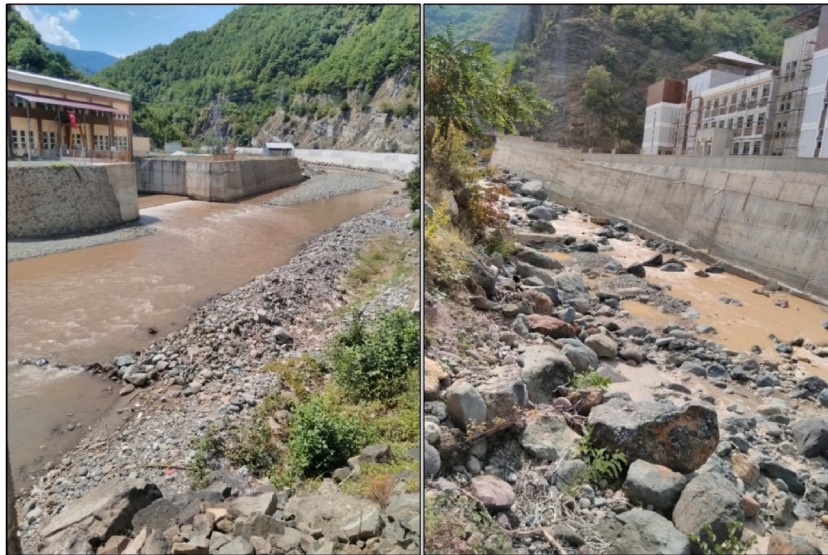
Fig. 14. The common application of constructing concrete walls along the streambed to stabilize the banks to protect both the roads and RoR-HEPP facilities (on the left), and houses/buildings (on the right) in the lower part of the Murgul Stream.

Similarly, when the sampling points in this study area were examined, it was also clear that the annual average TSS values generally tended to increase from the source to the river mouth for all the streams and catchments. However, various human-induced interventions can disrupt this balance by changing the natural structure of the channels, especially along the streams of Murgul, Fabrika, and Godrahav. For example, the construction of concrete walls along the streambed to stabilize the banks to protect both the roads, houses, and other structures as well as the establishment of several RoR-HEPP facilities for generating electricity are widespread within the catchment area of Murgul Stream [16,56] (Fig. 14).

Such structures and facilities operate as an impermeable barrier, allowing the natural movement of runoff water, sediments, organic materials, and other nutrients from the hillsides to the stream system, negatively impacting both the water quality and quantity of streams. Furthermore, it was projected that the TSS quantities would have several maxima in various months, many of which would be strongly associated to greater precipitation occurrences, notably in the spring months. (Fig. 15). For the current study, the mean TSS amounts varied significantly from 4.39 mg/L detected in the reservoir (due to the settlement of the materials with decreasing slope) to 71.25 mg/L detected in Murgul Stream (due to the intense disturbances) when all measurements were analyzed together (Table 2). However, among the sampling locations, the highest annual average TSS (with 236 mg/L) was calculated at the M4 sampling location within MSC. Since land use types of settlement, agriculture, and related activities in HSC (which covers most of the Hatila National Park) are quite limited, it followed a relatively more balanced course with respect to TSS values (Fig. 15).

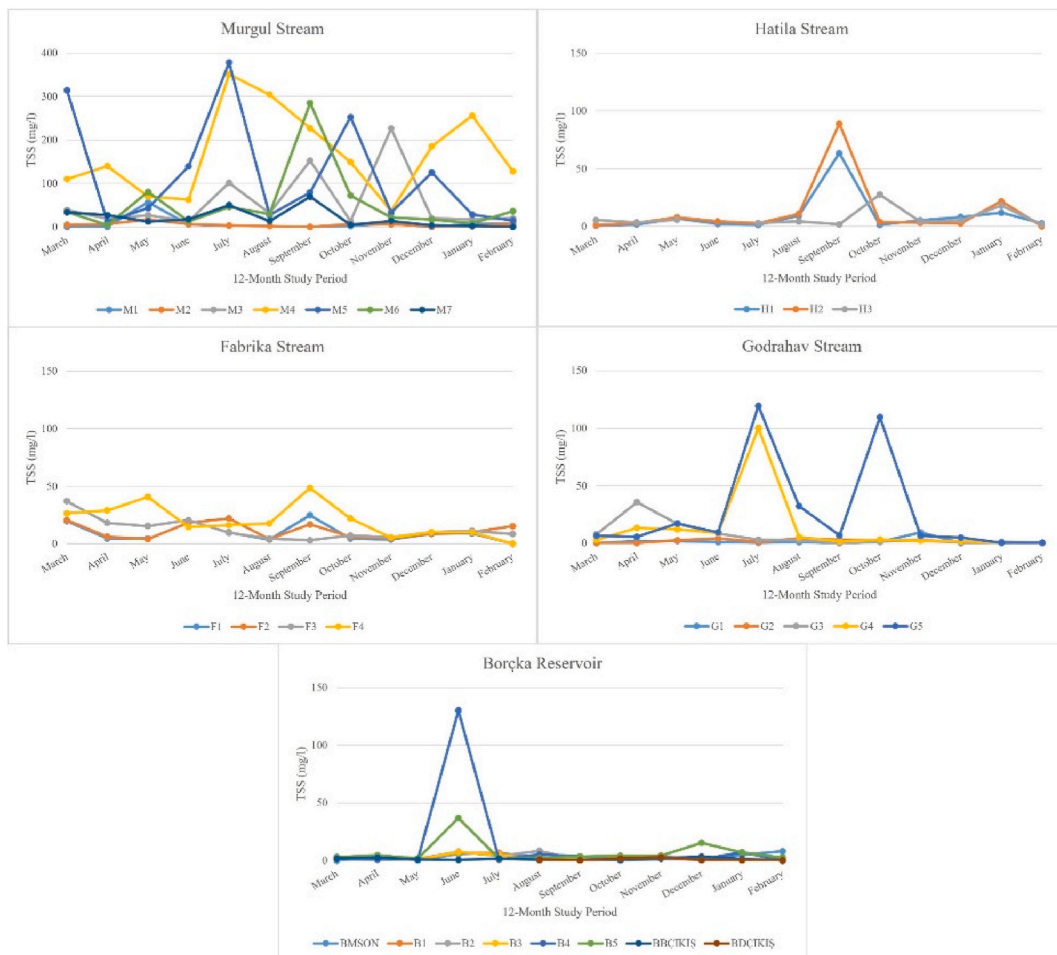
Fig. 15. Monthly changes of TSS for the streams of Murgul, Hatila, Fabrika, and Godrahav and the reservoir of Borçka Dam.

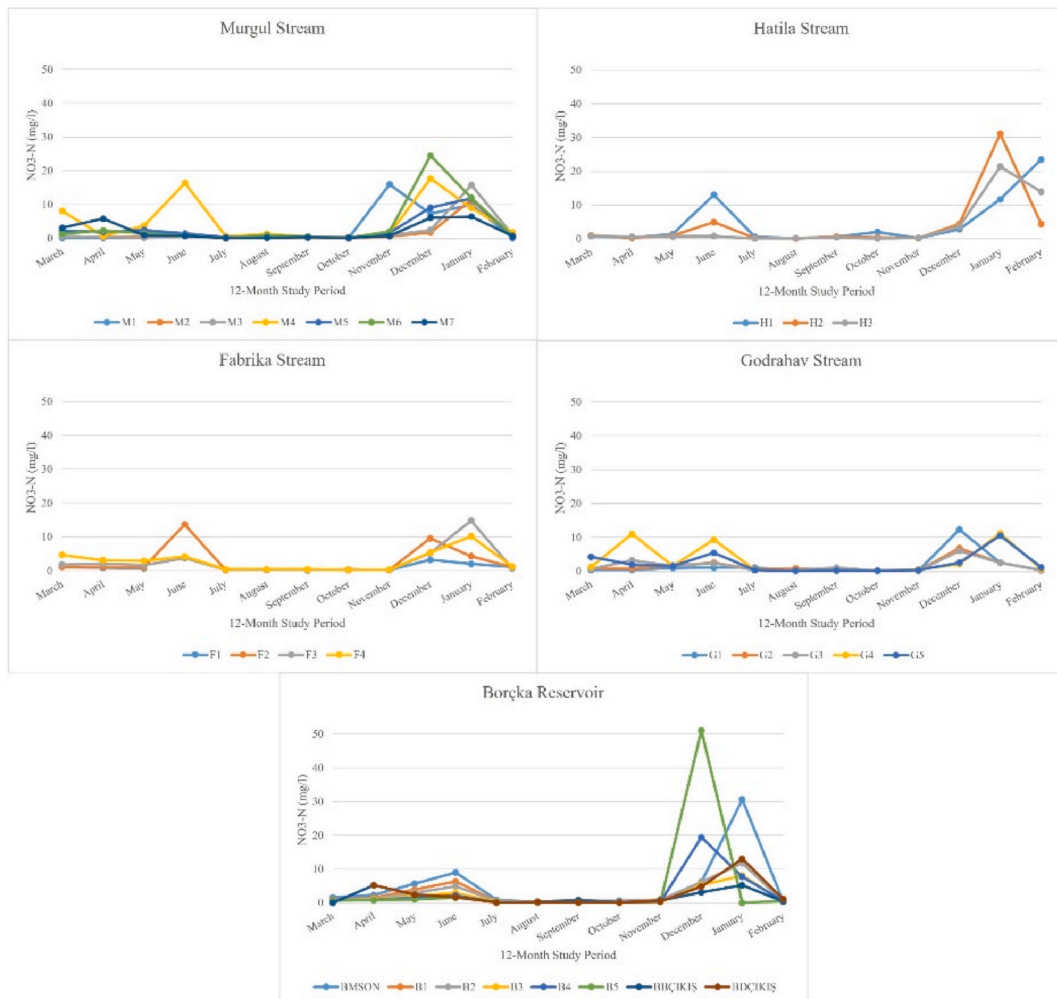
Fig. 16. Monthly changes of $\text{NO}_3\text{-N}$ concentrations for the streams of Murgul, Hatila, Fabrika, and Godrahav and the reservoir of Borcka Dam.

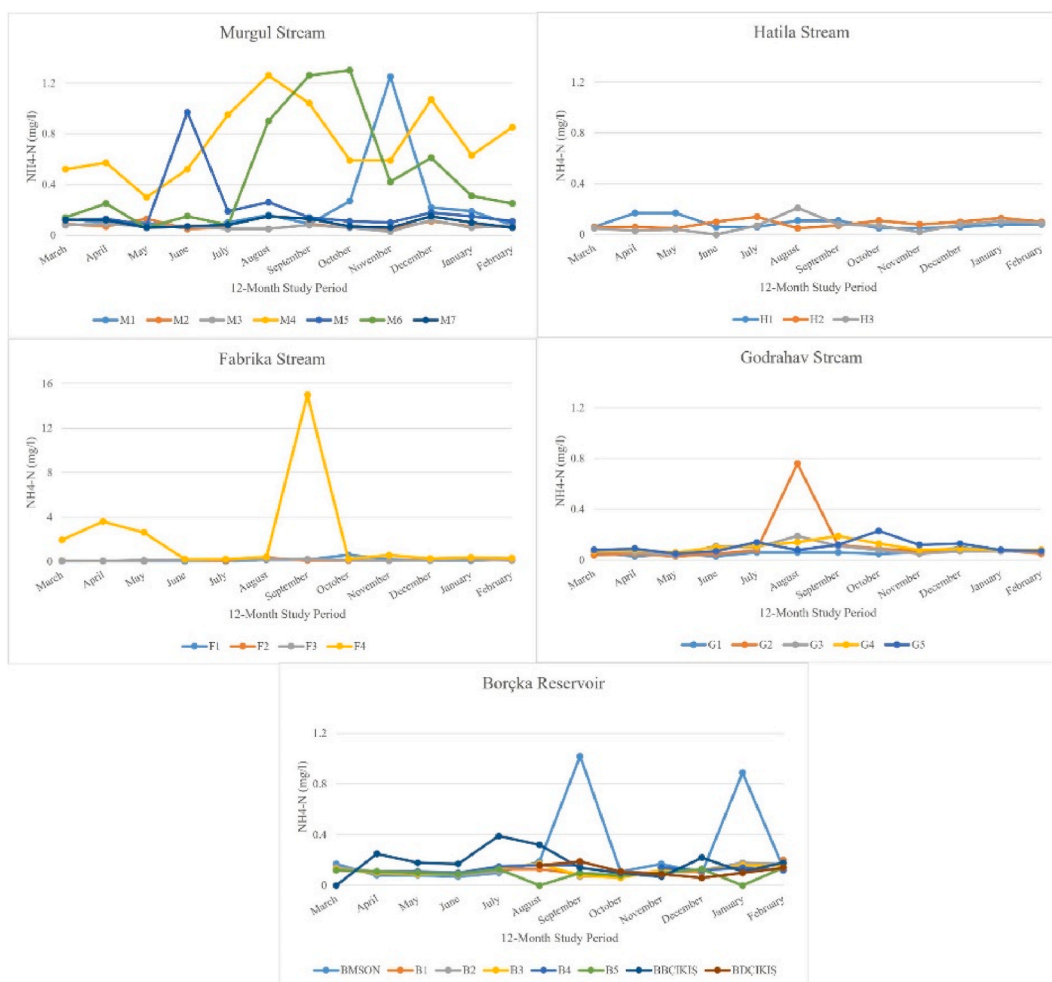
Fig. 17. Monthly changes of $\text{NH}_4\text{-N}$ concentrations for the streams of Murgul, Hatila, Fabrika, and Godrahav and for the reservoir of Borcka Dam.

reservoir showed a rather fluctuating course almost throughout the year when compared to the Fabrika and Godrahav Streams (Fig. 17).
