Uncoiling of reamer during intramedullary nailing for fracture shaft of femur

**Sanjay Meena,
Vivek Trikha,
Vivek Singh,
Samarth Mittal,
Tanmay S. Kishanpuria**

Department of Orthopaedics, All India Institute of Medical Sciences, New Delhi, India

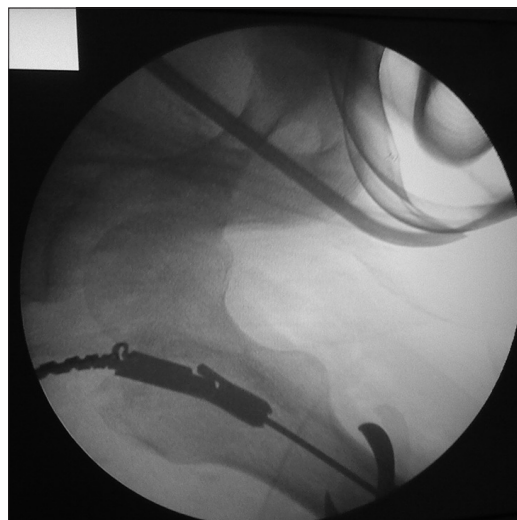
Figure 2: Intraoperative anteroposterior view of the right femur taken with image intensifier showing uncoiled reamer

He was taken to the operating room and was placed supine on a fracture table. After cleaning and draping in a standard fashion a greater trochanter entry point was made. To hasten the surgery the surgeon started with a reamer of 10 mm and whole canal was reamed over beaded guide wire. While removing the reamer from the canal, the reamer got stuck and it was neither going forward or backwards. An intraoperative image showed uncoiling of reamer. Further reaming in either clockwise or anticlockwise direction led to increased uncoiling of the reamer [Figure 2]. It was not possible to remove the assembly by pulling it out. A slotted hammer was positioned over the reamer against the drill attachments and the assembly was tapped out. Unfortunately, this led to the removal of the guide wire along the reamer [Figure 3]. A new guide wire was then again reinserted through the entry point into the canal and the procedure of interlocking nailing was completed successfully [Figures 4a and b]. At six months' follow-up

The flexible shafts of a reamer are made of coaxially arranged tubular wire coils. The shafts are driven clockwise with the power source. While removing the reamer from the canal they should be removed in the same direction (clockwise). The flexible shafts are designed to rotate only in one direction. Under no circumstances should they be reversed or the wire will uncoil with catastrophic results. In our case reversal of the coil was not done but this did not prevent the reamer from uncoiling. Several factors may be responsible for this complication.

Firstly, in our case reaming was initiated with 10-mm coil which may have contributed to uncoiling. Reaming should be initiated with the Flexible Shaft with 9.0-mm front-cutting reamer and progressed in 0.5-mm diameter increments.^[5] The reamer should be advanced with a steady, moderate pressure. At no time should it be forced into the canal. Partially retract the reamer often, to clear debris from the medullary canal. This prevents the reamer head from jamming in the medullary canal. If the reamer does get stuck inside the medullary canal, gentle use of the drill may free the reamer and a small-diameter reamer should then be used. Care should be taken when reaming across the fracture site as there may be some cortical damage, unless the fracture is properly reduced.^[6] If possible, the reaming rod should not be withdrawn across the fracture site. The position of the reaming rod should be reconfirmed with image intensification after this procedure.

In our case once the flexible reamer uncoiled, it was not possible to remove it simply by pulling. Once uncoiling has occurred, further reaming in clockwise or anticlockwise direction may lead to more uncoiling. A slotted hammer may be positioned over the reamer against the drill attachments and the assembly tapped out. If these manoeuvres are unsuccessful, open operative removal will be necessary but fortunately this was not required in our case. The tapping out of the assembly lead to the removal of guide wire also. This may occur since due to uncoiling effect, the coils of the reamer has tightly gripped the guide wire and it will not be possible to push it alone. Once the assembly was removed, it was not possible to isolate the reamer and the guide wire, so a new guide wire was again inserted and nailing was then completed.

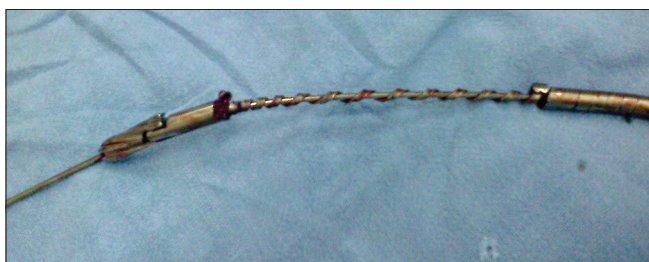
Figure 3: Photograph showing uncoiled reamer

Another reason contributing to this unique complication is the use of an indigenous implant made of poor quality

stainless steel. It should be noted that the instrumentation should be of good quality and not be too old. Repeated use of the same reamer over a long time in multiple surgeries may cause wear and tear of the coils and that can cause such complications.

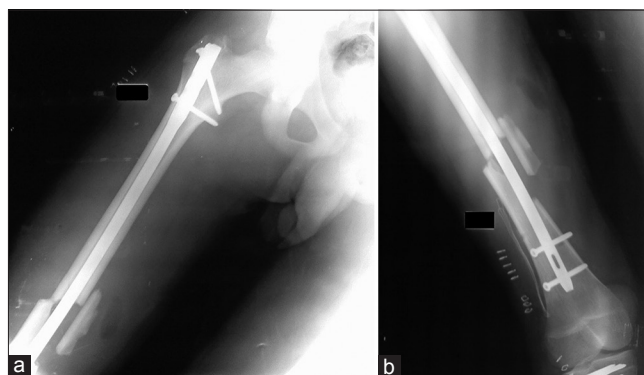
Figure 4: (a and b) Postoperative anteroposterior radiograph shows reduction and intramedullary fixation of right femur
