# Crack Detection in Images of Masonry Using CNNs

**Abstract:** While there is a significant body of research on crack detection by computer vision methods in concrete and asphalt, less attention has been given to masonry. We train a convolutional neural network (CNN) on images of brick walls built in a laboratory environment and test its ability to detect cracks in images of brick-and-mortar structures both in the laboratory and on real-world images taken from the internet. We also compare the performance of the CNN to a variety of simpler classifiers operating on handcrafted features. We find that the CNN performed better on the domain adaptation from laboratory to real-world images than these simple models. However, we also find that performance is significantly better in performing the reverse domain adaptation task, where the simple classifiers are trained on real-world images and tested on the laboratory images. This work demonstrates the ability to detect cracks in images of masonry using a variety of machine learning methods and provides guidance for improving the reliability of such models when performing domain adaptation for crack detection in masonry.

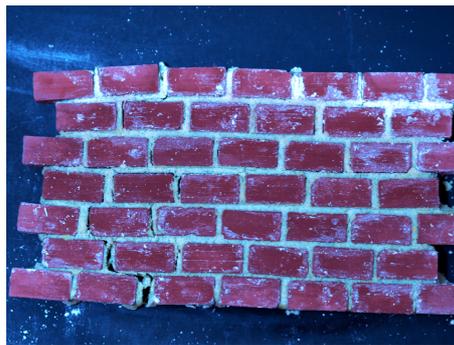
**Figure 1.** A sample image of wall built and cracked in the lab.

Small-scale experimental walls (such as shown in Figure 1) were built using miniature bricks which measured  $3.4 \times 1.7 \times 1.7$  cm and were cored with three evenly-spaced holes in the middle. Using small bricks made repeated building and cracking safer and faster. Each wall included 30 to 50 bricks with heights and widths both varying from 6–8 bricks. A total of 100 different bricks were used in the construction of 53 walls.

The shooting distance to the walls was variable as to not impact the results. Additionally lighting conditions were varied between the different walls as to not further bias the system. This is visible in Figure 1, where a blue tint is imbued by a blue tarp in the scene.

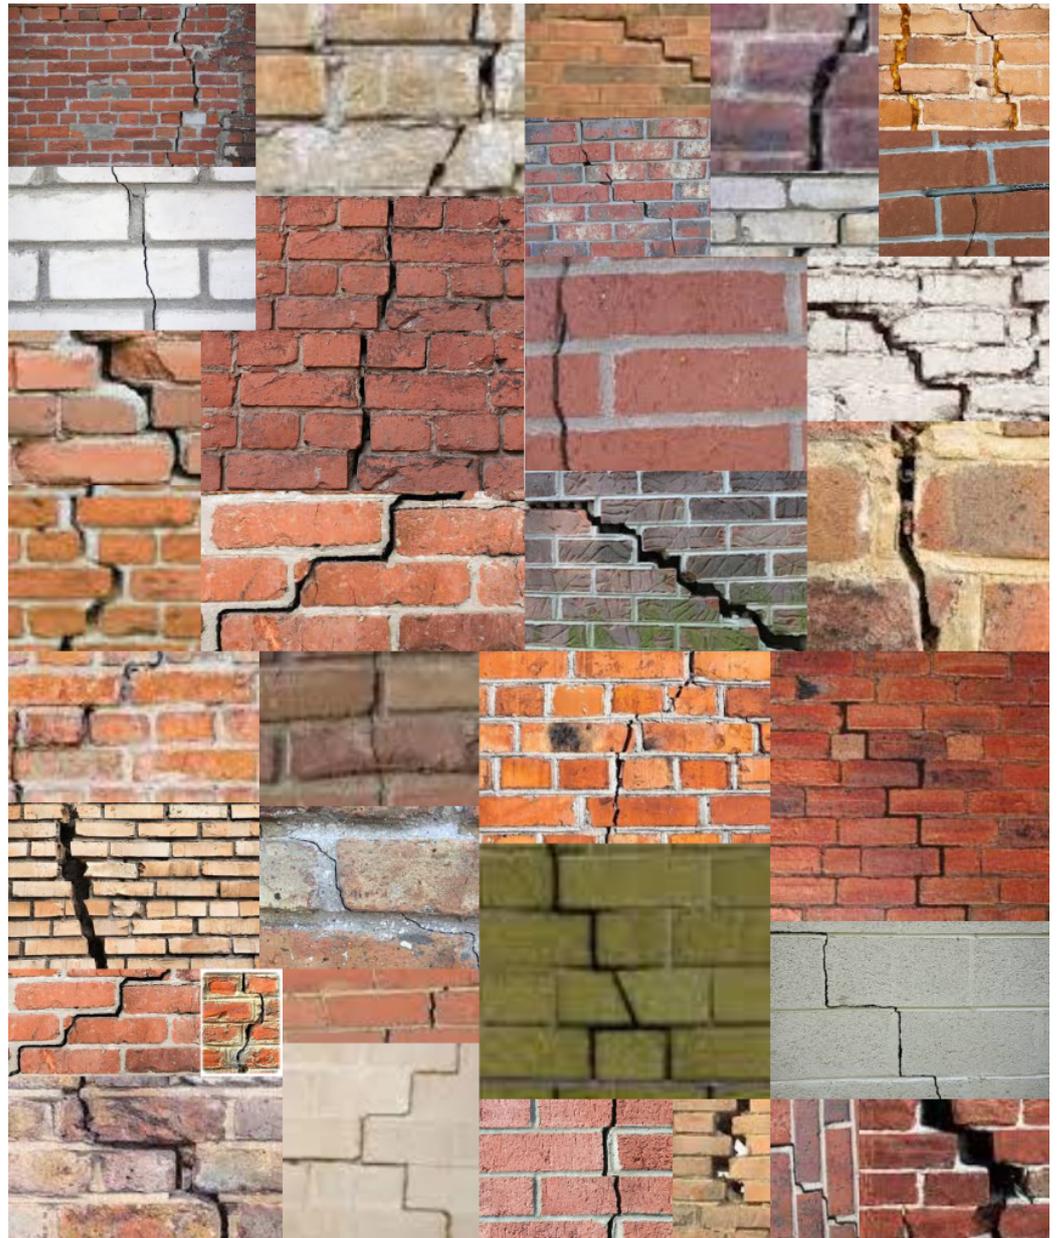
**Figure 2.** Illustration of some images found on Google which were labeled “Cracked”.

The models were also tested for their ability to classify real-world images after being trained on laboratory images. Pictures of different masonry walls (cracked and uncracked) were obtained using Google Image Search. To ensure that the architecture was tested on a variety of wall typologies, walls with bricks of different size, colors, shapes, level of deterioration (burned, spalling, with efflorescence) were utilized. Additionally, variety in the mortar typology (convex, concave) was included to test the efficacy of the developed architecture on diverse wall constructions (see Figures 2 and 3).

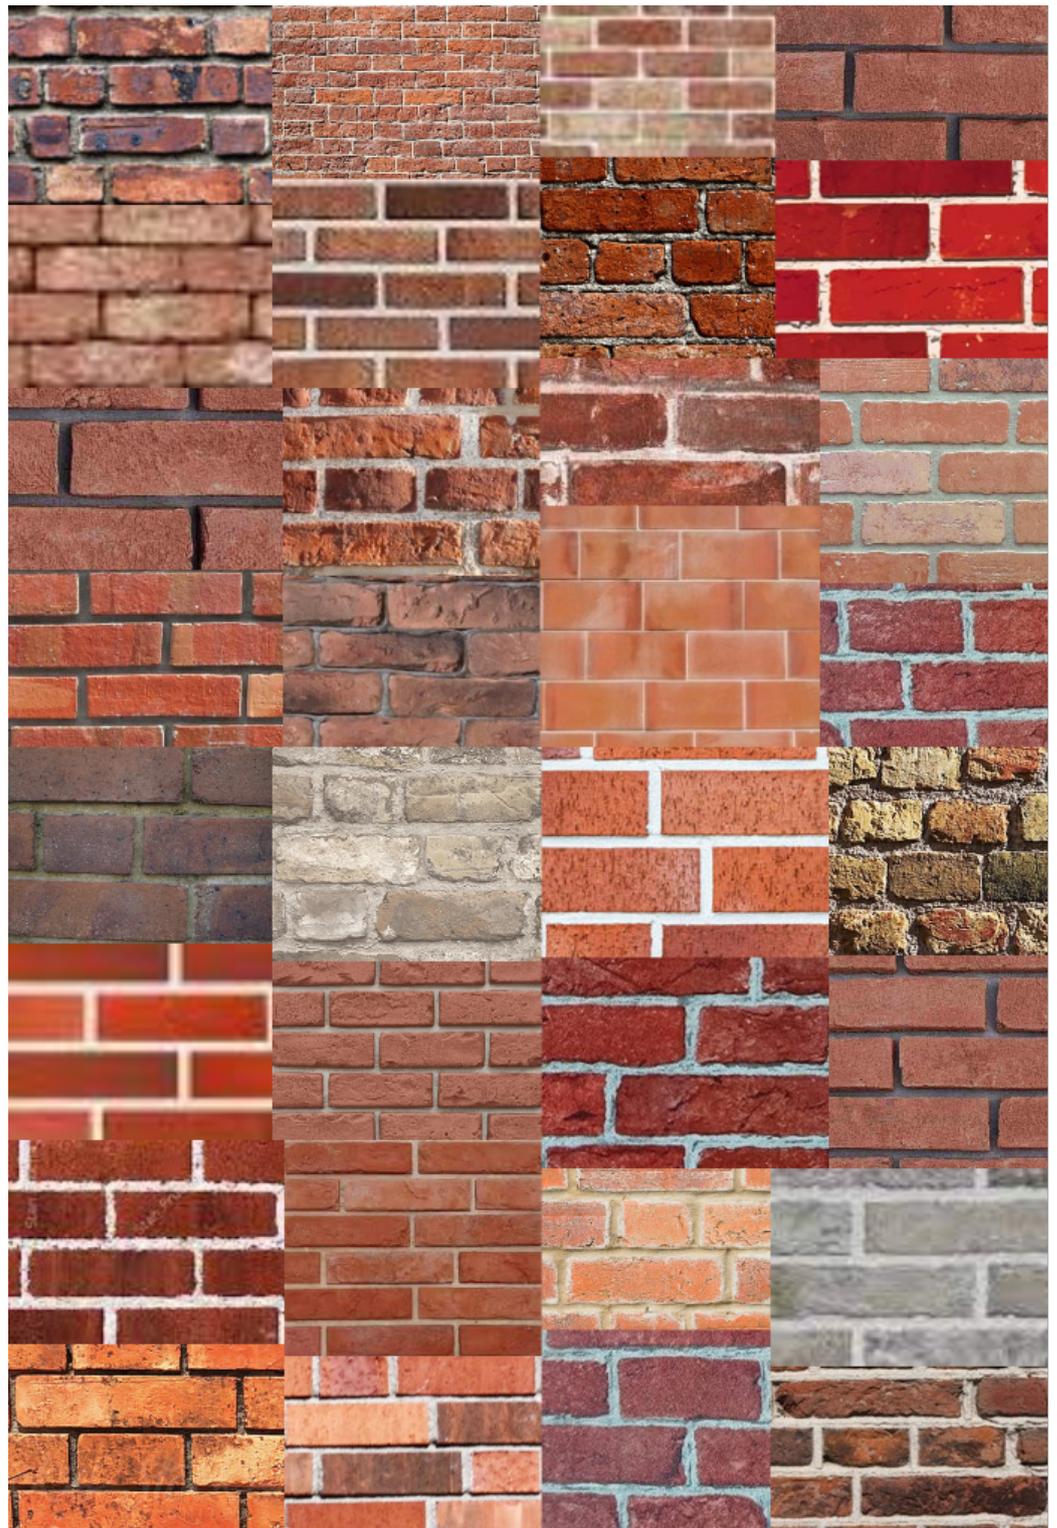
**Figure 3.** Illustration of some images found on Google which were labeled “Uncracked”.

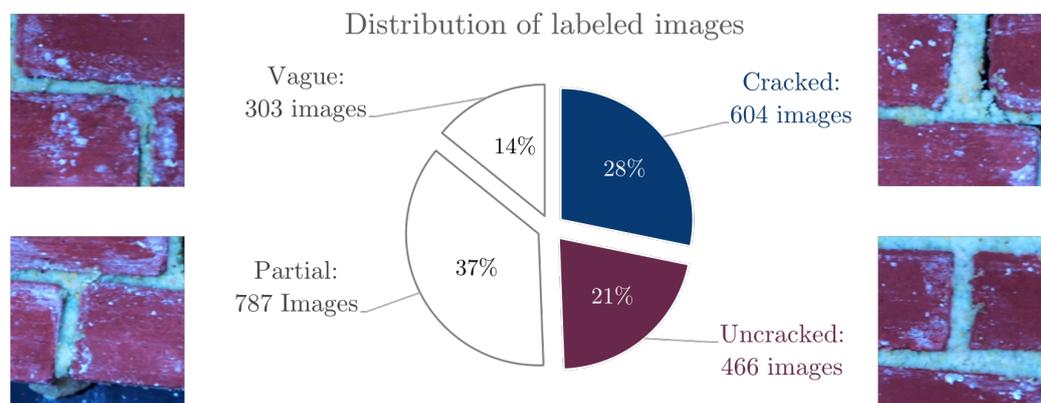
**Figure 4.** The distribution of images in the data set with representative examples.

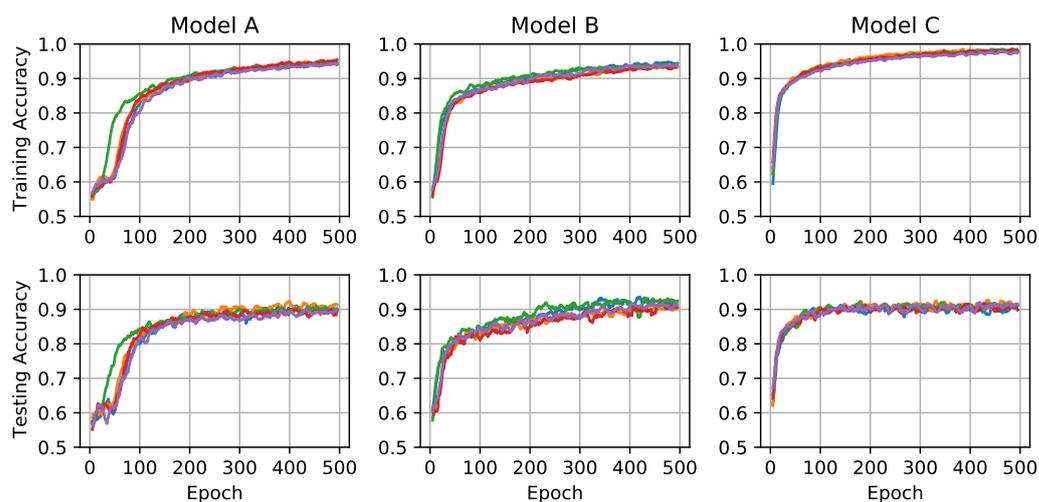
**Figure 5.** The accuracy of each architecture on training data (top) and testing data (bottom) during model training. Each line represents a different fold of the  $k$ -fold cross validation ( $k = 5$ ) and are running averages over 10 epochs for clarity. Architectures correspond to those described in Tables 1–3.

Training the models took around six minutes using four 2.60 GHz Intel Skylake cores and a single nVidia K20m GPU on a high-performance computing cloud. The accuracy of each model during training is shown in Figure 5. The lines show replicas of the same model training on a different data fold, initialized with different random initial weights, and under the effect of stochastic dropout. Interestingly, based on the training accuracy, Models A and B appear to learn at about the same rate and eventually reach about 95% accuracy, while Model C appears to learn more quickly and reach a higher accuracy of up to 99%. This is consistent with the greater trainable parameters in Model C, whereas Models A and B have about the same number.

However, as shown in the bottom row of Figure 5, the performance of each model on the testing data plateaued to much lower values than the training data, closer to 90% accuracy. The magnitude of this discrepancy reveals overfitting in cases where the model performed substantially better on training data compared to testing. This in turn indicates that the model will not be able to generalize to new images. Because the data set is small and there are so many trainable parameters in these models, overfitting is a major concern. From Figure 5, we observe that Models A and B had similar accuracy in training and testing and are therefore do not suffer significant overfitting. Model C, however, appears to have used its significantly greater number of parameters to overfit to the training data.

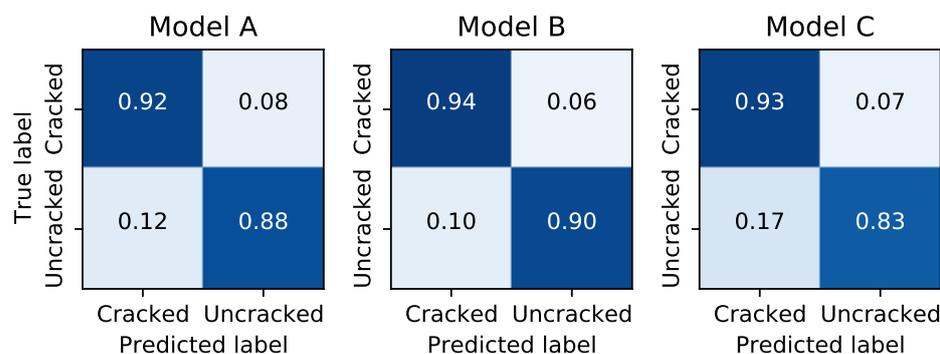
**Figure 6.** Confusion matrices for each architecture when tested on lab images not included in the training set.

The confusion matrices for each model are shown in Figure 6. While the performance of each model varied, they showed similar qualitative behavior on the test data. In general, True positives were more likely than true negatives, and false positives were about twice as likely as false negatives, exposing a bias towards predicting cracks were present in the images. Interestingly, Model C's inferior performance appears to come almost exclusively from these false positives, with approximately 50% higher False Positive incidence compared to the other two architectures.

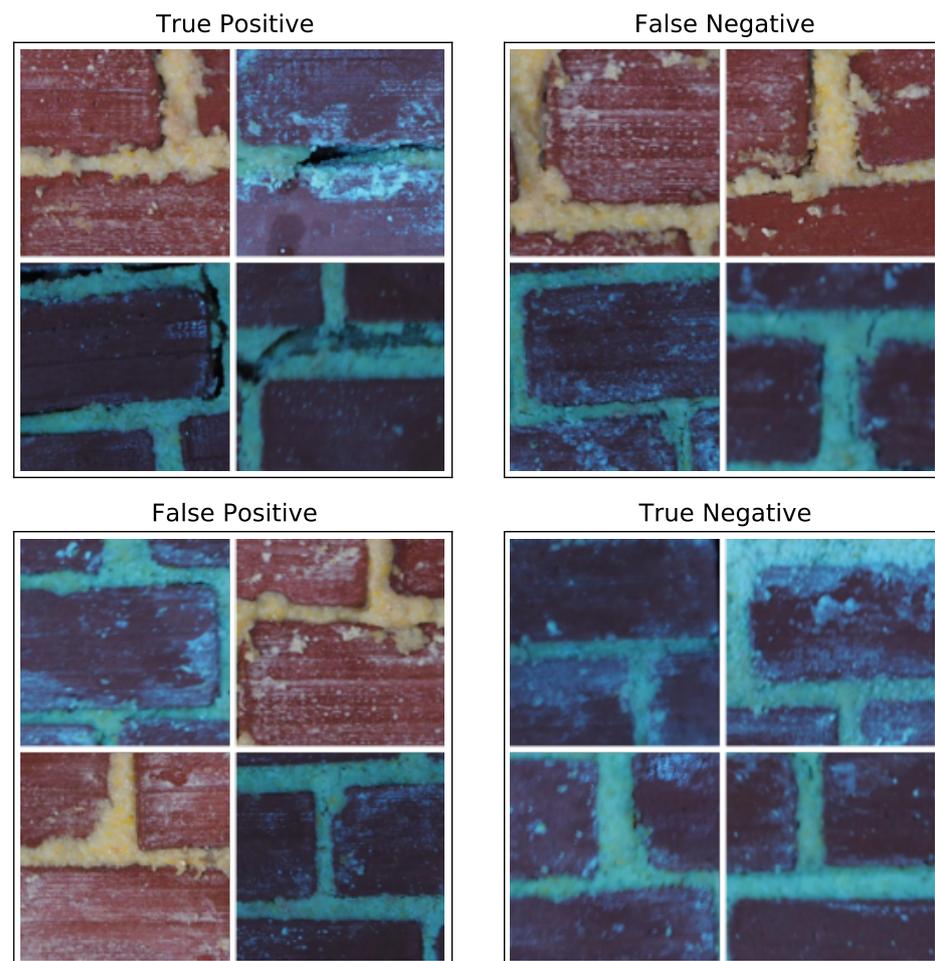
**Figure 7.** A random sample of four lab images from each case in the confusion matrix, as determined by Model C.

We examine these failure modes of Model C in more detail through visual examples in Figure 7. It seems that the images that are easy to identify as cracked—such as those with deep, expansive cracks—are correctly labeled as such. Likewise, images with clean, ortho-rectified mortar joints are readily identified as uncracked. For the false negative case, there appear to be some uneven and messy mortar joints which confuse the classifier by obscuring small, hairline cracks. For the false positive case, several appear to also have uneven joints which might create extra shadows that mislead the classifier. The blue tint of some images does not appear to create a systematic problem.

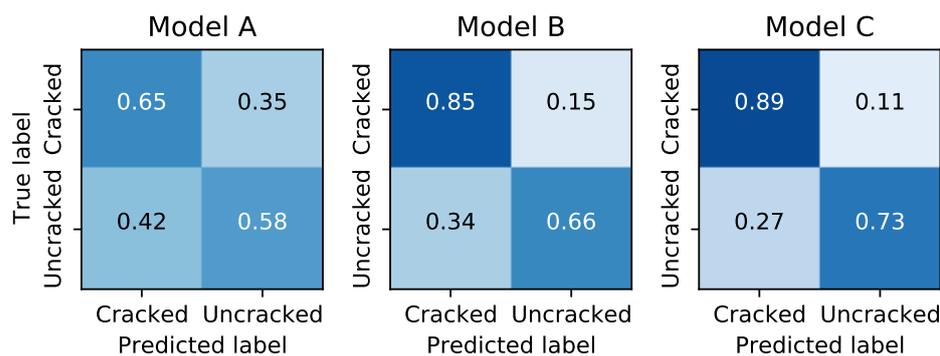
**Figure 8.** Confusion matrices for each architecture when tested on real-world images.

The relevant metrics when the CNNs are applied to these real-world images are presented in Table 5, and the associated confusion matrices in Figure 8. Interestingly, while the performance of all models was similar on the lab data (i.e., Figure 6), the model performance diverges significantly on the domain adaptation task. First, all models perform worse, which is to be expected since the real-world data set represents a much broader range of conditions. Somewhat surprisingly, Model A suffers about 50% greater deterioration in accuracy than Model B. This might be due to the shallower structure of the convolutional filters in Model A, which presumably are less capable of abstraction.

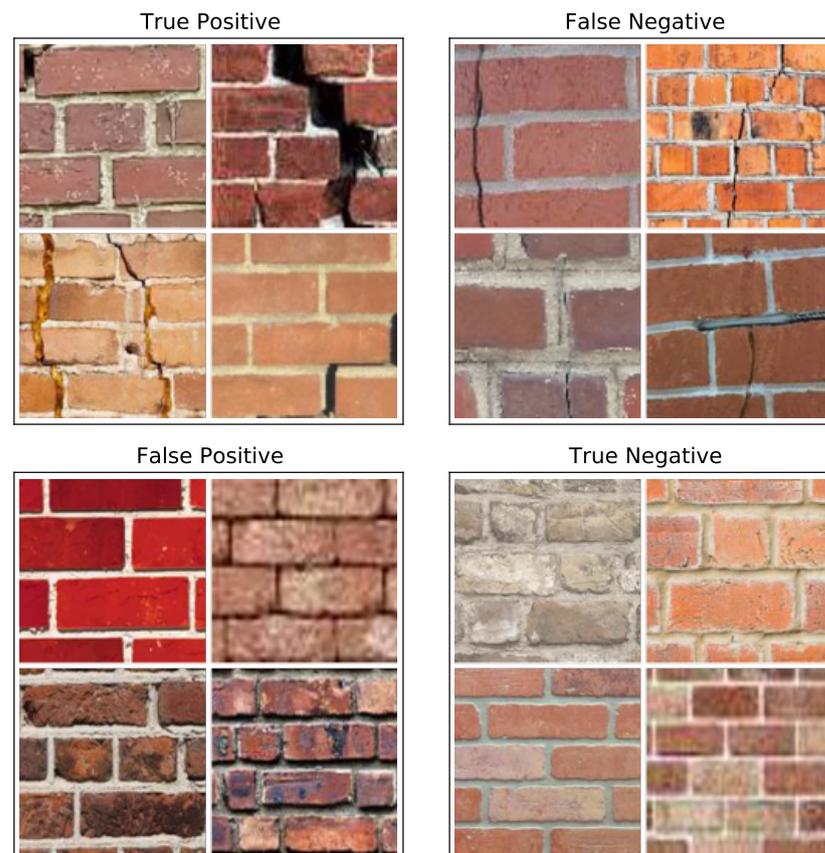
**Figure 9.** A random sample of four real-world images from each case in the confusion matrix, as determined by Model C.

We again examine these failure modes of Model C in more detail through visual examples in Figure 9. As in the lab data, the deepest cracks are easy to identify, as are uncracked images with clean mortar joints with faint or nonexistent shadows. For the false negative case, thin, straight cracks that are aligned with the mortar joints appear the hardest to detect. For the false positive case, it seems that strong shadows and discoloration on the brick face are the strongest contributors. We suspect that the color variation that occurs within a single real-world image is the primary reason for the high false positive rate compared to the lab images.

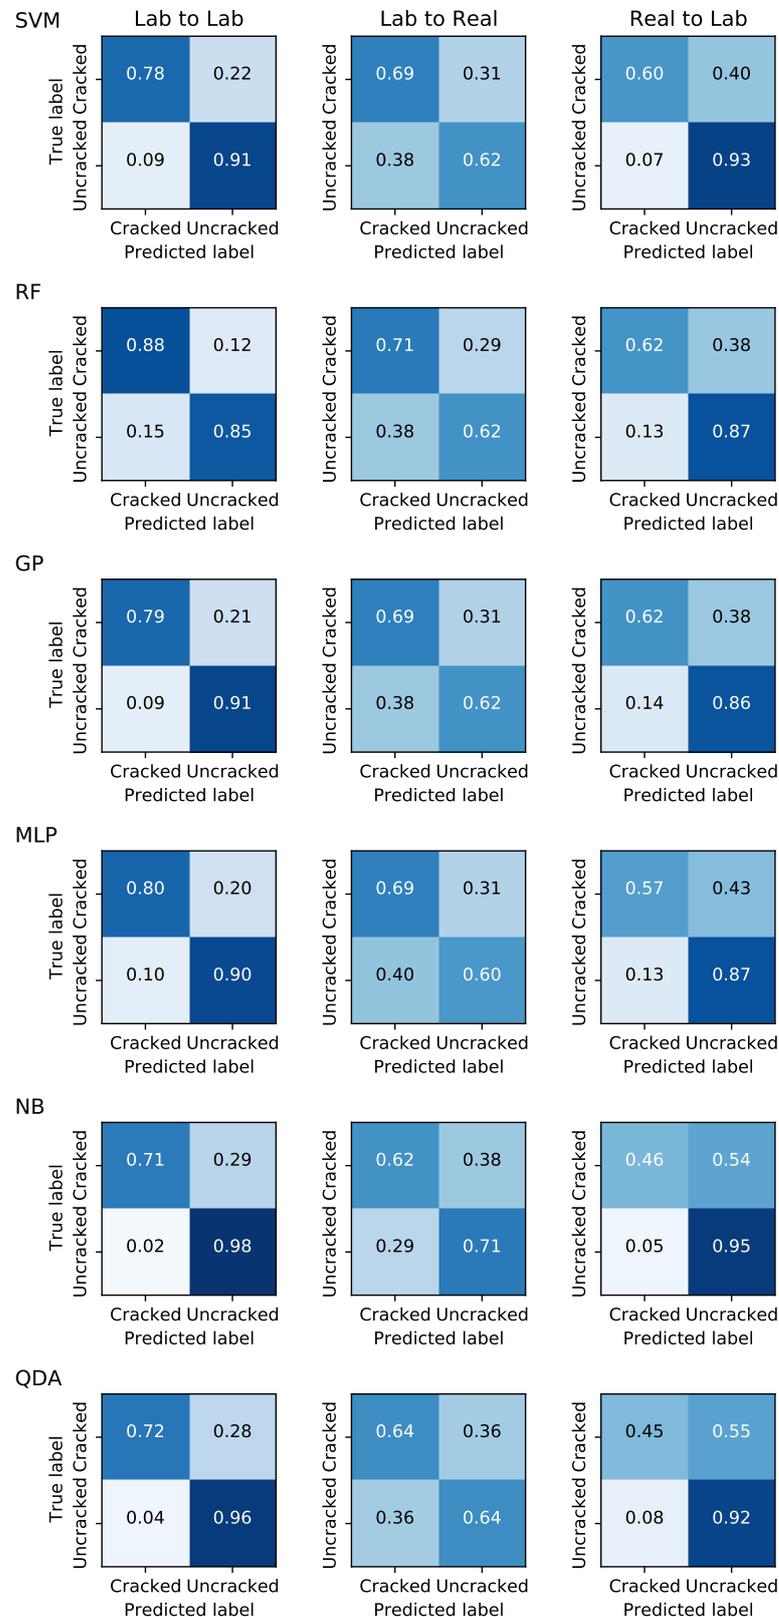
**Figure 10.** Confusion matrices demonstrating the performance of each classifier model (rows) under each train-test scenario (columns).

parameters and can be fit reasonably on our small real-world data set. The confusion matrices for each model under each of these three cases is shown in Figure 10.

As expected, the performance drops significantly on the domain adaptation task (Lab to Real). The models appear to segregate into two categories, with SVM, RF, GP, and MLP performing roughly equally, and NB and QDA performing notably worse. The advantage of RF over the other three in the former category appears to dissipate for domain adaptation, with only 2% better true positive rate. This implies overfitting by the RF model in the Lab to Lab scenario. Overall, these models appear comparable, although we note that SVM and RF train significantly faster than GP and MLP.

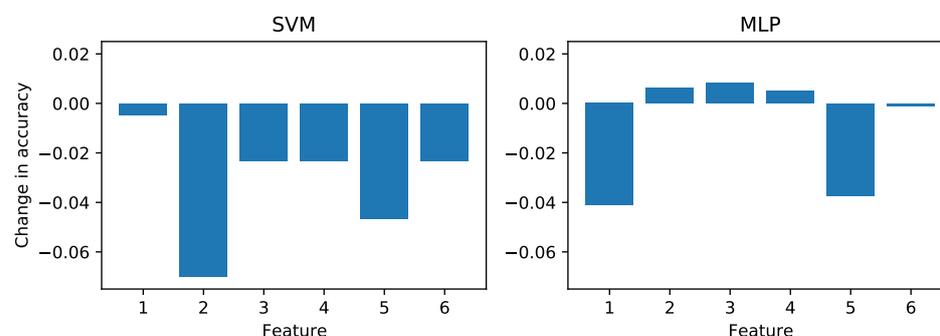
**Figure 11.** Permutation feature importance for the SVM and MLP models when trained and tested on the laboratory images.

This test was performed for both the lab and real-world data sets, with results shown in Figures 11 and 12, respectively. Comparing the results, we see that in the lab case both models relied mainly on Feature 5, the standard deviation of  $x$ -coordinates of  $S_2$ . SVM relies more heavily on the pixels in  $S_1$  while MLP uses  $S_2$ , while the remaining features are less significant. The positive values of the MLP probably indicate that the model is not fully converged (we used the default settings with no hyperparameter tuning).

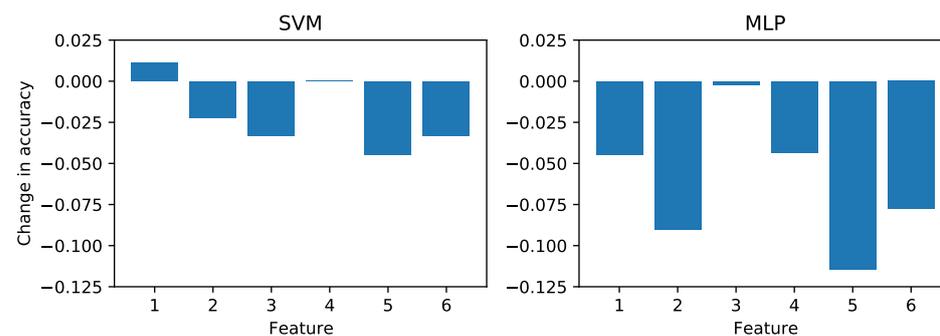
**Figure 12.** Permutation feature importance for the SVM and MLP models when trained and tested on the real-world images.

When considering the real-world case, both models use a completely different scheme, although Feature 5 remains prominent. The fact that the  $x$ -coordinate (Feature 5) is used more heavily than the  $y$ -coordinate (Feature 6) might reveal a bias in the data set towards cracks of a certain orientation. Likewise, the dominant use of only two features by the MLP in the lab training case is evidence of overfitting to a particular aspect of those data.
