FRACTURE OF THE TIBIAL COMPONENT IN TOTAL KNEE ARTHROPLASTY: REPORT ON TWO CASES

ABSTRACT

The authors report the rare occurrence of two cases of fracture of the tibial component in total knee arthroplasty. They review the literature and discuss the main

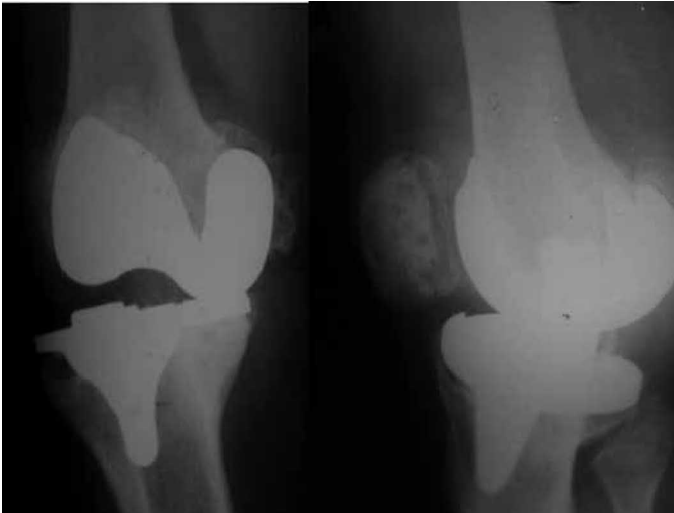
In January 2009, she went to the knee outpatient clinic for the first time with a condition of intense pain without any history of trauma and with laboratory tests that were negative for infection. In the physical examination, we observed varus knee deformity and a range of motion from 0 to 75°. In a radiographic examination on the knee while bearing weight, we observed a

fracture in the tibial component (Figure 1). TKA revision surgery was indicated, and this was performed in August 2009 (Figures 2 and 3). During the immediate postoperative period, we observed pain relief and functional improvement of the knee.

Figure 1- Preoperative radiograph of case 1.

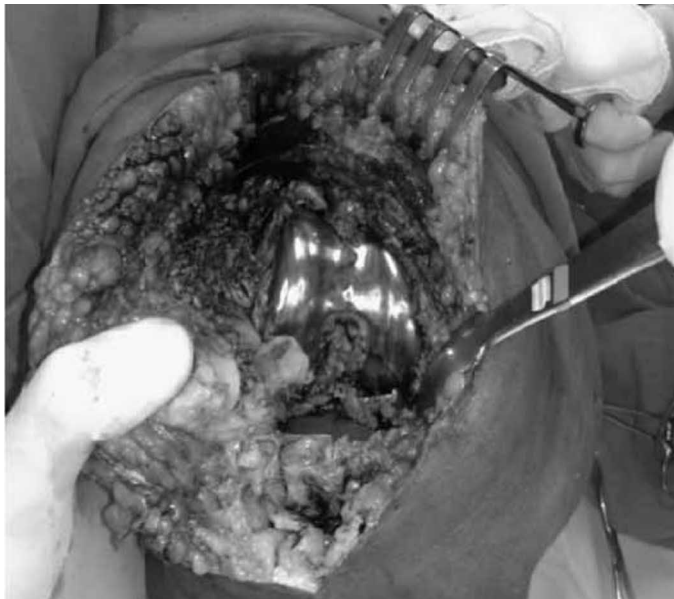
Figure 2 – Intraoperative view of case 1.

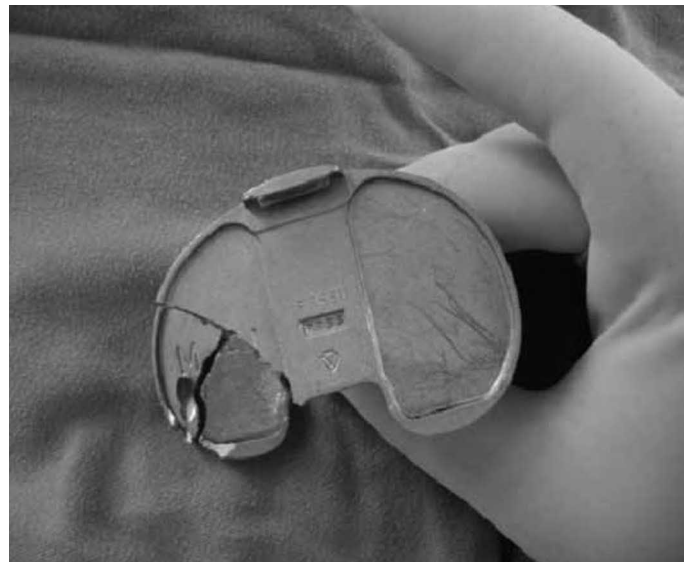
Figure 3- Fracture of the tibial component of case 1.

In our view, the two implants in our sample remained in varus knee positioning because of inadequate ligament balance. Because of this, greater weight was borne on the medial compartment of the knee, thus facilitating fracturing of the implant. Luring et al⁽⁷⁾ corroborated our thinking and reported that misalignment of the implant creates osteolysis and generates cyclic overload on the prosthesis used. Swarts et al⁽⁸⁾ considered that correct alignment was the main factor in TKA success. Rousseau et al⁽⁹⁾ observed that early failure in TKA (excluding cases of infection) was re-

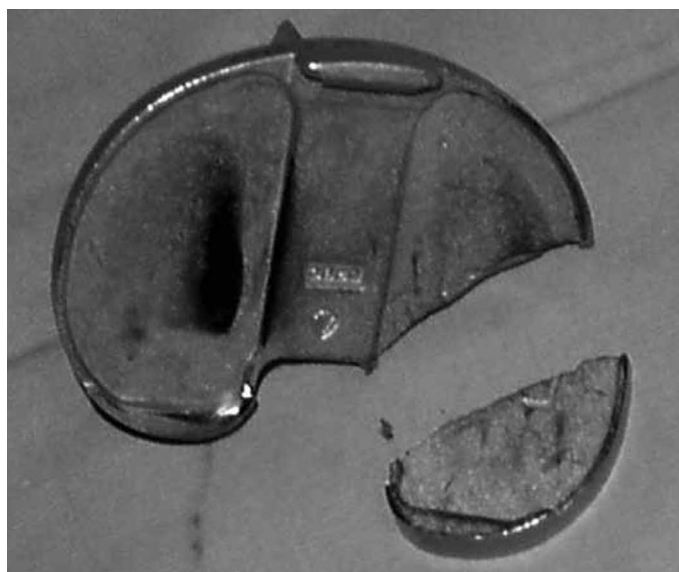
Figure 6 – Fracturing of the tibial component in case 2.

The two implants used in our study were of the same model made in the United States (Howmedica®). Flivik et al⁽¹⁰⁾ and Maruyama et al⁽¹¹⁾ concluded from their studies that inappropriate design was the main factor involved in fracturing of the tibial component. In our study, the prosthesis used was of modern design, and what drew our attention was the similar fracture location in the two implants.

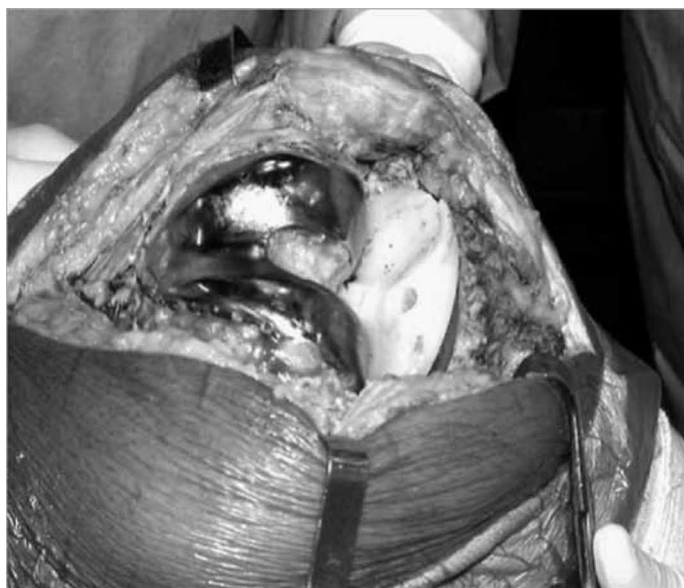
Figure 5 – Intraoperative view of case 2.

In April 1999, he went to the knee outpatient clinic of the National Institute of Traumatology and Orthopedics with a condition of intense pain, without any history or trauma and with laboratory tests that were negative for infection. In the physical examination and in the radiographic examination while bearing weight, we observed a varus knee deformity and a range of motion from 0 to 80° (Figure 4). TKA revision surgery was indicated, and this was performed in June 1999 (Figures 5 and 6). During the immediate postoperative period, we observed pain relief and functional improvement of the knee.
