# Article Accelerated Aging Behavior in Alkaline Environments of GFRP Reinforcing Bars and Their Bond with Concrete

Abstract: This study investigates the durability of glass fiber-reinforced polymer (GFRP) reinforcing bars (rebars) and their bond in concrete. Accelerated aging tests were first conducted on bare rebars that were either subjected to direct immersion in an alkaline solution or previously embedded in concrete before immersion in the solution (indirect immersion). Accelerated aging was conducted at different temperatures of the solution (20 °C, 40 °C and 60 °C) and for various periods up to 240 days. Residual tensile properties were determined for rebars subjected to direct immersion and served as input data of a predictive Arrhenius model. A large decrease in the residual tensile strength assigned to the alkali-attack of glass fibers was extrapolated in the long term, suggesting that direct immersion is very severe compared to actual service conditions. Short-beam tests were also performed on rebars conditioned under direct/indirect immersion conditions, but did not reveal any significant evolution of the interlaminar shear strength (ILSS). In a second part, bond test

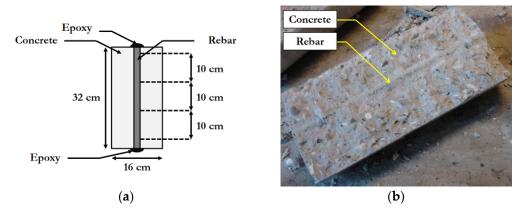
**Figure 2.** ILSS test specimens for indirect immersion: (**a**) geometry of specimens and (**b**) picture of a specimen after the splitting of surrounding concrete.

Some 32 cm long rebars were embedded in concrete cylinders with 16 cm diameter, before being immersed in the alkaline solution. The geometry of these specimens is shown in Figure 2a. Before immersion, the edges of the rebars were again locally sealed with an epoxy resin to prevent the penetration of alkalis through the cut sections.

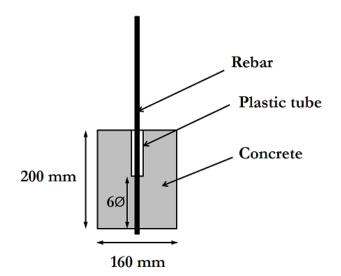
Figure 3. Geometry of the specimens used for pull-out tests.

In order to study the bond behavior between GFRP rebars and concrete, pull-out specimens were prepared according to the following procedure: 1.20 m-long straight rebars were partially embedded at the center of a normal strength concrete cylinder (of diameter 16 cm and height 20 cm). The specimen's geometry is illustrated in Figure 3. Concrete was cast while the rebar was set in the vertical position. A plastic tube, called a bond breaker, was placed between the rebar and concrete at the upper side of the concrete block, in order to prevent edge effects induced by the reaction support during pull-out tests (this test protocol is detailed in Section 2.3.7). The length of the bond breaker was chosen so that the embedment length of the bar in concrete is equal to six bar diameters (Figure 3). This condition is supposed to favor preferential failure by the slippage of the rebar [35]. It is worth noting that the same batch of concrete was used for casting the pull-out specimens and for embedding the GFRPs of short-beam specimens (series exposed to indirect immersion).

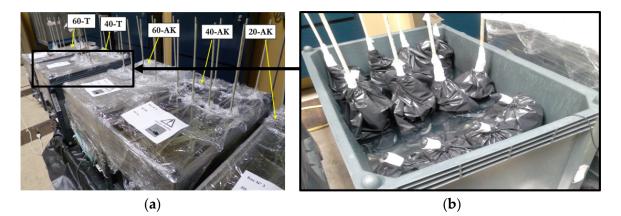
Figure 4. (a) Picture of the five thermoregulated tanks and (b) detail of the 40-T tank.

Five tanks were used for conditioning the samples in the different accelerated aging environments, as shown in Figure 4a. Three tanks, in which the aging environments were denoted 20-AK, 40-AK, and 60-AK, were filled with an alkaline solution and respectively maintained at room temperature (about 20 °C in the laboratory) and at constant temperatures of 40 °C and 60 °C (using heating resistances). These tanks were used both for the direct immersion of GFRP rebars and for the indirect aging of embedded specimens.

The two other tanks, in which the aging environments were denoted 40-T and 60-T, were filled with water and regulated at temperatures of 40 °C en 60 °C, respectively. These tanks were intended for applying pure thermal aging conditions, in order to study possible differential thermal effects between the rebars and concrete. Before being placed in these tanks, the specimens were first wrapped with hermetic plastic bags to avoid contact with water and keep them in a dry state (Figure 4b). Only embedded GFRP specimens (i.e.,  $16 \times 32$  specimens for short-beam tests and pull-out specimens) were placed in these pure thermal environments.

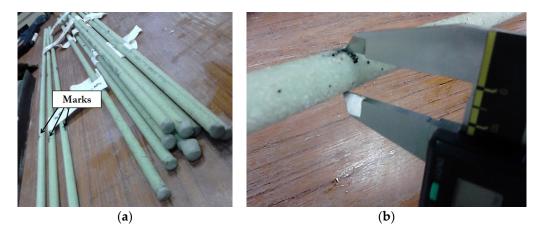
**Figure 5.** (a) Marked GFRP rebars used for monitoring the changes in mass/diameter over aging and (b) illustration of the diameter measurement on a sand-coated rebar (as a reminder, the nominal diameter of all rebars was 12.7 mm).

In addition, diameter measurements were performed with a caliper of precision 0.01 mm at fixed locations of the bars identified by marks (reticles) drawn at the surface (one mark per sand-coated rebar and 3 marks per smooth rebar). Such marked rebars are shown in Figure 5a, and an illustration of the diameter measurement on a sand-coated rebar is presented in Figure 5b.

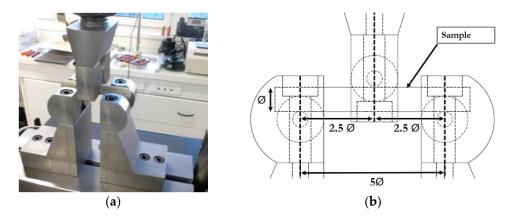
**Figure 6.** Short-beam test: (**a**) picture and (**b**) detailed scheme of the test configuration (dimensions are in mm).

Tests were carried out on 100 mm-long rebar samples. Three identical samples were tested for each aging condition and aging time. To perform these tests, a specific frame (Figure 6) was manufactured at the laboratory and installed on a universal testing machine of capacity 50 kN, model 5969 from Instron (Norwood, MA, USA). The specificity of this frame relies on the geometric shape of the supports, which is designed to ensure quasipunctual contact and avoid any slip of the circular cross-section of the sample. The distance between the two lower supports was set to 5 times the rebar diameter  $\emptyset$  (Figure 6b). The test was controlled by the displacement of the upper support at a rate of 1 mm/min. The apparent interlaminar shear strength (ILSS) of the tested rebar was deduced from the ultimate load *F* by the relation ILSS = 0.849  $F/\emptyset^2$  [42].

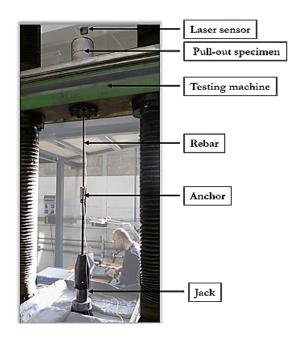
Figure 7. Picture of the pull-out test setup.

The specimens dedicated to bond characterizations were tested by the pull-out method according to the ACI 440.3R-04 guidelines [38], using a 350 kN Losen testing machine. The test setup is shown in Figure 7. Specimens were installed on the drilled horizontal crosshead beam of the machine, with the rebar passing through the beam hole. The rebar is loaded using a jack, via a wedge-type anchor. The loading is controlled by the displacement of the jack at a speed of 1.2 mm/min.

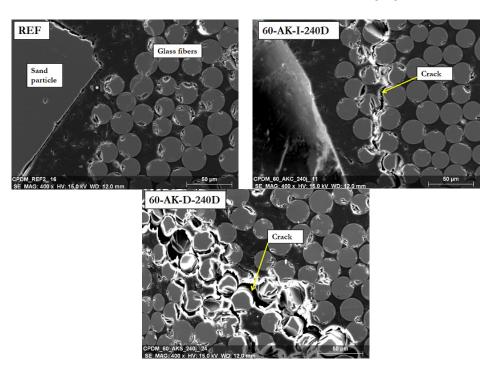
damage the reference samples. Such embrittlement process is more severe in the case of direct immersion in the alkaline solution than for the indirect aging condition.

**Figure 9.** SEM images of the cross section of reference and aged GFRP rebars, at locations close to the external sand coating layer.

Figure 9 displays typical SEM images showing the periphery of the cross-sections of GFRP rebars after 240 days at 60 °C in AK-D and AK-I conditions. The picture of a reference rebar is also provided for comparison. One can observe many cracks on the 60-AK-D-240D sample but only exclusively near the external sand coating layer and not in the central part of the bar cross-section. Some cracks are also detected on the 60-AK-I-240D samples but to a much lower extent. Since the rebars have not been mechanically stressed during or after aging, these cracks are therefore either directly related to aging-induced degradation or due to the polishing process on samples used for SEM observation. In both cases, these cracks reveal an embrittlement of the fibers and the fiber/matrix interface induced by aging at the outermost region of the rebars, since an identical surface preparation did not

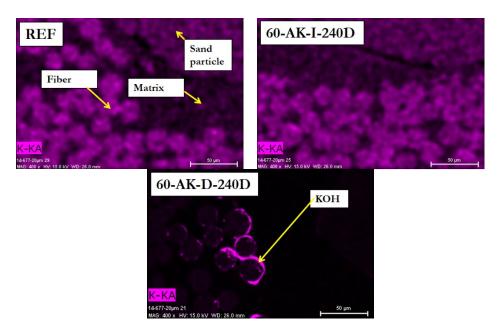
**Figure 10.** EDX mapping of K over cross-sections of the reference and aged GFRP rebars, at locations close to the external sand coating layer.

Complementary EDX analyses were carried out at the surface of the same polished samples, in order to monitor the possible migration of alkalis from the aging solution to the inside of the rebars. Figure 10 displays the typical mappings of the spatial distribution of potassium element (K) over the analyzed cross-sections. This element is a good marker of the alkaline solution, which is mainly composed of potassium hydroxide (KOH).

For the 60-AK-D-240D sample, the concentration of K can be observed at fiber/matrix interfaces close to the external coating of the rebar. In the reference sample and in the 60-AK-I-240D rebar, the distribution of K is much more diffuse and probably relates to some potassium initially present in the composition of the materials (especially in the glass fibers). This result suggests that the substantial diffusion of alkalis may occur within GFRP rebars subjected to direct immersion, but it remains restricted to the outermost layer of the bar.

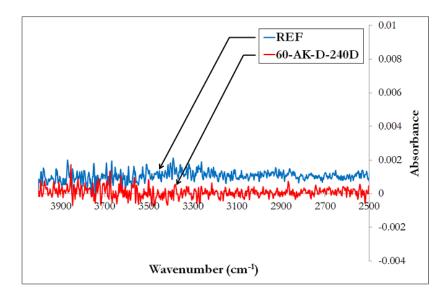
**Figure 11.** FTIR spectra in the region of 2500–4000 cm<sup>-1</sup> from a reference sample (REF) and from a sample aged in the alkaline solution at 60 °C for 240 days (60-AK-D-240D).

Figure 11 displays the typical FTIR spectra recorded for unaged reference samples and for samples aged by direct immersion in the alkaline solution at 60 °C for 240 days (60-AK-D-240D). On these spectra, the region between 3300 and 3600 cm<sup>-1</sup> is of great interest as it contains the vibration bands of hydroxyl groups (OH) [11]. In this region, the comparison of spectra from the reference and aged samples does not reveal any significant change induced by alkaline aging. In particular, no additional hydroxyl groups is detected, hence there is no evidence of hydrolytic degradation of the polymer matrix. This result is consistent with previous DSC analyses and confirms that the vinylester matrix used in these GFRP rebars exhibits good resistance to alkaline environments.

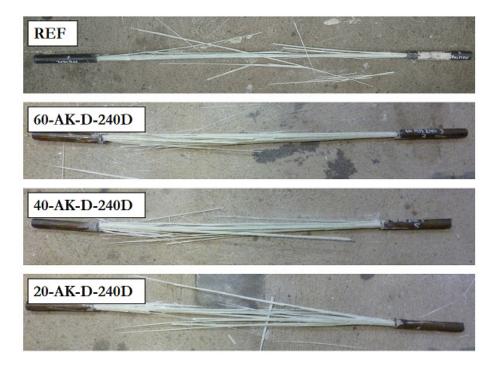
Figure 12. Typical failure modes after tensile tests on aged GFRP rebars and reference samples.

All GFRP rebars showed brittle failure during a tensile test. Figure 12 presents the typical tensile failure modes obtained in the case of GFRP rebars exposed to direct immersion in the alkaline solution for 240 days (AK-D-240D) at different temperatures and for the unaged reference bar as well. Visual observation does not reveal any change in failure mode resulting from aging.

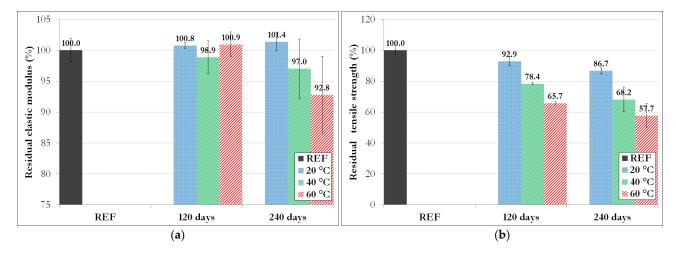
**Figure 13.** Residual tensile properties of GFRP rebars subjected to direct immersion in the alkaline: (**a**) elastic modulus and (**b**) tensile strength.

The elastic modulus and tensile strength determined for the reference specimens and the aged GFRP rebars are reported in Table 6 and summarized in the graphs of Figure 13.

Experimental results reveal only small variations in the elastic modulus after aging (with a maximum loss of 7% after 240 days at 60 °C). Conversely, a substantial decrease in the tensile strength is observed after aging. In particular, one can notice (i) a gradual decrease in resistance over time and (ii), at a given time, a drop of resistance when raising the aging temperature (strength loss up to 42% after 240 days at 60 °C).

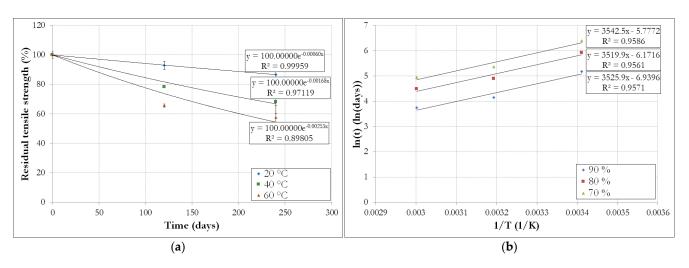
**Figure 14.** (**a**) Residual tensile strengths of GRP bars as a function of direct aging time and (**b**) Arrhenius lines for different retention rates of the tensile strength.

From experimental data, it is possible to trace the evolution of the residual tensile strength of rebars (in %) as a function of time for each aging temperature (see Figure 14). Although only three values of residual strength (0 days, 120 days and 240 days) are available for each temperature in our present study, exponential regressions were performed using Equation (5) on these data, in order to determine the three  $\tau$  coefficients for the three test temperatures considered in this study (20 °C, 40 °C and 60 °C). The results of these identifications are displayed in Figure 14a. In order to increase the robustness of the data fitting, it would be necessary to perform other measurements at additional aging times. Unfortunately, this was not possible in the present study due to time constraints.

Figure 14b presents, from the identified curves R(t) at different temperatures, the natural logarithm of the reaction time necessary to reach residual tensile strength values

It is worth noting that the three Arrhenius lines displayed on Figure 14b are almost parallel, which supports the initial hypothesis of a single degradation reaction mechanism or at least of a dominant mechanism.

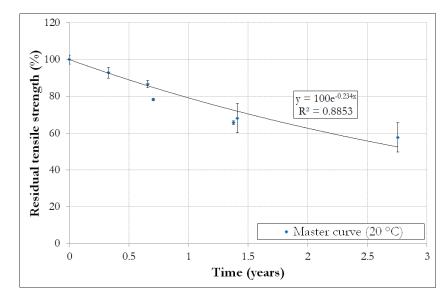
**Figure 15.** Master curve (residual tensile strength versus aging time) at a reference temperature of 20 °C.

Finally, knowledge of the temperature shift factors enable the construction of the master curve describing the long-term evolution of the residual tensile strength at the reference temperature of 20  $^{\circ}$ C, as shown in Figure 15.

This master curve predicts a large degradation of the tensile strength of about 40% after 2.5 years of exposure. Similar predictions were reported by [3] on glass/vinylester FRP rebars aged in an alkaline solution. However, it must be recalled that this direct aging condition is very harsh and provides extremely pessimistic results.

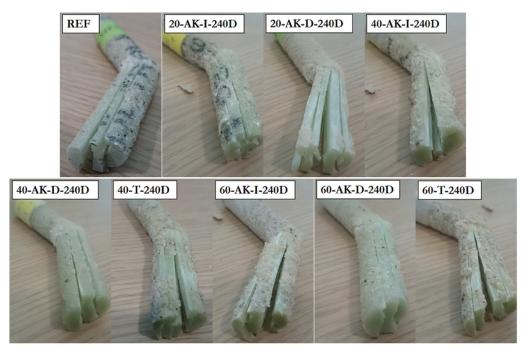
Figure 16. Failure modes observed after short-beam tests on reference and aged GFRP rebars.

Short-beam tests were performed on reference samples and on GFRP rebars exposed for 240 days to direct (AK-D) and indirect (AK-I) immersion in the alkaline solution at different temperatures and to pure thermal aging (T) as well. Figure 16 shows that the failure mode was identical for all specimens and was initiated by delamination at the neutral axis of the GFRP bars.

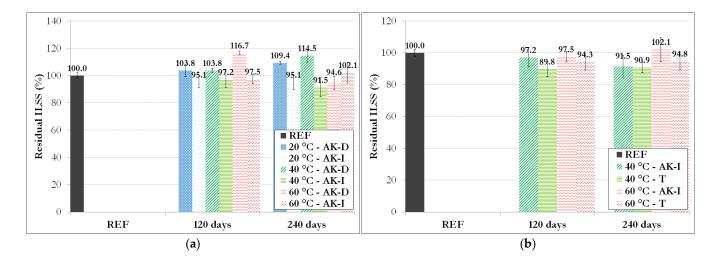
**Figure 17.** Residual interlaminar shear strength of GFRP rebars after aging in different environments: (**a**) AK-D versus AK-I and (**b**) AK-I versus T.

ILSS values determined on the various specimens are referenced in Table 8 and summarized in Figure 17.

At first, the results show that accelerated aging does not induce a significant decrease in the ILSS of GFRP rebars, whatever the type of accelerated environment. With regard to rebars subjected to direct immersion in the alkaline solution (AK-D), it is even possible to note slight increases in ILSS (except for the 60-AK-D-240D samples). The trend observed here is therefore very different from that previously described for the tensile strength. Note that the failure mechanisms of these two tests are very different, because the ILSS value relates more to the properties of the matrix and fiber/matrix interface, while the longitudinal tensile strength is mainly governed by the tensile properties of glass fibers. The relative stability of the ILSS of aged bars would therefore confirm the good chemical resistance of the vinylester matrix that had already been demonstrated previously by DSC and FTIR analyses and also the good resistance of the fiber/matrix interface (at least in the core specimen, as SEM observations revealed some cracks in the outermost region).

In addition, for a given temperature and exposure time, rebars exposed to direct immersion (AK-D) exhibit slightly higher ILSS values compared to rebars exposed to indirect immersion (AK-I), and some values may even be greater than the initial ILSS (up to a 17% increase for 60-AK-D-120D rebars). Because this property (ILSS) related the chemical resistance of the matrix and the fiber/matrix interface, direct immersion in the alkaline solution does not therefore represent a particularly penalizing condition.

The results also highlight higher ILSS values for the rebars subjected to the AK-I environment compared to pure thermal aging out of solution (T). This phenomenon could result from a possible confinement effect of the fibers in the AK-I condition, driven by the swelling of the polymer matrix due to the absorption of some interstitial solution. Such a confinement effect would be beneficial to the fiber/matrix load transfer and hence to the ILSS. Finally, the overall higher ILSS values obtained for rebars aged in direct immersion (AK-D) compared to those aged in the two other environments could result from a greater diffusion of the solution in these AK-D samples, hence a larger swelling phenomenon of the polymer matrix and a stronger confinement effect of the fibers. However, this hypothesis

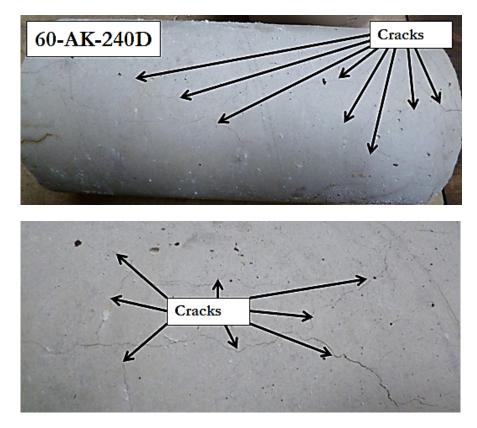
Figure 18. Typical surface aspect of 60-AK-240D concrete cylinders.

Results of the compression tests are reported in Table 9 for both aged specimens and reference samples. Overall, one can notice an increase in the compressive strength after aging, which accounts for a notable post-curing effect related to the progress of cement hydration reactions with time. As an exception, the 60-AK-240D specimens were the only one that exhibited a loss in compressive strength, which nevertheless remained limited (about 10%). This phenomenon was correlated to the development of multidirectional cracks regularly distributed at the surface of the cylinders, as illustrated in Figure 18. These cracks suggest a possible internal swelling reaction of the concrete, but further investigations would be necessary to identify more precisely the origin of this phenomenon.

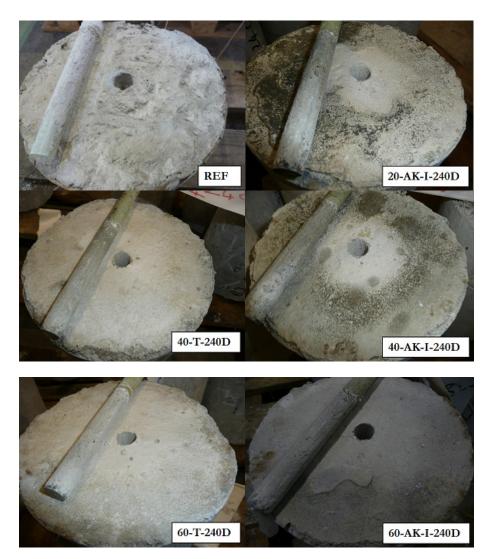
Figure 19. Typical failure modes observed after pull-out tests on reference and aged specimens.

Pull-out tests were then carried out on specimens aged for 240 days in the different environments, and the typical failure modes are illustrated in Figure 19. Overall, there is very little difference between the failure modes before and after aging, regardless of the type of aging environment. Failure always occurs at the interface between concrete and the sand coating of the GFRP rebar.

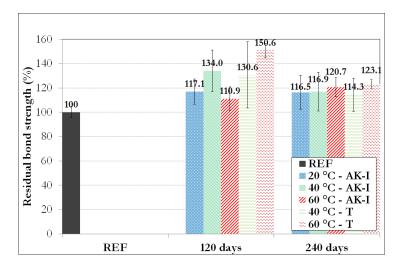
**Figure 20.** Residual bond strengths of pull-out specimens exposed to the different aging environments for different periods.

Bond strength values determined on reference and aged pull-out specimens are reported in Table 10 and summarized in Figure 20.

Globally, an initial increase in bond strength is observed over the first 120 days of exposure, regardless of the type of aging environment, followed by a decreasing trend between 120 days and 240 days. The bond strength values at 240 days of exposure still remain higher than that of the reference specimens. Note that experimental dispersion was rather large in the case of aged samples, which made comparisons difficult.
