# SCIENTIFIC REPORTS

## Erosion and sedimentation during the September 2015 flooding of the Kinu River, central Japan

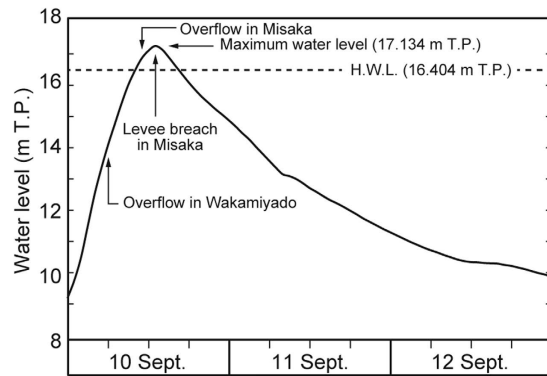
**Figure 2. Hydrograph for the Kinu River at the Mitsukaido gauging station (Fig. 1B) from 10 to 12 September 2015.** Measured water levels<sup>37</sup> were expressed compared to Tokyo Peil (T. P.; mean sea level in Tokyo Bay). H.W.L. means High Water Level at this station, a threshold height for flooding relative to the neighboring levee height.

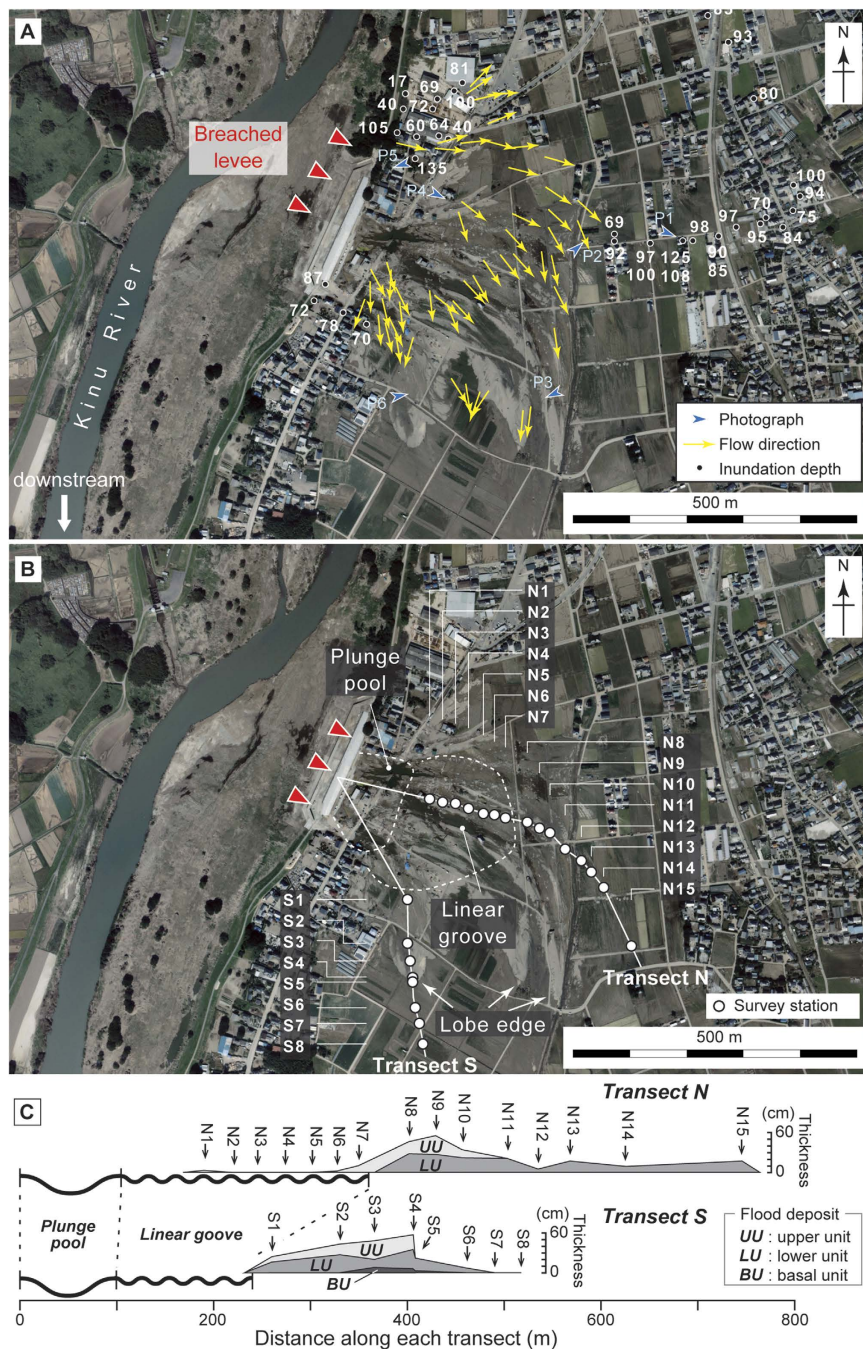
**Figure 3. Detailed map of the survey sites with panels A and B displaying the same area.** The aerial photo was obtained from the Geospatial Information Authority of Japan<sup>38</sup> (CKT-2015-12-C4-14) and taken on 29 September, 2015. (A) Map showing the survey locations on the photograph (blue arrowhead; Fig. 4), flow direction (yellow arrow) and inundation depth (black circle with the measured depth). (B) Map showing the survey stations where erosional and depositional features along Transects N and S were investigated. Transects N and S start at the breached levee and extend in the direction of flow. (C) Sectional view of the lateral distributions of erosional and sedimentary features along each transect from the breached levee. Note that erosional depths are not to scale.

The water depth during flooding, deduced from water marks and water-borne debris (Fig. 4A), was generally constant at most of the surveyed locations within the study area and ranged from 17 to 135 cm (83 cm on average) (Fig. 3A). Leaning plants, bedforms, and erosional scours (Fig. 4B–D) indicated an ESE–SSE flow direction that was perpendicular to the Kinu River flow in the area next to the breached levee (Fig. 3A). With increasing distance away from the breached levee, the direction of the flow gradually turned southward (Fig. 3A).

Sedimentary and erosional features found in the flood deposits were laterally variable across the study area (Fig. 3C). The basal unit of the flood deposit was only found at three stations along Transect S. The lower unit was generally confined to areas distant from the breached levee, whereas the upper unit was generally confined to areas close to the breached levee. The lower unit of the flood deposit was found at stations N8–15 and S1–8, while the upper unit was found at stations N1, N6–10, and S1–4 (Figs 3B, 5 and 6). The latter overlapped the former at N8–10 and S1–4 where they showed a vertical stacking pattern with lateral offset. Abrupt lateral changes in thickness and sedimentary features were occasionally found in the two units. With increasing distance from the Kinu River, the

lower unit showed a slight thinning trend, while the upper unit showed a slight thickening trend along both transects (Fig. 3C). Along Transect N, the lower unit thinned from 28 cm at N8 to 17 cm at N15, while the upper unit thickened from 3 cm at N1 to 12 cm at N10. Along Transect S, the lower unit thinned from 16 cm at S1 to 7 cm at S6, while the upper unit thickened from 8 cm at S1 to 22 cm at S6. At stations N9 and N11, the lower unit was characterized by a series of graded layers, although more commonly, a single inversely-graded layer was present (Fig. 5). In general, the upper unit consisted of a sandy graded layer. However, at stations N1 and N6, the upper unit consisted of either a thin muddy-sand or a sandy-mud layer and transitioned into gravelly sand at station N7 (Fig. 5).

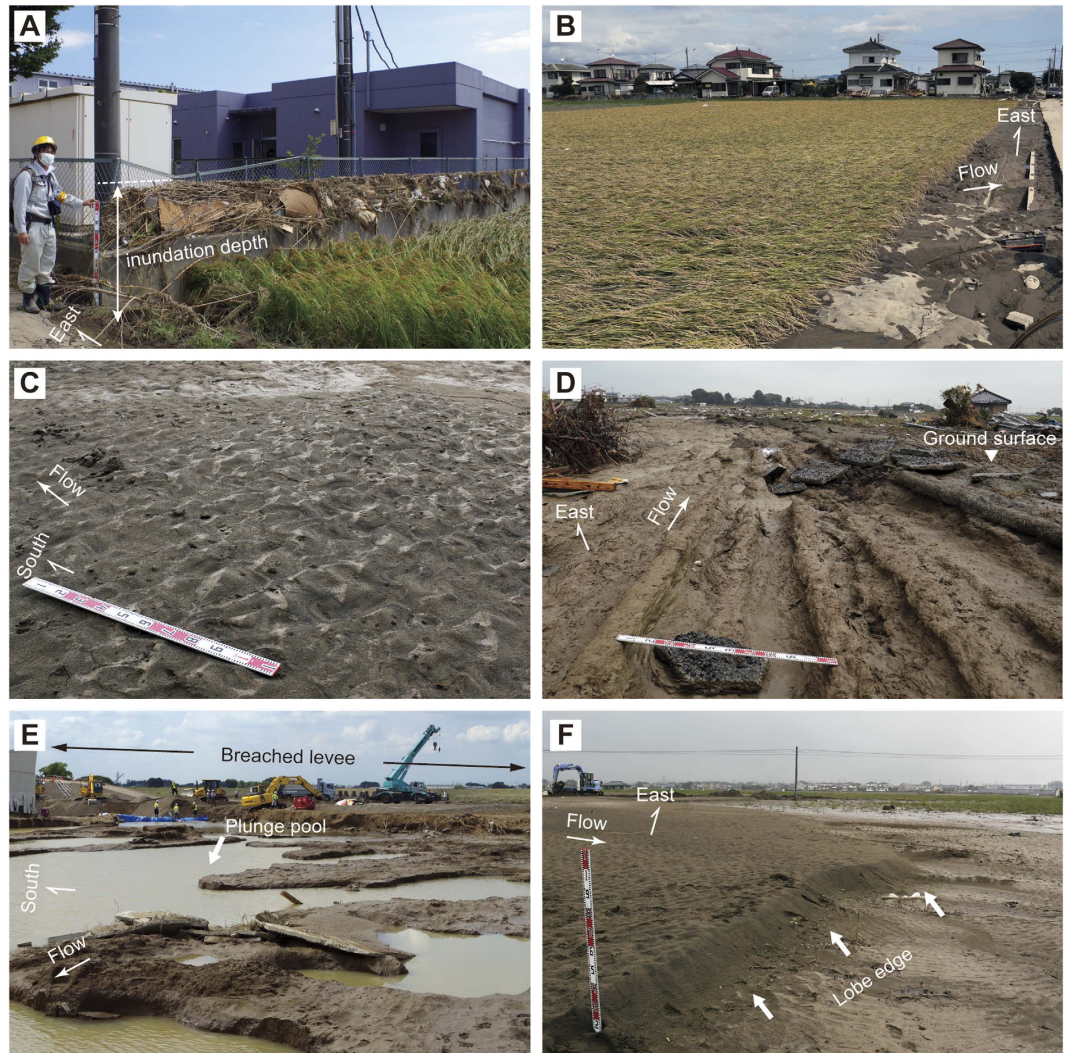
**Figure 4. Photographs of the study area. Locations are shown in Fig. 3A (P1–6).** The scale bar in panels A, C, D and F represents 1 m. (A) Water-borne debris on the fence at P1 showing the inundation depth of flooding. (B) Leaning rice plants showing the direction of flooding water at P2. (C) Ripple marks on the surface of the flood deposit indicating the flow direction at P3. (D) Linear grooves along the flow direction at P4. (E) Plunge pools scoured by the 2015 flood just behind the breached levee at P5. (F) Lobe edge of the flood deposit at P6.

Numerous geomorphological features of erosion and sediment deposition resulting from the flooding were found within the study area. These features, including plunge pools, linear grooves and flood deposits, were exclusively found in a small area located next to the breached levee and were parallel to the main flow direction. Plunge pools, scoured by the flooding water, were several meters deep, 100 m wide and found at the toe of the breached levee's back slope (at P5 in Figs 3A,C and 4E). Roads and houses close to the plunge pools were completely destroyed and swept away. Adjacent to the plunge pools, numerous well-developed linear grooves were observed (Fig. 4D). The linear grooves were orthogonal to the Kinu River and found in a zone that extended for 250 m along the direction of flow. These grooves were observed at stations N1–7 along Transect N, and between the plunge pools and station S1 along Transect S (Fig. 3B,C). In the linear groove zone, up to 1 m of the pre-flood soil was laterally eroded, causing the underlying semi-consolidated muddy floodplain deposits to be exposed. Linear grooves that were several tens of centimeters deep and wide were dug further into the floodplain deposits as scour marks. The erosional surface was covered by either a thin mud drape (generally less than 1 cm thick; at N2–5; Fig. 3B) or by a thicker sandy flood deposit (generally several centimeters thick, with a maximum depth of 10 cm; at N1, N6–7; Figs 3B and 5). The flood deposit was limited to the area surrounding N1, N6–15 and S1–6 (Figs 3B,C, 5 and 6). In some places (N2–5, S7–8), only a thin mud drape overlay the surface. Bedforms such as unidirectional current ripples and dunes were widely found at the surface within the study area (Fig. 4C). At the midpoint between S4 and S5, the bedforms comprised a stepwise architecture resembling a deltaic lobe ranging heights comprised between 20–30 cm (Figs 3B,C and 4F).

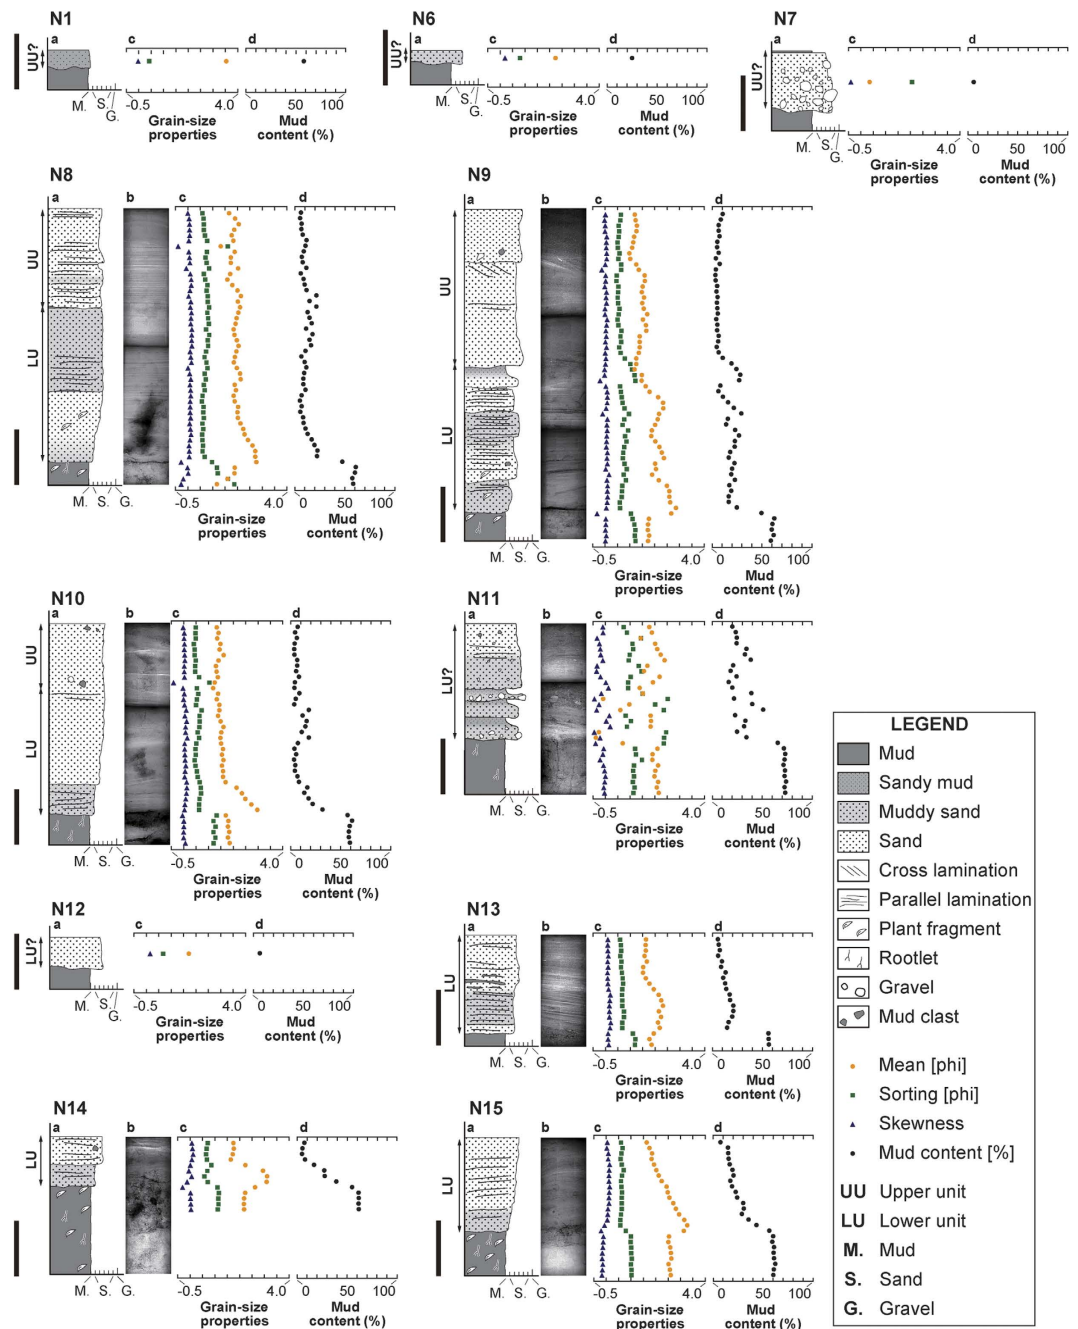
**Figure 5.** Schematic column (a), soft X-ray image (b), graph of grain-size properties (mean, sorting and skewness) of the particles larger than  $63\mu\text{m}$  (c), and mud content (d) of the flood deposit along Transect N (N1, N6–15). The scale bar beside each column represents 10 cm.

higher mud content of 62.55% (Figs 5 and 6). Soft X-ray radiography indicated the presence of mud clasts, gravels, and parallel and cross laminations at various depths in the flood deposits. (Figs 5 and 6).

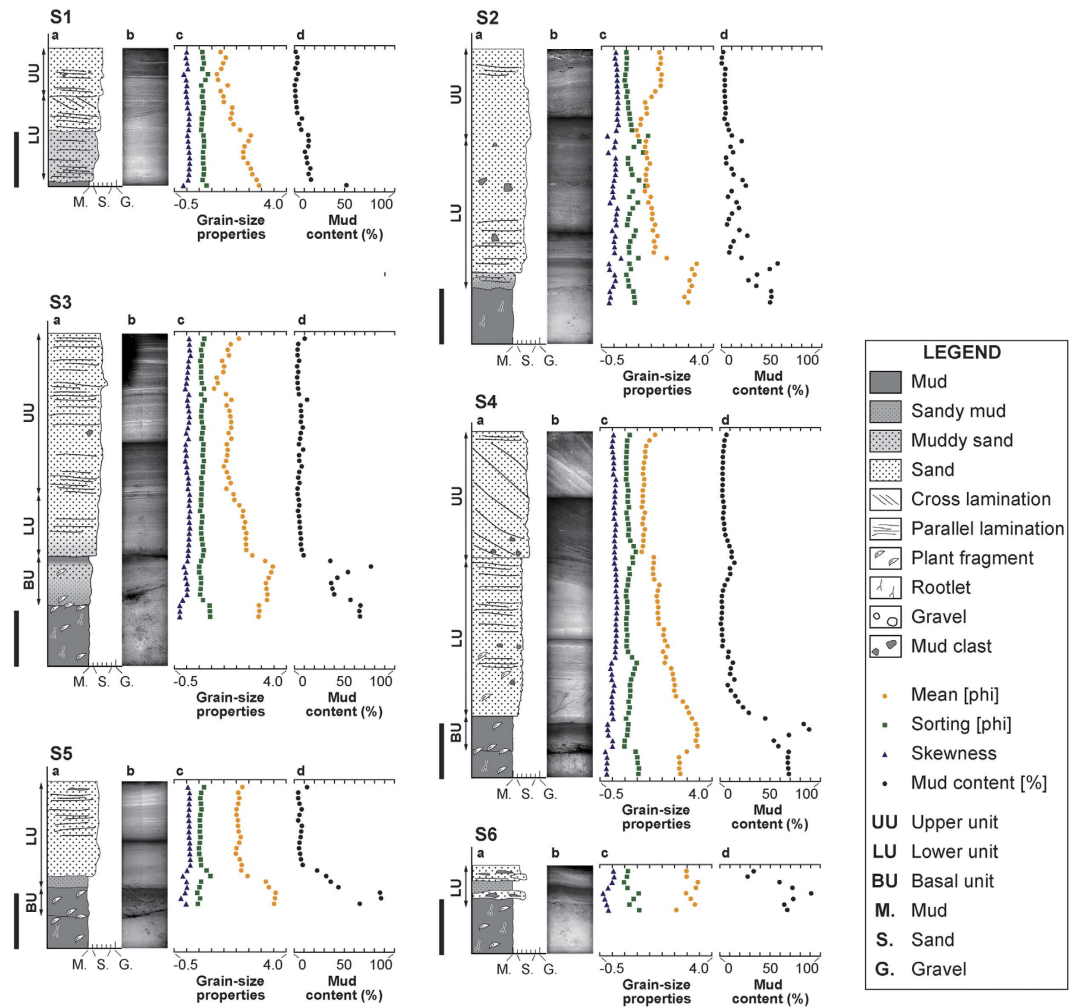
**Figure 6.** Schematic column (a), soft X-ray image (b), graph of grain-size properties (mean, sorting and skewness) of the particles larger than  $63\ \mu\text{m}$  (c), and mud content (d) of the flood deposit along Transect S (S1–6). The scale bar beside each column represents 10 cm.

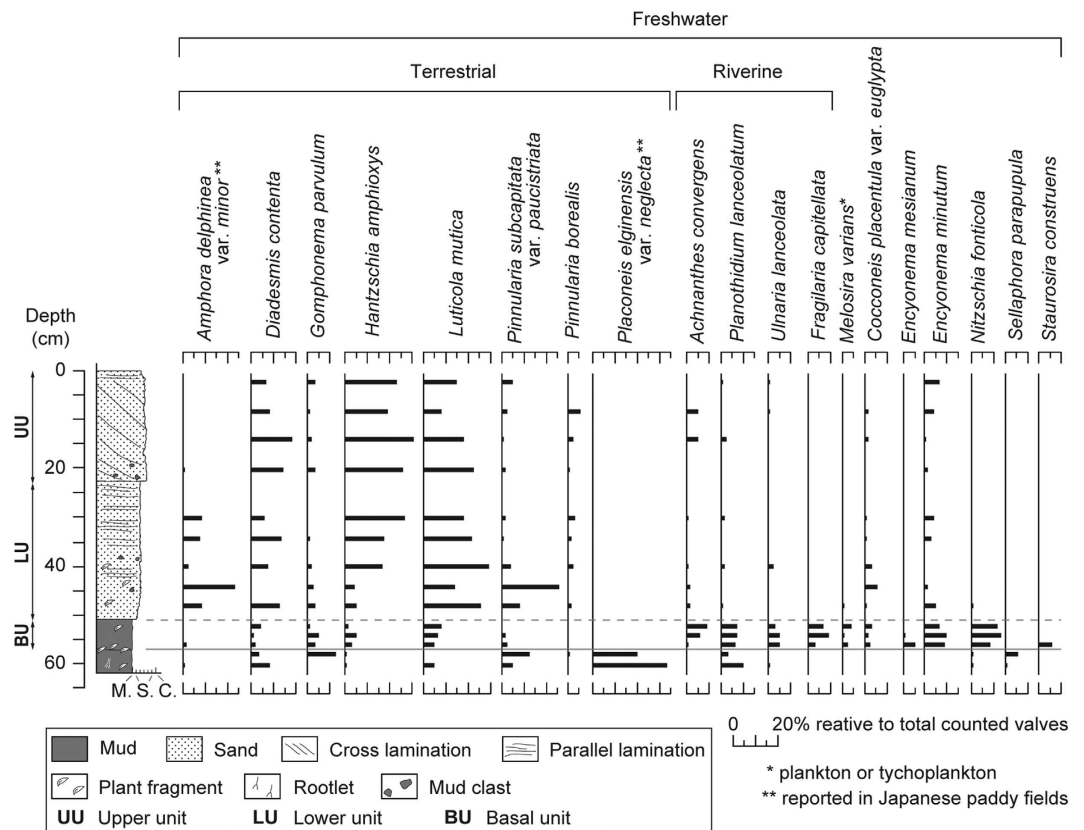
**Figure 7.** Diatom assemblages for the flood deposit at S4 showing changes in the relative abundance of the dominant species.

Diatom analysis for the deposit found at station S4 revealed that freshwater species were generally dominant, but the species composition of the assemblages varied as a function of the sedimentary facies (Fig. 7). The underlying soil contained many freshwater terrestrial taxa such as *Placoneis elginensis* var. *neglecta*, *Pinnularia subcapitata* var. *paucistriata*, and *Gomphonema parvulum*. These assemblages abruptly changed at the contact between the underlying soil and the muddy basal unit. The basal unit was characterized by riverine benthic diatom species (*Planthidium lanceolatum* and *Ulnaria lanceolata*)<sup>15</sup>, other freshwater species, and a decrease in terrestrial taxa

Distinct changes in diatom assemblages are recognized within the deposit at S4. The muddy basal unit of the flood deposit is characterized by a mixture of benthic, planktonic riverine and terrestrial freshwater diatom species. These assemblages were likely to be formed from suspended load due to the initial overtopping of the levee. Because diatom valves are known to exhibit the same depositional behavior as that of silt-sized sediment grains, the dominant species were probably incorporated with the fine fractions of the deposit. The sandy lower and upper units of the flood deposit were dominated by terrestrial diatom species (*Diademsis contenta*, *Hantzschia amphioxys*, and *Luticola mutica*). Such species are commonly found on the surface of wet soils and mosses, but not in coarse-grained sediments<sup>28–30</sup>. This implies that living diatoms were transported from their original habitat, or pre-existing valves that were buried in soils were scoured, and incorporated with flood sediments during high-energy inundation flow. The observed difference in assemblages can be attributed to the different origins and transportation processes, which are consistent with the depositional processes deduced from the sedimentary features.
