Article

# Monitoring of Strain and Temperature in an Open Pit Using Brillouin Distributed Optical Fiber Sensors

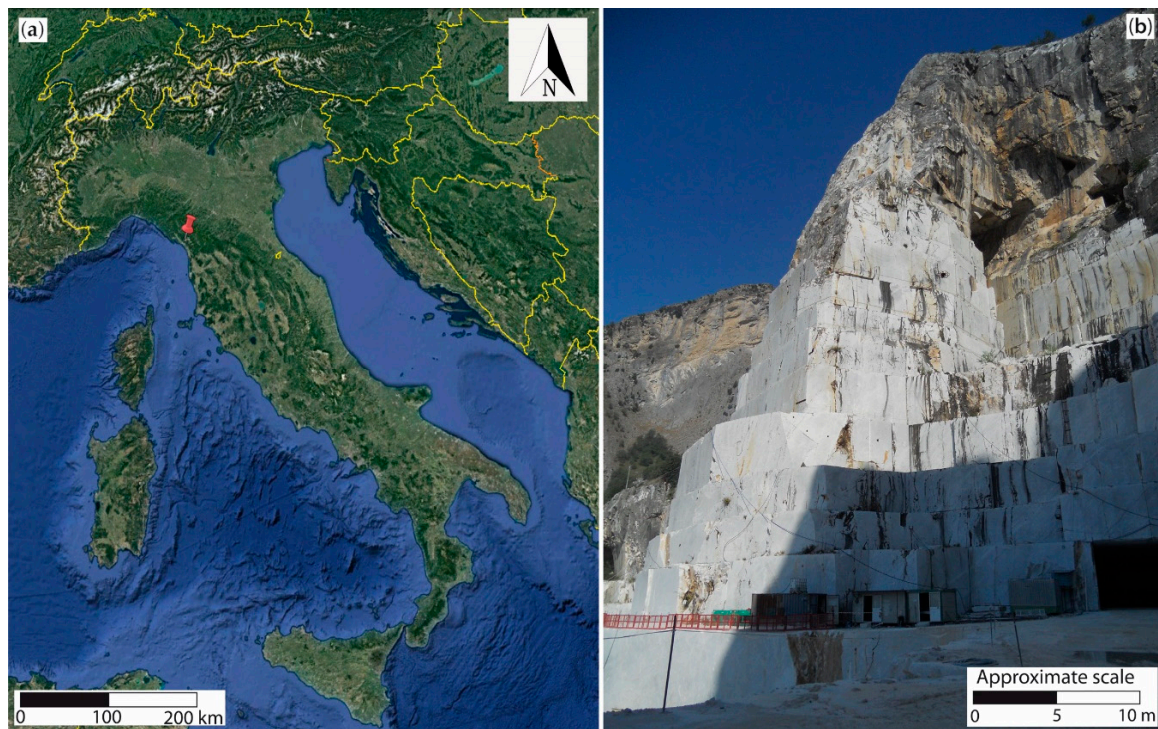
**Figure 1.** (a) Location of the Lorano marble quarry in Italy. (b) Panoramic image of the investigated Pradetto cut site.

A very important element of the Lorano open pit is the Pradetto cut site (Figure 1b), a marble buttress (about 120 m high, 30 m wide and 40 m deep) derived from previous mining activities and object of monitoring activities as described in [35]. Accessible from three sides, at its base, the excavations keep on with a downward feed. While the “Ordinary marble” outcrops in the buttress, the “Veined Grey Marble” characterizes the mountain above. Regarding the structural and engineering-geological analysis, previous studies [15,35,36] show four high angle sets of discontinuities and, despite a good quality of the rock mass (from the Basic Rock Mass Rating RMR<sub>b</sub> [37]), potentially unstable joint systems along the three different slopes of the buttress were highlighted from kinematic stability analyses [15].

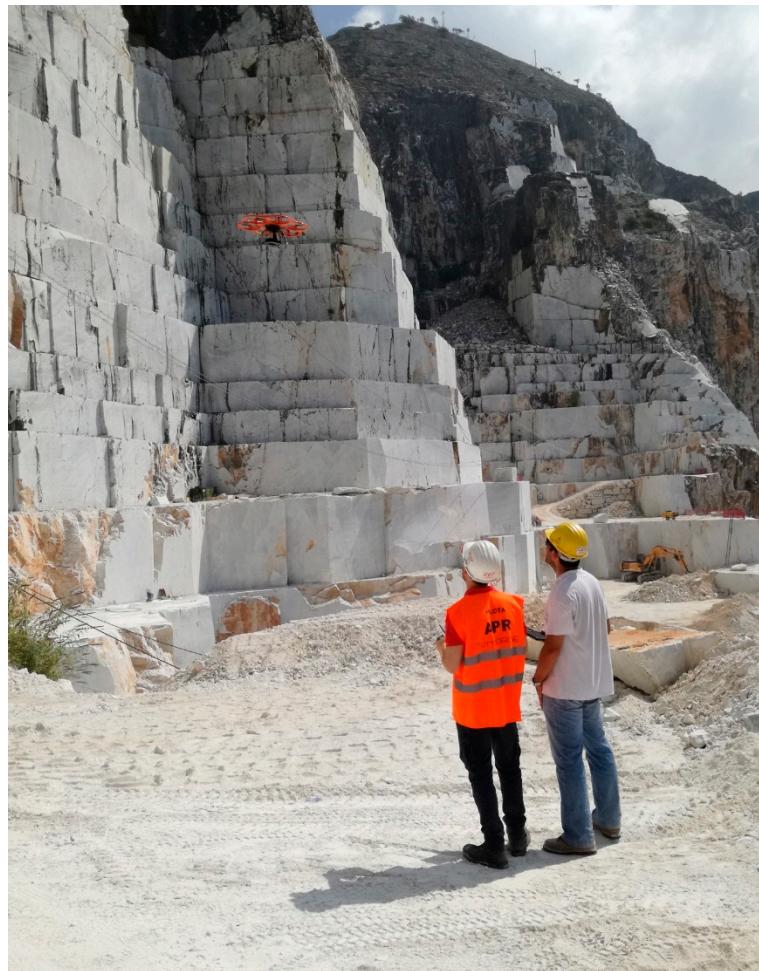
**Figure 2.** UAV survey at the Lorano marble quarry.

Under the guidance of previous results on slopes stability, DOFS were installed on the buttress by specialized climbing workers. With the scope of determining and georeferencing the DOFS exact position and facilitating comparisons with the topographic-geotechnical monitoring system, an aerial photogrammetric survey was carried out through an Unmanned Aerial Vehicle (UAV). The photogrammetric survey was carried out using the Aibotix™ X6 V1 multirotor drone (Figure 2) which, with an autonomy of about 15 minutes, can operate in the visible range (400–700 nm) of the electromagnetic spectrum using a Nikon Coolpix A type camera. The equipment also consists of i) the Inertial Navigation System (INS) with GNSS, accelerometers and gyroscopes, ii) a video camera for remote inspection and iii) the flight management software. The flight was designed defining a Ground Sampling Distance (GSD) of about 1.4 cm/pix and an average flight distance from the slopes of about 50 m. As Ground Control Points (GCPs), which are necessary to improve the accuracy of the exterior orientation of the photographs, and Check Points (CPs), whose function is positional accuracy assessment, natural and artificial targets of known coordinates taken from previous works [35] (i.e., aerial photogrammetric surveys and terrestrial laser scanning) were used. For this reason, it was not necessary to perform a new topographic survey.

For this case study, the image processing involved 548 digital photographs and the positioning of 49 GCPs and 8 CPs. The final Root Mean Square Error (RMSE) of the exterior orientation phase is around 8 cm for GCPs and 10 cm for CPs.

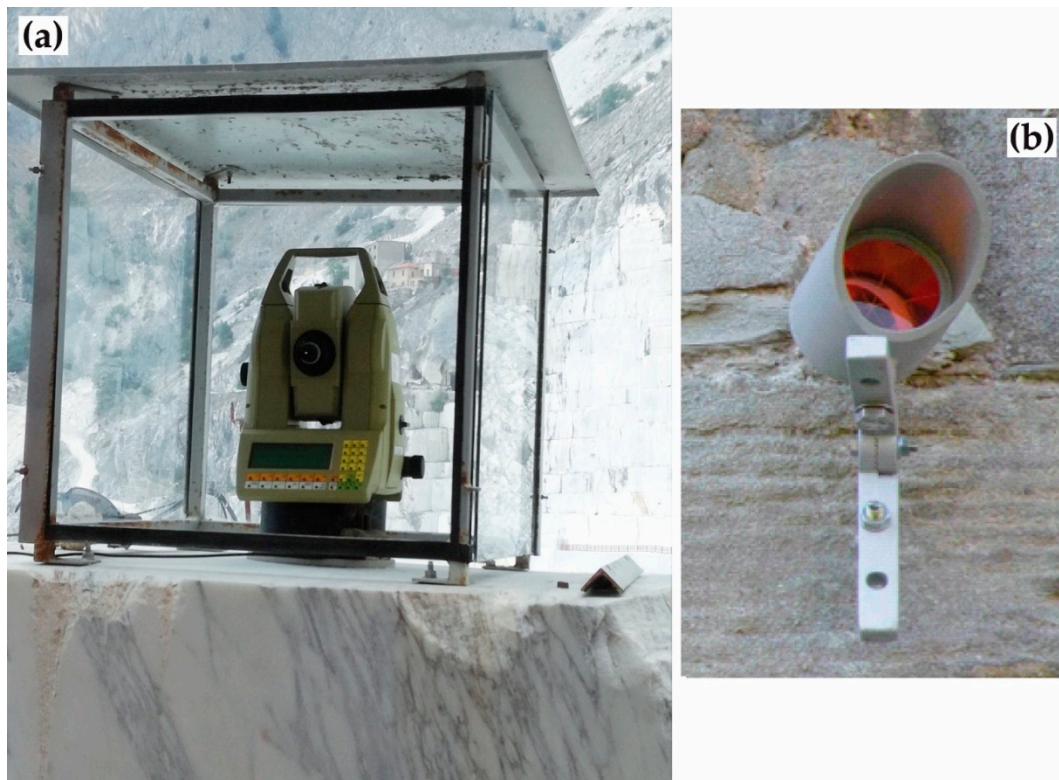
**Figure 3.** (a) RTS installed at the Lorano marble quarry. (b) Detail of a prism placed on the excavation site walls.

The topographic monitoring system installed at the open pit consists of a Leica<sup>TM</sup> TCA2003 RTS (Figure 3a), which is a tool for topographic survey that combines a laser distancemeter, an electronic theodolite and a computer on a single device. More details about the instrument can be found in [15].

At the Lorano site, the RTS was placed on top of a stable marble block [15], at an approximately 300 m distance from the buttress and it was protected by a metallic box with anti-aberration glasses (Figure 3a). The RTS, starting from December 1st 2012, automatically detects, every 6 h (at 0.00, 06.00, 12.00 and 18.00 h), the 3D distance measurement of 24 prisms (an example in Figure 3b) positioned both on the pillar (20 measurement points) and outside it (4 reference points), so as to be able to discriminate between the relative movements due to local fracturing from the absolute ones, i.e., those of the entire pillar. The reference points (Figure 4), moreover, allow to have additional control in external stable areas, useful, above all, in the calibration phase of the monitoring system.

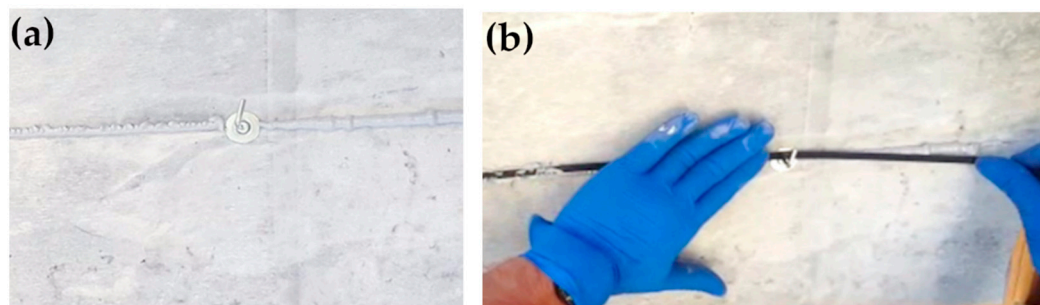
**Figure 7.** (a) Adhesive resin layer applied on the buttress along the path designed for optical fibers. (b) Positioning of the sensor cable on the glue layer.

The position of the optical fiber was designed by trying to intercept as many rock mass discontinuities as possible and following the location of topographic measurement prisms and geotechnical sensors on the quarry walls. Two different phases, pre-installation of the witness wire and installation of the effective sensor cable, were carried out by specialized climbing workers (Figures 7 and 8). In particular, the pre-installation phase took place through the installation of mechanical hooks and the engagement of the witness wire. Afterwards, the witness thread was removed, and a layer of “Sikaflex®-11 FC+”, adhesive resin (Figure 7a), based on polyurethane and characterized by a Secant Modulus of Elasticity of  $\sim 0.60 \text{ N/mm}^2$  (after 28 days) ( $+23 \text{ }^\circ\text{C}$ ) (ISO 8339), was applied through a special compressed air gun. Polyurethane adhesives are “structural adhesives” which can be used to join very different types of materials together with a long-lasting and strong bond. In particular, “Sikaflex®-11 FC+” is an adhesive commonly and widely used in several works on optical fibers [61,62]. The sensor cable was placed on the adhesive and secured to metal plugs (Figure 7b). The cable was then covered with glue to improve adherence to the surface and to protect DOFS from both meteoric events and ultraviolet rays (Figure 8c). Since DOFS installation cannot have right angles or smaller, some different setting was necessary in zones characterized by artificial rock cuts and fracturing. Figure 8b, as an example, shows a typical setting adopted in these situations.

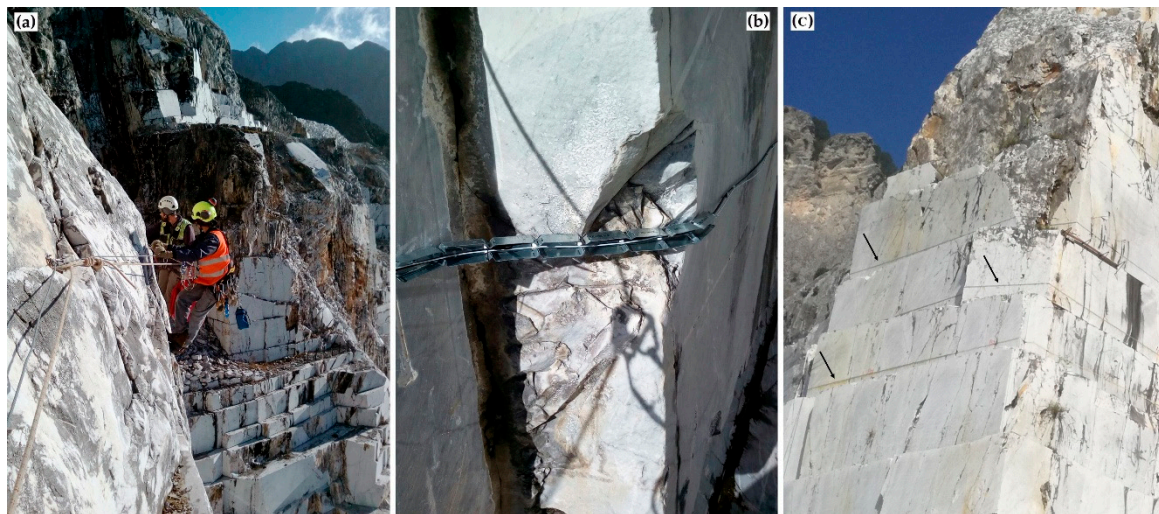
**Figure 8.** (a) Installation of the optical fiber on the marble buttress carried out by specialized climbing workers. (b) Detail of a special optical fiber setting, reinforced by metal elements, in an area characterized by artificial rock cut and fracturing. (c) The black arrows indicate the sensors (light grey lines) glued to the buttress.

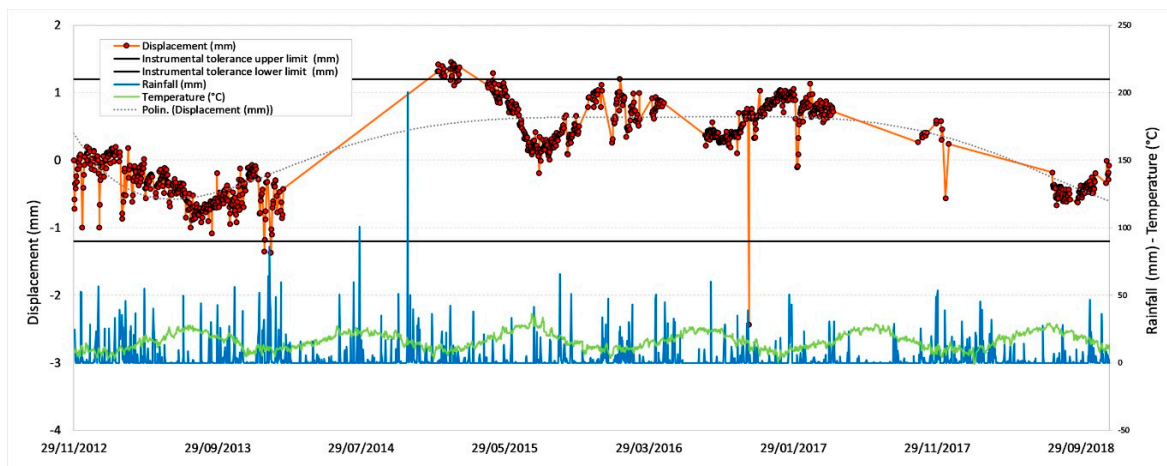
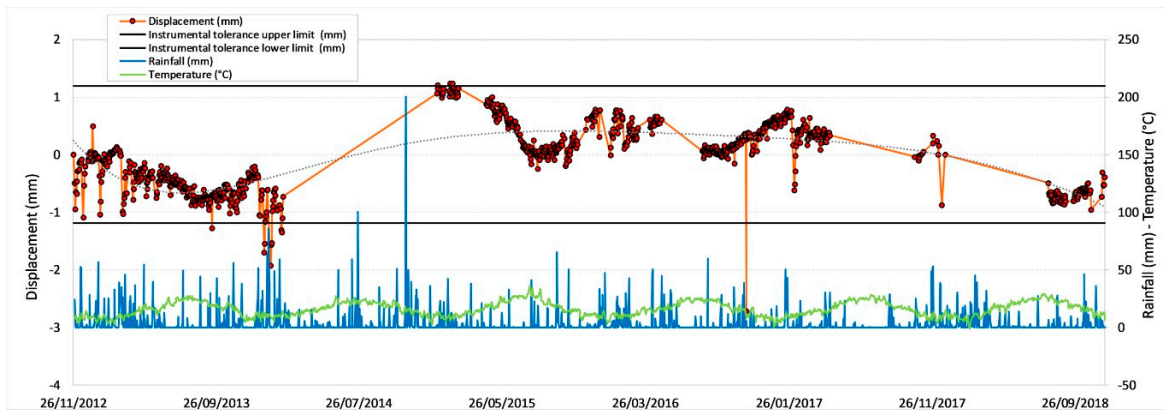
**Figure 11.** Displacement recorded by the RTS at the measurement point G02 compared to daily average rainfall and temperature. The black lines indicate the instrumental tolerance threshold values.

Figure 12. Displacement recorded by the RTS at the measurement point G15.

Figure 13. Displacement recorded by the RTS at the measurement point G17.

Figure 14. Displacement recorded by the RTS at the measurement point P07.

Figure 15. Displacement recorded by the RTS at the reference point R01.

Figure 16. Displacement recorded by the RTS at the reference point R02.

The displacement recorded in every prism was correlated to the daily rainfall and the average daily temperature. The graphs also show the RTS instrumental tolerance threshold values as calculated for the individual prisms taking into consideration the instrumental angular accuracy and their distance from the RTS; these threshold values vary from  $\pm 0.55$  mm to  $\pm 1.62$  mm [15].

As can be seen from the graphs in Figures 11–16, the RTS suffered periodic malfunctions and phases of inactivity during the whole 2012–2018 timespan. Moreover, this paper aimed at analyzing results that overlap with the available DOFS data. The availability of contemporaneous RTS and optical fiber measurements is limited to the summer and autumn seasons of 2018 and, more specifically to the time interval between 30/07/2018 and 28/11/2018 (about 4 months), with two interruption periods from 06/09/2018 to 22/09/2018 and from 30/10/2018 to 22/11/2018. The interruption periods were related to technical issues.

The analysis of the previous graphs (Figures 11–16) suggests a substantial difference in the displacement recorded by the RTS between reference (Figures 15 and 16) and measurement points (Figures 11–14) linked to the absence, in the first case, of anomalous values. The peaks of measurement points, which bring the associate prism closer to the observation point (i.e., the position of the RTS), occur in conjunction with thunderstorms. All the measurement points, installed in different positions with each other, show this very similar trend, suggesting an almost unanimous behavior of the entire

marble structure [15]. Even if the anomalous values exceed the instrumental thresholds, these are values of slight entity ( $<3$  mm) that do not represent a particularly critical situation, as demonstrated by the results from other sensors (as discussed later) and reality, since not rockfall occurred in the whole monitored time span.

Moreover, there is a generalized sinusoidal trend that can be related to the thermal response of marble slopes to the temperature variation. In fact, on an annual scale, it is possible to see that the displacement values are characterized by a decrease, at the beginning of the warm season, and by an increase with the arrival of the cold season. This behavior of the marble, known as thermoclasty, is most likely related to the anisotropy of calcite mineral, which tends to expand and contract in directions constrained by crystallographic axes [15,64–66]. The phenomenon is probably encouraged by different elements: i) the water infiltration within the rock discontinuities during the rain events; this can increase the inner pressure with a consequent growth in volume and expansion of the joints, thus creating a general stress that has repercussions on the whole buttress; ii) the site morphology and iii) the stress reduction due to both mining and natural causes (emersion condition linked to the geology of the area).

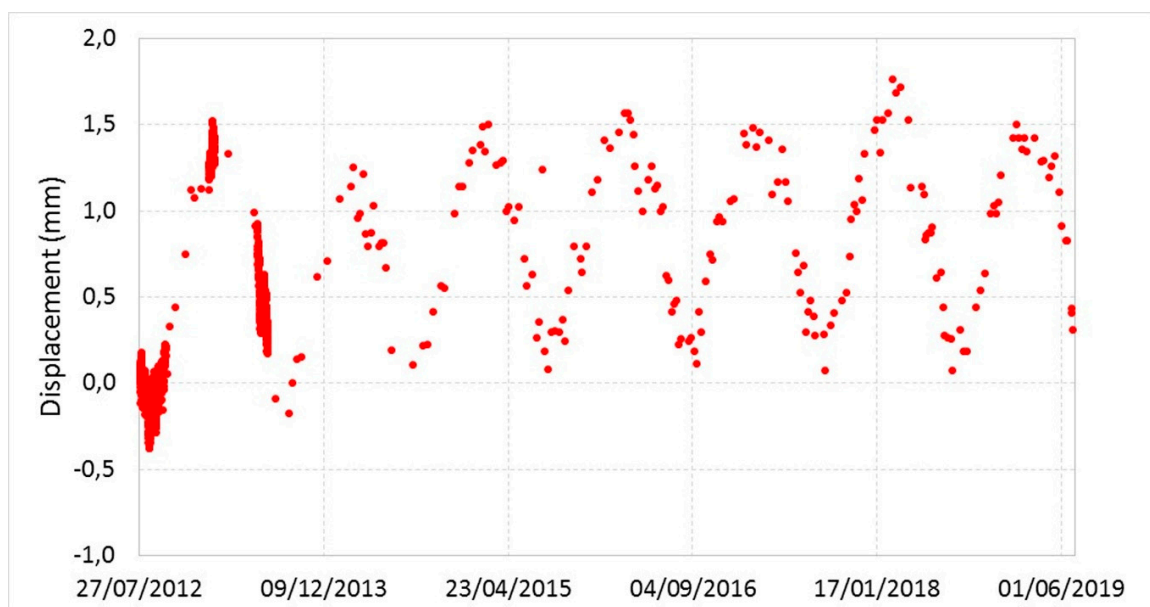
**Figure 17.** Displacement recorded by the crackmeter FS4 from 2012 to 2019.

**Figure 18.** Displacement recorded by the extensometer ES3B1, 6 m long sensor, from 2012 to 2019.

The measurements recorded by the geotechnical sensors in the 2012–2019 time period (some examples are given in Figures 17 and 18 for crackmeter FS4 and extensometer ES3B1, respectively) confirm the general stability of the monitored site. The graphs show sinusoidal symmetrical trends that are yearly replicated with a good approximation. In particular, the values of the observed quantities reach the local minimums during the summer season and the local maximums in winter. This behavior may be attributed to the summer thermal expansion which tends to close fractures. On the contrary, in winter, joint aperture increases for the absence of rock thermal expansion and the presence of water and ice within fractures. Nothing particularly different from previous years was recorded during 2018. The deformation quantities confirm the absence of significant movements of the rock mass [43,44].

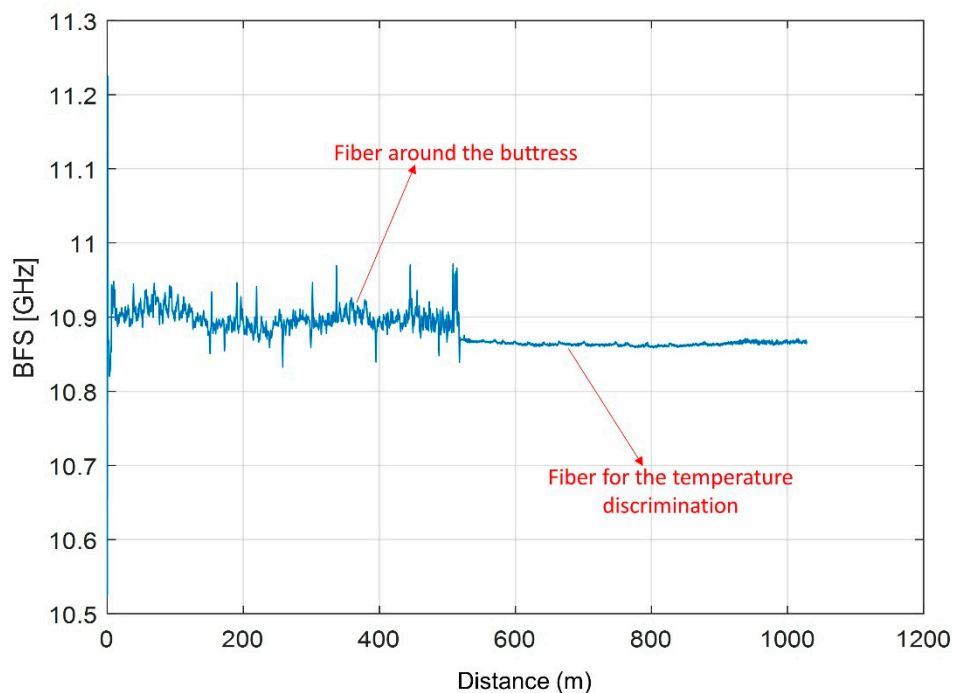
**Figure 19.** BFS profile acquired on 4 January 2018 (first measurement).

In the Lorano marble quarry, BOTDA type measurements were performed at a spatial resolution of 20 cm. The first acquisition was executed on 4 January 2018 (Figure 19).

The first 500 m of the profile (Figure 19) correspond to the fiber sensor fixed around the buttress, and present the typical oscillations deriving from the deformations associated with the gluing. The profile continues for another 500 m, maintaining, in this second part, a much more stable trend which is typical of the fibers used for the temperature discrimination [67].

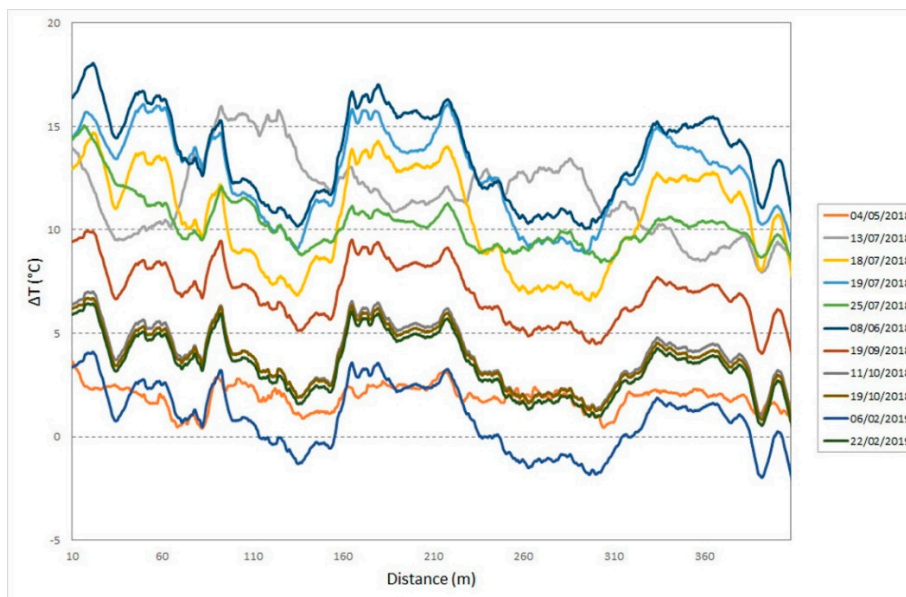
**Figure 22.** DOFS temperature variation profiles along the marble buttress from January 2018 to February 2019.

Profiles of temperature variation (Figure 22) were obtained starting from the BFS data and using 7 February 2018 as the reference measure. As in the case of strain, the temperature data were filtered using a moving average filter over 51 points (still achieving a spatial resolution of 10 m). The graph shows the natural difference between the temperature measurements taken in autumn and winter compared to those taken in spring and summer. The temperature data detected by optical fiber, in fact, vary between  $-10\text{ }^{\circ}\text{C}$  and  $+20\text{ }^{\circ}\text{C}$ , as result of the natural seasonal variations in the case of an open pit.

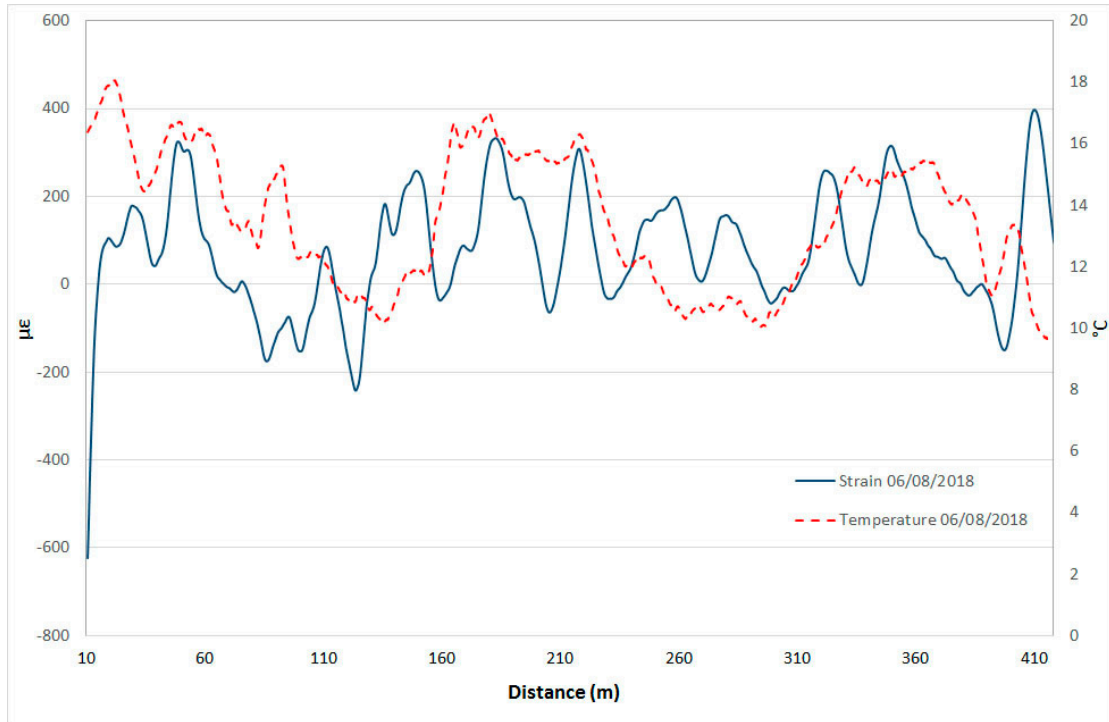
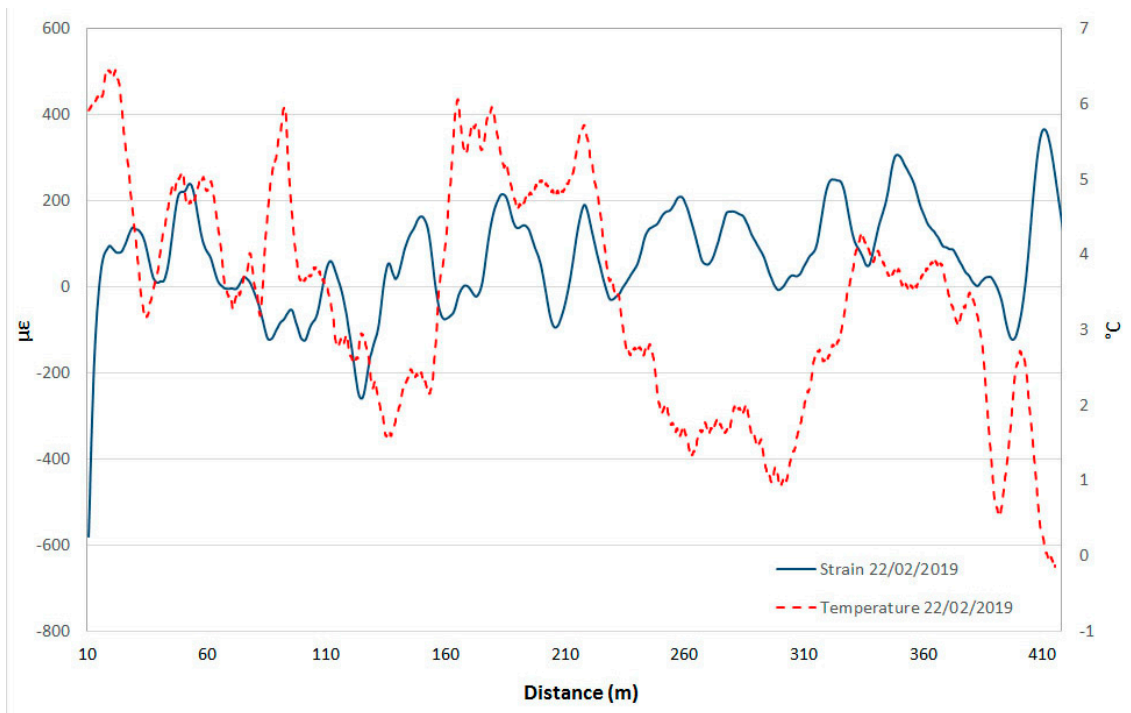
Figure 23. Example of comparison of strain and temperature profiles in summer.

Figure 24. Example of comparison of strain and temperature profiles in winter.

Figures 23 and 24 show two examples of the comparison between strain and temperature at two individual dates, one for the summer (Figure 23) and the other for the winter season (Figure 24). The graphs demonstrate how higher temperatures correspond to greater strain. It is important to underline that these strain values are always lower than the alarm threshold values of Figure 21.

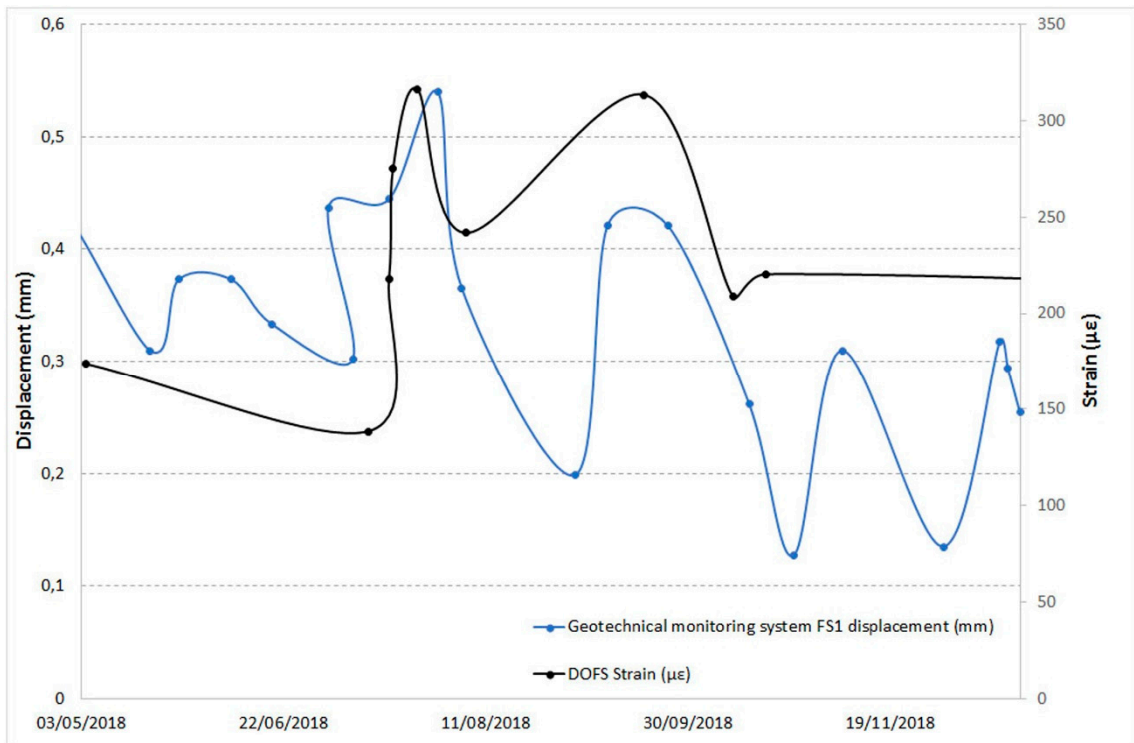
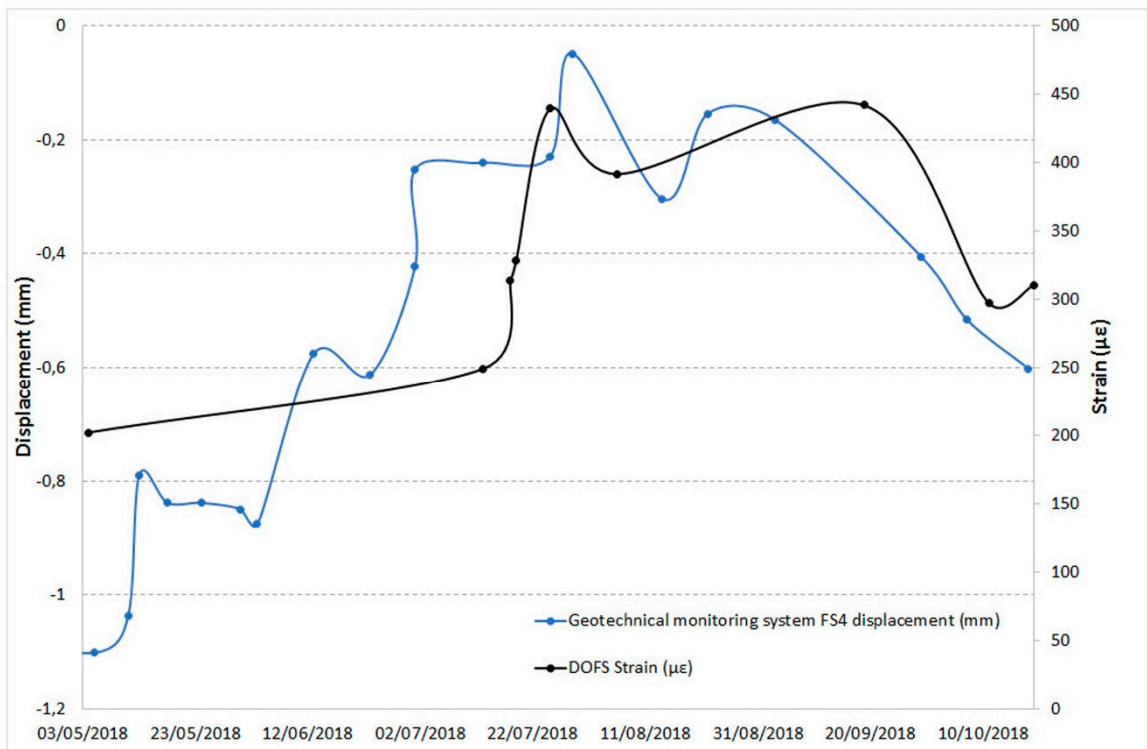
**Figure 25.** Comparison between the P05 RTS measuring point displacement (data interpreted according to a second order polynomial) and DOFS strain values in the same area.

**Figure 26.** Comparison between the G15 RTS measuring point displacements (data interpreted according to a second order polynomial) and DOFS strain values in the same area.

Figure 27. Comparison between the FS1 crackmeter displacements and DOFS strain values in the same area.

Figure 28. Comparison between the FS4 crackmeter displacements and DOFS strain values in the same area.

Figure 29. Comparison between the ES4 extensometer displacements and DOFS strain values in the same area.

Below are some examples of comparison with displacements recorded by the other monitoring techniques in the overlapping time periods. Figures 25 and 26 show the DOFS strain values versus the RTS displacements, Figures 27–29 illustrate the DOFS strain values versus the geotechnical monitoring system displacements, and Figure 30 juxtaposes the temperature values measured by DOFS, the geotechnical monitoring system and the “Carrara Fossola” weather station.

At the observed scale, the trends of strain values from DOFS and that from displacements recorded by RTS and geotechnical sensors are very confusing even if quite similar if compared to each other. There is a close correspondence between the trend of the displacement values recorded by the crackmeters and the strain profiles (examples are reported in Figures 27 and 28), characterized by a certain cyclicity and higher values in the warmer months. Figure 29, instead, shows an example of a comparison between the extensometer displacements and the DOFS strain values. Both graphs show a decreasing trend, a local maximum reached in the hottest period (first recorded by the optical fiber) and a rising trend in the last part of the year.

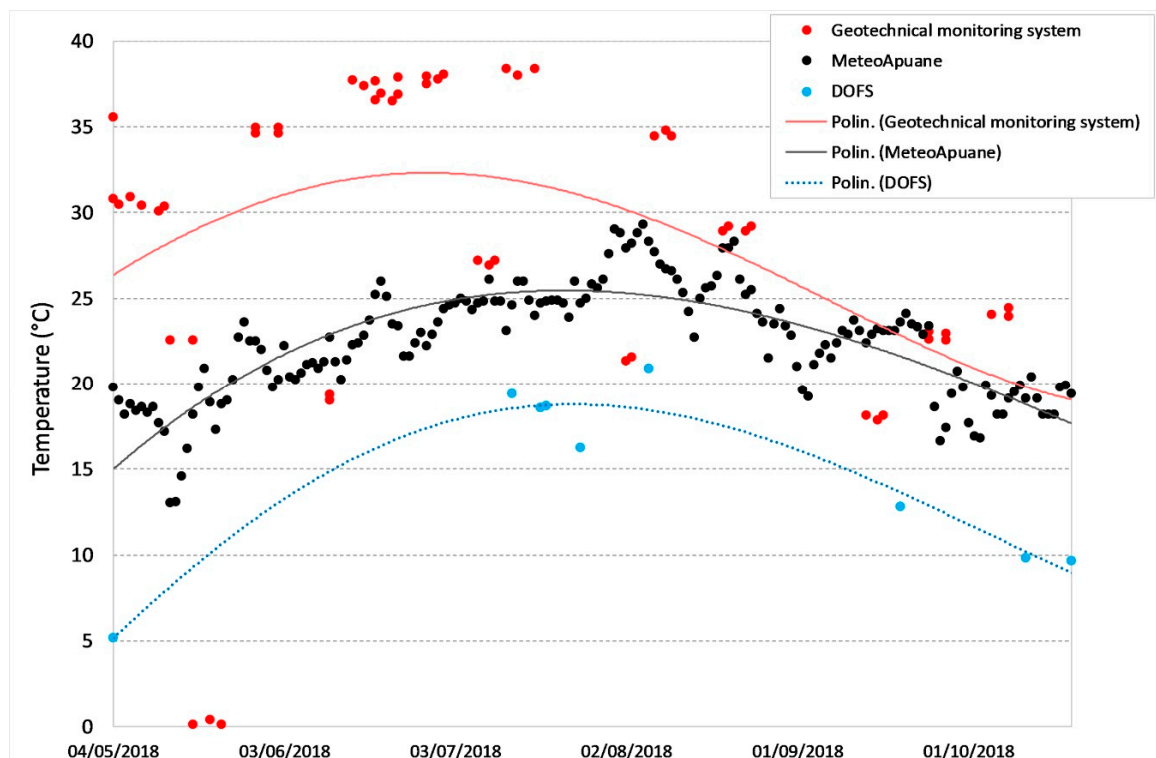
Figure 30. Comparison between the temperature values measured by DOFS, FS1 geotechnical sensor and “Carrara Fossola” weather station. The data were interpreted according to a fifth order polynomial.

The trends of the average daily temperature values measured by DOFS (average of all values recorded along the DOFS sensor cable), geotechnical monitoring system and weather station (Figure 30) are quite comparable, even if the DOFS values are lower than the others. This may be due to several reasons: first, to the different altitude between the station (55 m a.s.l.) and the marble buttress (about 600–700 m a.s.l.); secondly, to the coating and to the glue necessary to protect fiber optic from both meteoric events and ultraviolet rays. Moreover, the temperature measured by the fiber, resulting from the external temperature (air) and the temperature of the rock where the fiber is placed, vary according to the time of day, the position and the sunlight exposure: there may be shaded areas and

zones exposed to the sun along the fiber path. These conditions have their effect in determining the average temperature values along the entire path of the optical fiber.
