CASE REPORT

Migration of a Kirschner wire to the dorsolateral side of the foot following osteosynthesis of a patella fracture with tension band wiring: a case report

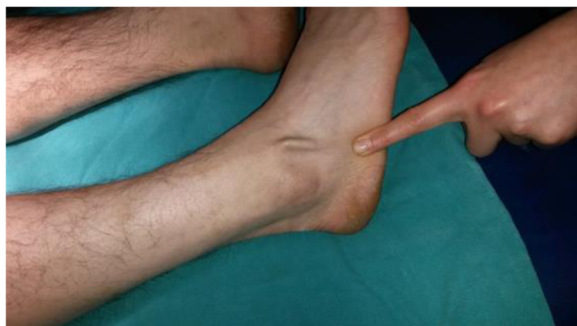
Fig. 1 Palpable foreign body under the skin on the dorsolateral side of the right foot

A 28-year-old male patient from Turkey presented to our clinic with complaints of palpable foreign bodies under the skin in the dorsolateral side of his right foot (Fig. 1). Except for the palpable and moving body of about 6 cm length under the skin in his foot, he had no functional complaints. An X-ray demonstrated the presence of a K-wire of about 6 cm length in front of the lateral malleolus in the dorsolateral side of his foot (Fig. 2). There was a cerclage wire from the tension band fixation

On physical examination, our patient showed no restriction in his knee movement. Routine blood test results showed no abnormalities. Palpation of the K-wire showed that the wire was mobile under his skin (Fig. 1). Our patient reported that, after removing the first wire, he had not felt any serious discomfort during the migration of the other wire over a period of 5 years.

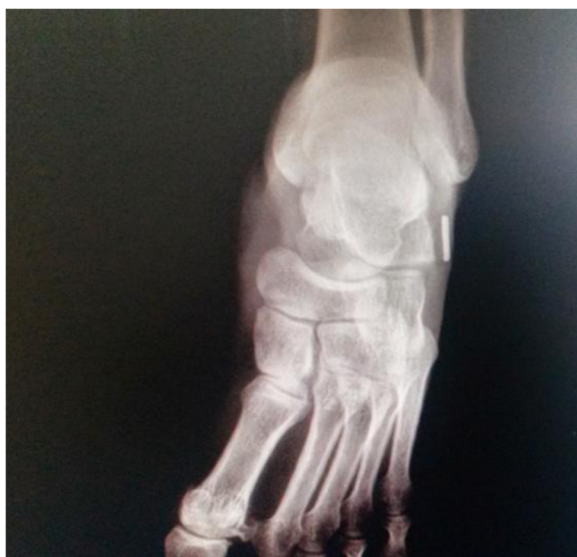
Fig. 2 Anteroposterior plain radiography showing a Kirschner wire in the dorsolateral side of the right foot

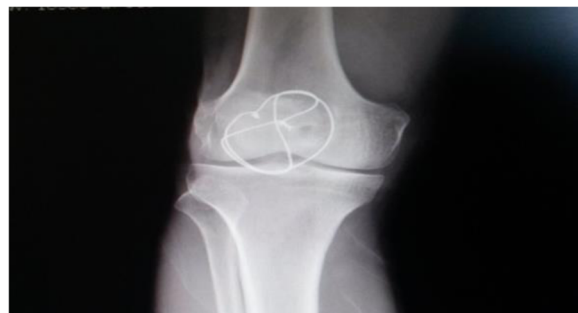
Fig. 3 Anteroposterior plain radiography showing a cerclage wire from the tension band fixation of the patella of the ipsilateral knee

of his patella in the ipsilateral knee (Fig. 3). There was no diagnostic challenge. Our patient explained that he was operated on by another orthopedic surgeon in the same hospital after a patellar fracture in 2007 and he had not attended regular checks. He also reported that a wire similar to the one in the X-ray had protruded through his skin in 2009 and he had removed the wire by pulling it out. This statement explained why the K-wire was not in place.

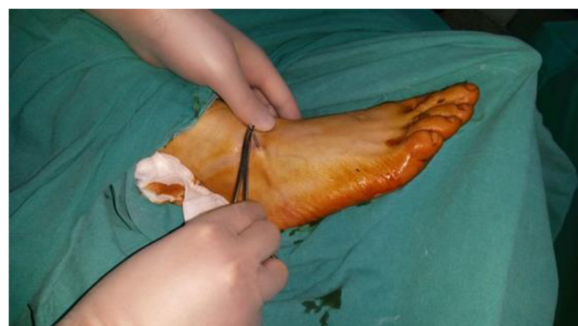
Fig. 4 The Kirschner wire was pulled out with the help of a clamp

Our patient was taken to the operating room. After staining, a 3-mm skin incision was made that coincided with the proximal end of the K-wire, and the K-wire was pulled out with the help of clamp (Fig. 4). Our patient was discharged on the same day. The cerclage wire in his patella was not removed to avoid creating complications and because of our patient’s unwillingness to have it removed.
