Unidirectional valve malfunction by the breakage or malposition of disc

-two cases report -

Malfunction of the unidirectional valve in a breathing circuit system may cause hypercapnia from the rebreathing of expired gas, ventilation failure, and barotrauma. Capnography is a useful method for monitoring the integrity of the unidirectional valve. We experienced two cases of malfunction of a unidirectional valve which caused leakage and reverse flow, diagnosed early as a change of the capnographic waveform. One case was caused by expiratory unidirectional valve breakage. The other was caused by an incorrectly-assembled inspiratory unidirectional valve. (Korean J Anesthesiol 2013; 65: 337-340)

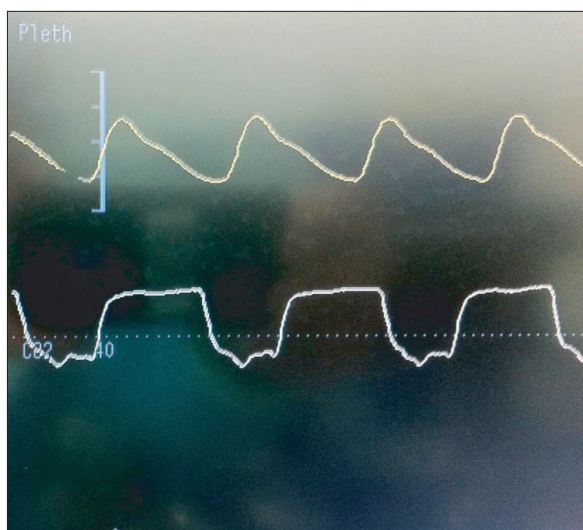
pressure was 140/80 mmHg, heart rate 90 beats/min, respiratory rate 18 times/min, and SpO₂ 98%. After a normal test of preanesthetic leak test by closing the pop-off valve, occluding the Y-piece, and pressurizing the circuit to 30 cmH₂O with the oxygen flush valve and flow test by using the ventilator and a breathing bag attached to the "Y"-piece as described in the 1993 FDA Anesthesia Apparatus Checkout Recommendations [5] on the breathing circuit, propofol 120 mg and rocuronium 30 mg were given intravenously, followed by uneventful endotracheal intubation. After intubation, SpO₂ was 99% and end-tidal CO₂ (ETCO₂) measured through a previously calibrated side stream capnometer (S/5™ Anesthesia Monitor, GE Healthcare, Finland) was 34 mmHg. The anesthesia was maintained with O₂ 1.5 L/min, air 2.5 L/min, sevoflurane 2–3 vol%, and remifentanyl 0.2–0.5 µg/kg/min. The anesthesia ventilator (Narcomed 2B, Dräger, Germany) was set at volume control mode (tidal volume 500 ml, respiratory rate 10 times/min, I/E ratio 1 : 2). Systolic blood pressure was maintained at 100–150 mmHg, diastolic pressure at 60–90 mmHg, heart rate at 50–90 beats/min. About 10 minutes after the anesthesia began, ETCO₂ suddenly increased to 52 mmHg and P_iCO₂ 30 mmHg was noted (Fig. 1). It was the second general anesthesia of the day in this operating room. In addition, during the first 10 minutes, the capnography waveform was normal. Therefore, we initially suspected an erroneous capnometry reading and recalibrated. Breath sounds were clear and bilaterally equal. Since the core temperature measured using a Thermoscan® (infrared tympanic thermometer IRT4020, Braun, Germany) was normal range (36.4°C), malignant hyperthermia was ruled out. Carbon dioxide absorbent had not changed color. This implied the possibility of rebreathing. Blood pressure was 115/62 mmHg and heart rate was 85 beats/min.

Fig. 1. The capnogram showing that both inspiratory and expiratory CO₂ are increased (lower graph).

When the breathing system was rechecked, breakage of the expiratory unidirectional valve through transparent dome, which is divided into three pieces, was discovered (Fig. 2). After replacement of the broken disc by a new one, the capnogram waveform returned to normal. The surgery was completed smoothly and the patient had an uneventful recovery.

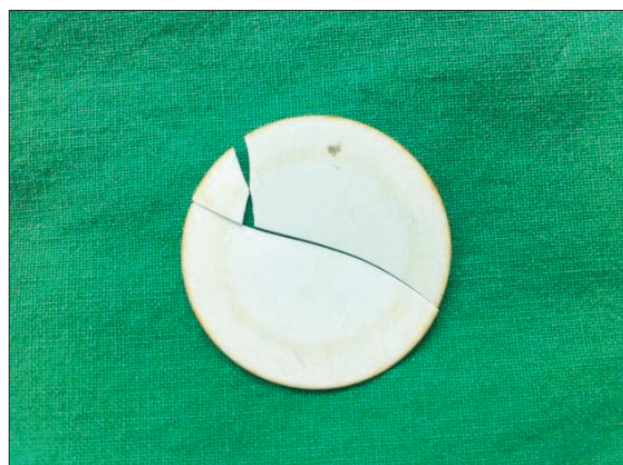
Fig. 2. The broken expiratory valve.

rate of patient by malignant hyperthermia, we checked the body temperature, but it was within normal range of temperature. Therefore, we suspected the cause of abnormal CO_2 waveform to be rebreathing of the breathing circuit. At that time, we found the broken expiratory valve disc through the transparent dome. When a disc breaks suddenly in the midst of anesthesia like our case 1, capnography can be used to identify unidirectional valve incompetence. Expiratory valve malfunction is more frequent than the inspiratory one due to its exposure to a humid alveolar gas [8].

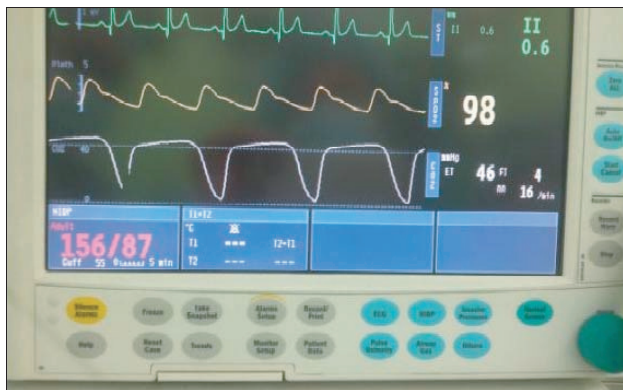
Fig. 3. The capnogram showing a gradually sloping descending limb, elevated inspired CO_2 of 4 mmHg, and ETCO_2 of 46 mmHg (lower graph). ET: endtidal.

limb of inspiratory phase were noted, which implied inspiratory valve malfunction (Fig. 3). Blood pressure was 156/87 mmHg and heart rate was 75 beats/min. When we inspected the inspiratory valve through the transparent dome, the disc was not located in the center, horizontally. We disassembled the unidirectional valve component right away, which revealed an improper orientation of disc and disc locking apparatus (Fig. 4). After correction, the capnogram waveform returned to normal. The surgery was completed smoothly and the patient had an uneventful recovery.

If the inspiratory valve fails to close, CO_2 gas is usually detected only at the beginning of inspiration because it would permit the exhaled CO_2 to enter the CO_2 free inspiratory limb of the breathing circuit, and to be breathed in by the patient during the next inspiratory period [11]. As in case 2, the capnogram will display

a prolonged plateau, gradually sloping descending limb without approaching the zero baseline [12,13]. When the incompetence of inspiratory valve is mild, it is not a severe problem. But if it is severe or the operation time is long, profound hypercapnia can occur. After case 2, we disassembled all unidirectional valve disc locking apparatuses in our hospital and examined them closely. Only case 2's disc locking apparatus of inspiratory unidirectional valve was loosely-fitting, so it could be easily mispositioned while reassembling. In case 2, the surgery was the first one done on Monday. It was presumed that the duty nurse of the prior day assembled the valve improperly after cleaning. A centrally and horizontally-located disc which at first covers the whole orifice of inspiratory valve could move peripherally enough to make a gap as the induction of anesthesia goes on. Loose disc locking apparatus should be repaired to maintain the correct alignment.

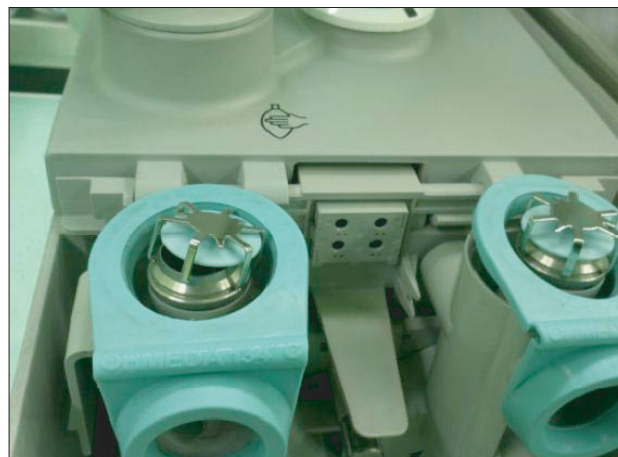
Fig. 4. Properly connected expiratory unidirectional valve (Right) and improper orientation of disk and disc locking apparatus (Left). Note that the disk locking apparatus of which its foot is not put on the groove of valve.
