Case report

Adverse Local Tissue Reaction due to Acetabular Corrosion in Modular Dual-Mobility Constructs

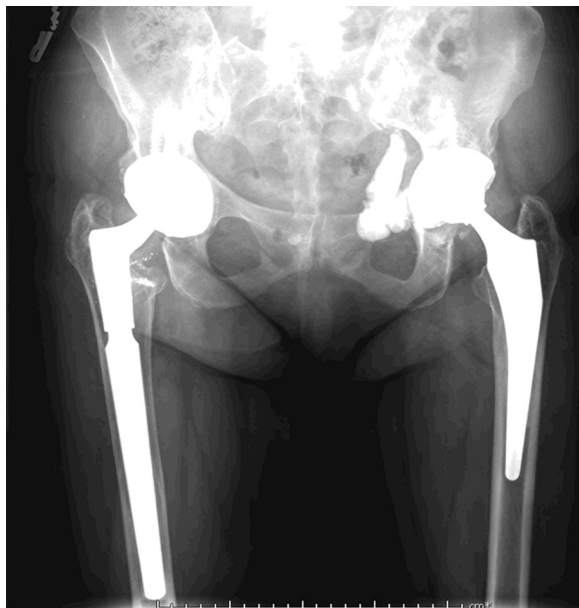
Figure 1. Anteroposterior (AP) radiograph of case 1 at presentation with dual mobility right THA without radiographic evidence of failure.

increasing groin and thigh pain without any radiographic evidence of implant failure (Fig. 1). Infection workup was negative, but her cobalt (2.5 ppb) and chromium (1.2 ppb) levels were both elevated. Metal artifact reduction sequence magnetic resonance imaging (MARS-MRI) demonstrated blooming metallic artifact in the right gluteus medius muscle consistent with ALTR. She did have a cobalt-chromium head in her left THA, but she was asymptomatic and MARS-MRI demonstrated normal findings on the left side. A diagnostic right hip injection provided 100% pain relief. She underwent revision THA with removal of the DM construct and exchange to a 40-mm ceramic head on sequentially annealed highly cross-linked polyethylene. At the time of surgery, the synovial fluid was brownish gray consistent with ALTR. The abductor musculature appeared relatively normal on gross inspection. The DM cobalt chrome liner was found to be canted eccentrically on close inspection and demonstrated corrosion at the liner shell interface (Fig. 2). Intraoperative cultures were negative for infection. The acetabular and femoral components were well fixed and in an appropriate position. The femoral stem trunnion was pristine without evidence of corrosion. At the latest follow-up 4 months postoperatively, she was progressing well with no assist device and

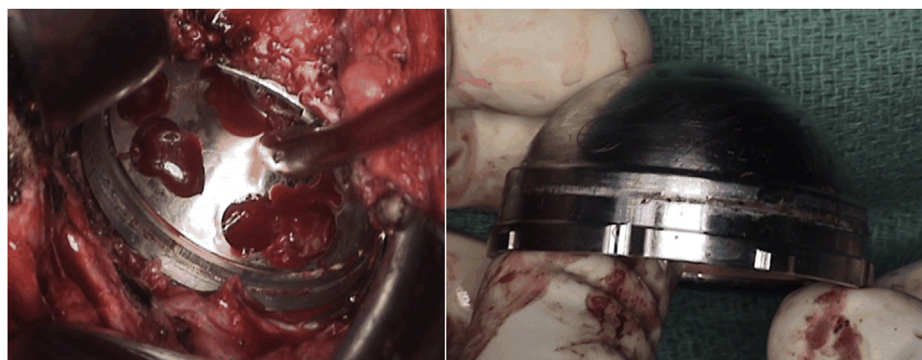
Figure 2. Intraoperative photographs of case 1 at time of revision demonstrating corrosion at the liner-shell interface.

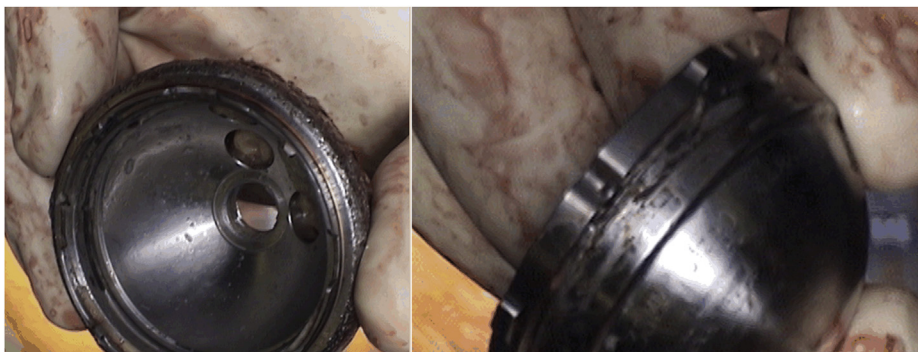
Figure 4. Intraoperative photographs of case 2 at time of explant demonstrating corrosion at the liner-shell interface.

cases. Case 2 was revised specifically for infection with liner malseating and MACC noted at the time of revision. While case 3 developed an infection after reimplantation, retrospective review of the initial revision supports contribution of MACC and ALTR to the substantial bone loss and aseptic loosening rather than infection as a primary etiology of failure. This is presumed because of normal inflammatory markers, less than 3000 WBCs, and negative cultures. In addition, revision THA for MACC has demonstrated a high rate of early complication including infection and dislocation [22].
