Degradation Phenomena on “Homemade” Explanted Aortic Textile Endografts

Objective: In the 1990s, the concept of “homemade” endografts (EGs) using commercially available materials was proposed in clinical practice for endovascular abdominal aortic repair (EVAR). The aim of this study was to analyse the ageing phenomena of these EGs in light of explant analyses.

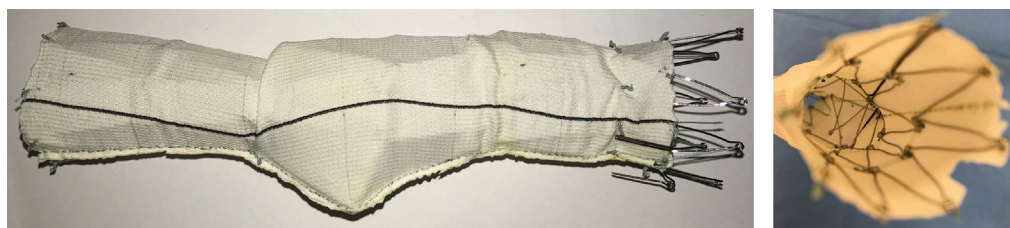
Figure 1. Photographs of one specimen of explanted homemade endograft with a global and an inner view.

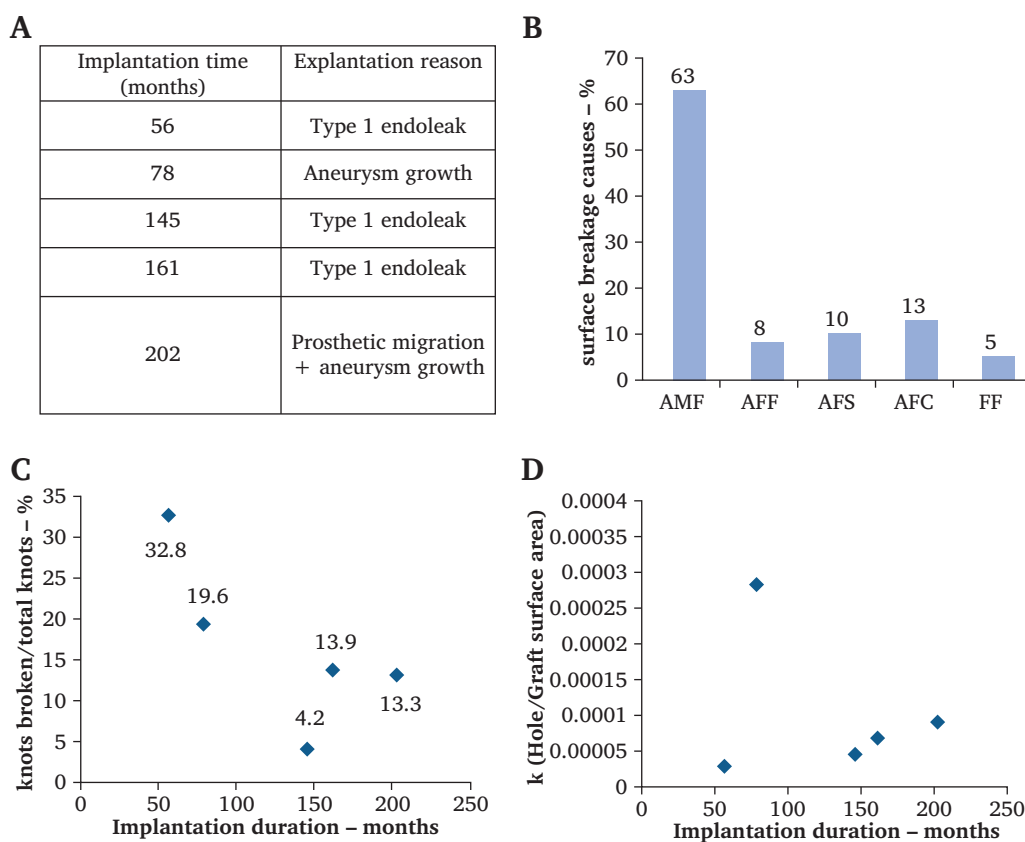
Figure 2. Information and degradation phenomena on five HMEGs. (A) Information of five HMEGs. (B) Percentage of causes concerning holes and cuts on the fabric surface. (C) Ratio of broken knots/total knots used to connect adjacent stent rings inside HMEGs. (D) Correlation of implantation duration and k value. AFS = abrasion fabric stitch; AFF = abrasion fabric/fabric; AMF = abrasion fabric/metal; AFC = abrasion fabric/calcification; FF = fabric fatigue.

Five explanted HMEGs from 876 implanted at the department of La Pitié Salpêtrière were studied; they were collected between 2012 and 2014. They were implanted to treat aorto-iliac aneurysms. Implantation duration ranged from 56 to 202 months. Reasons for explantation and implantation duration are shown in Fig. 2A. None of these explants presented with a type 4 endoleak.

Fig. 2B shows the percentage of the different causes of holes and cuts on the fabric surface among the cohort.

However, serious knot ruptures (Fig. 3I), used to connect adjacent stent rings together to form the whole stent body, were observed inside all five HMEGs. Up to 33% of knots were broken on one HMEG (Fig. 2C). The knot ruptures ranged from 4% to 33% (mean: 17%). These phenomena caused detached stent segment dislocation leading to serious HMEG contour deformation. The knot ruptures could be related to the friction brought by the metal stent as well as to the blood flow.

Characterisation of hole surface area. Fig. 2D shows the correlation between k value and implantation duration. No correlation was found between the hole surface area and the HMEG total surface area. The hole surface area varied from 0.38 to 3.21 mm². The k value varied from 2.88×10^{-5} to 2.83×10^{-4} . The higher k value was approximately three to 10 times higher than the four other k values. Except this higher k value, the others ranged from 2.88×10^{-5} to 9.04×10^{-5} . The higher k value represented a hole surface of 3.21 mm² on an HMEG explanted because of aneurysm

sac growth at 78 months. Except for this higher k value, there is a tendency for k values to increase with time.

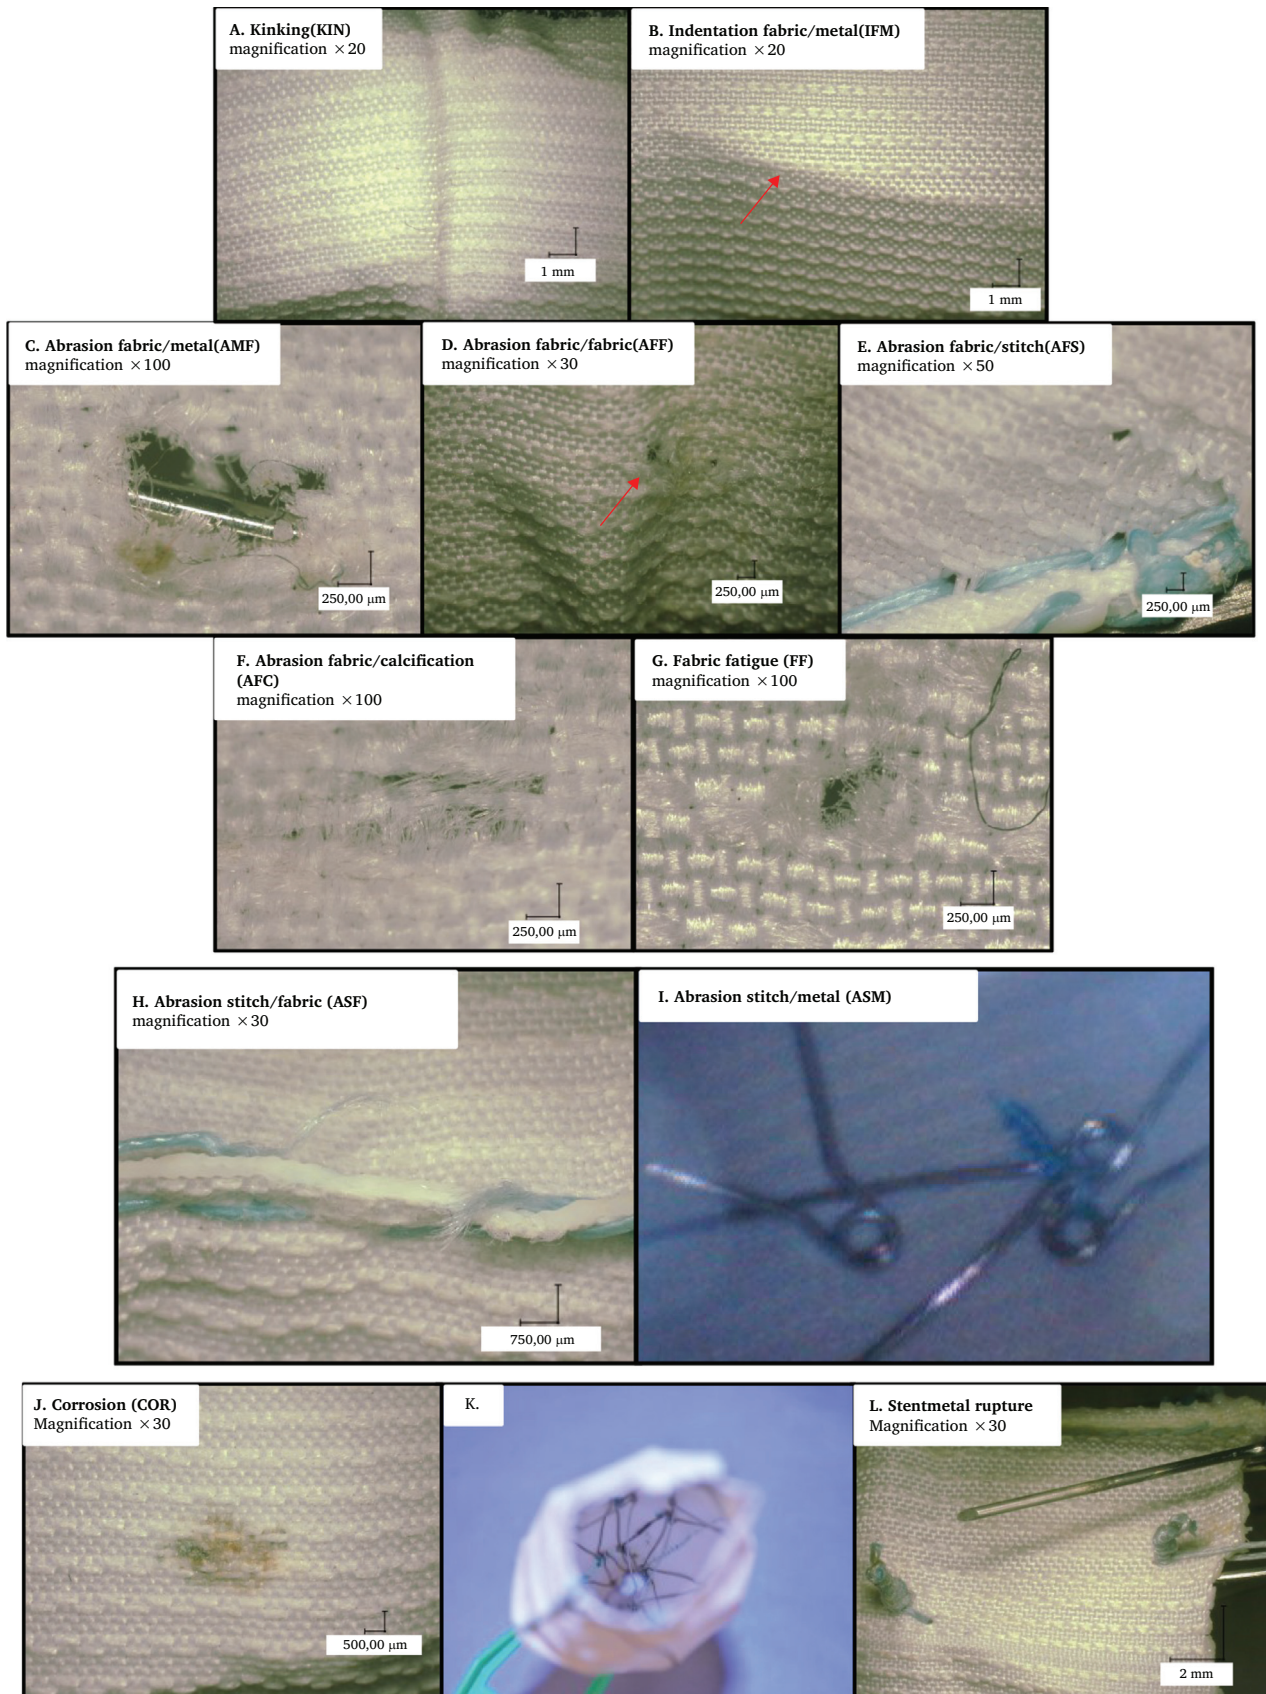
Figure 3. Classification of fabric, stitch, and stent degradation. Classification of fabric degradation. (A) Compression: kinking (KIN). The compression in the sheath leads to permanent kinks. (B) Indentation fabric metal (IFM). A mark (red arrow) is seen where the internal stent pressed hard into the fabric. (C) Abrasion. Abrasion fabric/metal (AMF). The stent rubs against the fabric and causes lesions.

(D) Abrasion fabric/fabric (AFF). Depending on the position of the graft in the artery, abrasion between two areas can occur (red arrow). (E) Abrasion fabric/stitch (AFS). The filaments of the stiches move against the fabric and cause abrasion. (F) Abrasion fabric/calcification (AFC). Hard particles in the environment of the graft damage the fabric. (G) Fabric fatigue (FF). Cyclical movement causes tears in the fabric. The characteristic pointing geometry of the cut filaments is visible. Classification of stitch degradation. (H) Abrasion stitch/fabric (SF). Depending on the position of the graft, a cyclical movement can cause abrasion of the stitching touching the fabric. (I) Abrasion stitch metal (ASM). The abrasion starts under the knot, where it is in contact with the metal. Classification of stent segment degradation. (J) Corrosion (COR). (K) Rupture of the fixing knots led to the detachment of the adjacent struts from the circumferential rings. (L) Rupture of the stent metal.

Fig. 3 shows all the degradation mechanisms observed in the fabric, the stitches, and the stent segments.

Defects identified on the fabric. Sixty-three per cent of the fabric surface lesions (holes and cuts) were related to abrasion between metal stent and fabric (Fig. 2B, Fig. 3C, 24 cases). At the same time, a total of 24 KIN (Fig. 3A) were found, which led to multiple areas of weakness. Fourteen of 32 surface lesions (44%) were identified near or on these kinks (excluding abrasion between fabric and aortic calcifications). The kinking phenomena promoted the appearance of surface breakages due to cyclic friction between stents and fabrics and between fabrics (AFF, Fig. 3D, three cases) and due to cyclical flexion of fabrics leading to TF (Fig. 3G, two cases).

and stitching filament (Fig. 3E) or abrasion between fabric and aortic calcifications (Fig. 3F). Four cases of abrasions were observed between fabric and stitching filament, on two HMEGs at 56 and 202 months of implantation duration. Five cases of abrasions were observed between fabric and aortic calcifications, on two HMEGs, at 56 and 78 months of implantation duration. As described previously,¹³ the damage is explained by the cyclical moving contact between aortic wall calcifications and the HMEG.

The triple cover running suture degradation was far less important than the degradation level of fabric materials or knot rupture. There were only two cases of cover running suture ruptures (Fig. 3H) caused by multiple frictions of the implanting environment and the stitched fabrics. Despite these ruptures, openings were not observed between the two textile parts.

Lesions identified on the stent. Stent degradation consisted of two kinds of ageing phenomena, corrosion (Fig. 3J) and strut detachment from the circumferential stent rings (Fig. 3K), in all specimens. There was only one case of broken stent (Fig. 3L). The strut detachment, as mentioned above, was due to rupture of the fixing knots, which led to strut dislocation.
