Data Article

Dataset on geosynthetic material debris contamination of the South-East Baltic shore

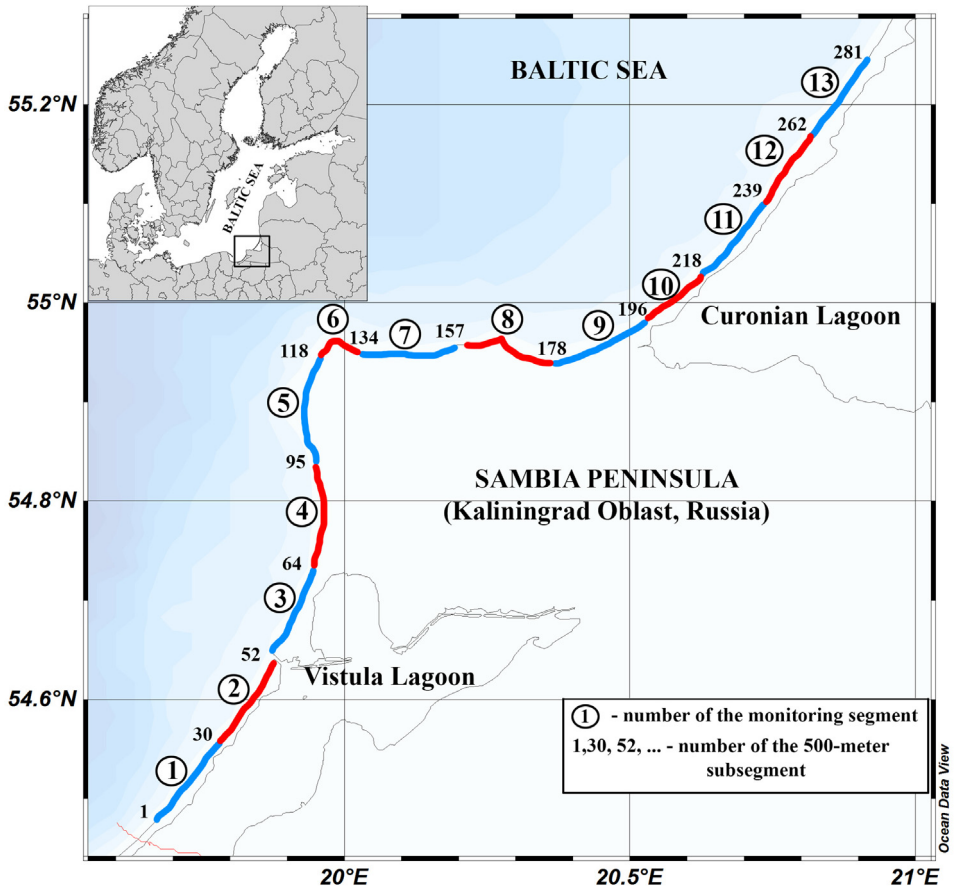
Fig. 1. Monitoring field design in the South-Eastern Baltic. The numbers of the monitoring shore segments are in circles. The numbers of reference points mark the end of the monitoring segment.

- The number of the 500 m coastline subsegment (column “№ Subsegment”). The approximate position of the subsegments is shown in Fig. 1, which presents the segments monitored during one day. The numbers of the reference point marked the northern end of coastline subsegment (this number is also the number of coastline subsegment) are also indicated.
- Coordinates (WGS 84) of the center of the subsegment (columns “Latitude [degree]”, “Longitude [degree]”)
- Number of samples of geosynthetic material of different types (Geotextile, Gabion coating, Geocontainer, Geocell, Geomat) found on corresponding subsegment (columns “Geotextile [numbers]”, “Gabion coating [numbers]”, “Geocontainer [numbers]”, “Geocell [numbers]”, “Geomat [numbers]”).

The study area (Fig. 1) in the South-Eastern Baltic included the beaches of the Kaliningrad Oblast (Russia) and also contains the beach segments on the adjacent territories: the Polish shore from the Poland-Russia border on the Vistula Spit to the mouth of the Vistula River, the Lithuanian shore from the border Lithuania-Russia on the Curonian Spit to the border of Latvia-Lithuania. Therefore, the transboundary shores of the sandy barrier, the Vistula and Curonian spits were studied as a whole.

The main activity was applied to the shore of the Kaliningrad Oblast, which was divided into 13 monitoring segments of nearly equal length. The length of such a specific monitoring segment was approximately 10 km (± 1.5 km), making it possible to efficiently carry out work on it in one expedition day. The average time spent on one monitoring segment is about 6-8 hours. In addition, the monitoring segments were assigned to reach the starting and ending points of the section by road.

The segments were numbered in the direction from south to north (from west to east), starting from the state border with the Republic of Poland (on the Vistula Spit) and ending at the state border with the Republic of Lithuania (on the Curonian Spit).

There are two sections (No. 1-2) on the Russian side of the Vistula Spit; 3 sections on the western shore of the Sambia Peninsula (No. 3-5); 4 sections on the northern shore (No. 6-9) of the Sambia Peninsula; 4 sections (No. 10-13) on the Russian part of the Curonian Spit. This numbering was used for logistic purposes during the organisation of monitoring activity.
