Case report

Successful recovery of central venous catheter fragment from coronary venous sinus and right ventricle: A case report [☆]

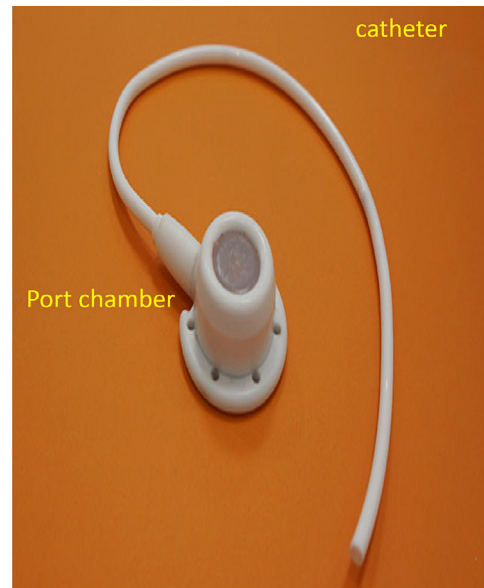
Fig. 1 – Chemoport catheter.

tral venous catheter placement. The Chemoport system has 2 parts: a Port chamber and an attached central catheter made of silicone (Fig. 1). Central catheter is inserted into a central vein either internal Jugular vein or subclavian vein and port chamber is placed into a subcutaneous pocket. Access of this

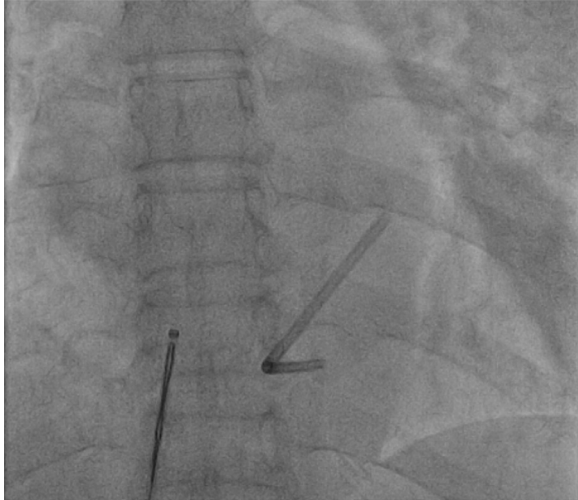
Fig. 3 – Chemoport catheter lodged partly in CS and partly in RV.

A 60-year-old lady was referred by the surgical oncologist for possible percutaneous retrieval of Chemoport catheter fragment which fractured and embolized. Chemoport catheter was placed 14 months ago for adjuvant chemotherapy following radical mastectomy of left breast. This lady underwent radical mastectomy of left breast and subsequently radiotherapy for carcinoma breast. At the end of chemotherapy X ray chest was done before planned extraction of chemoport catheter. X ray chest revealed fracture of catheter where it crosses the junction of first rib and clavicle (Fig. 2). She has no other co-morbid conditions. Clinical examination and ECG were unremarkable. Fluoroscopy revealed flexible catheter taking "U shape" with one arm lodging in CS and the other in RV cavity (Fig. 3). As far as literature is concerned, it is the first such case.

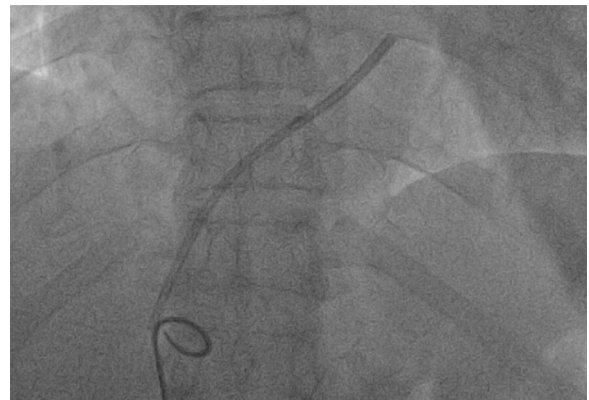
Fig. 7 – Catheter tip in IVC after straightening.

embolized catheter without success (Fig. 4). After several attempts with snare, we took recourse to pigtail catheter [Cordis] with which we could catch and straighten the RV end of the catheter into IVC (Figs. 5 and 6). This position was favorable for grasping the tip of the catheter using the snare device (Fig. 7). It was then snared using a 15 mm loop snare (EN snare Endovascular Snare System, Merit Medical Systems Inc, UT, USA) (Fig. 8). Then whole assembly of snare, captured catheter fragment and 8 F sheath were pulled out in unison (Figs. 9 and 10). The patient tolerated the procedure well without any complications. Had the fragment been embedded deeply in the CS it would not have been feasible to extract it percutaneously. There was 1 such case report where the catheter fragment could not be extracted as it was sitting deeply in the CS.

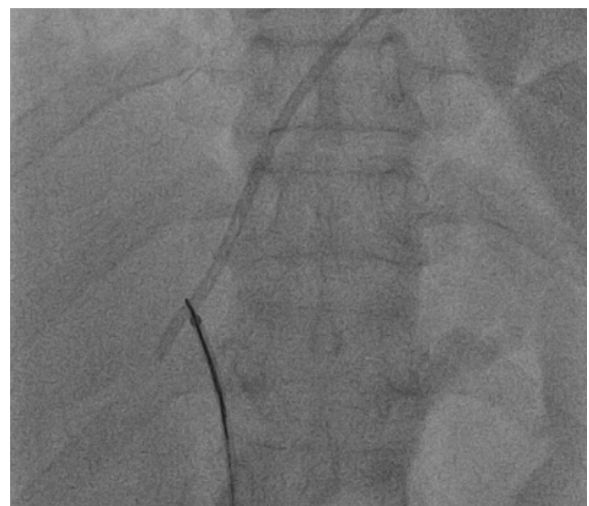
Fig. 8 – IVC end of the catheter was seized by Snare.

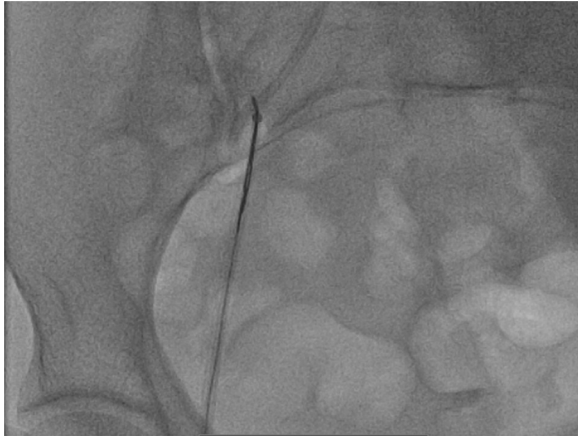
Fig. 9 – Whole assembly including venous sheath is being pulled out.

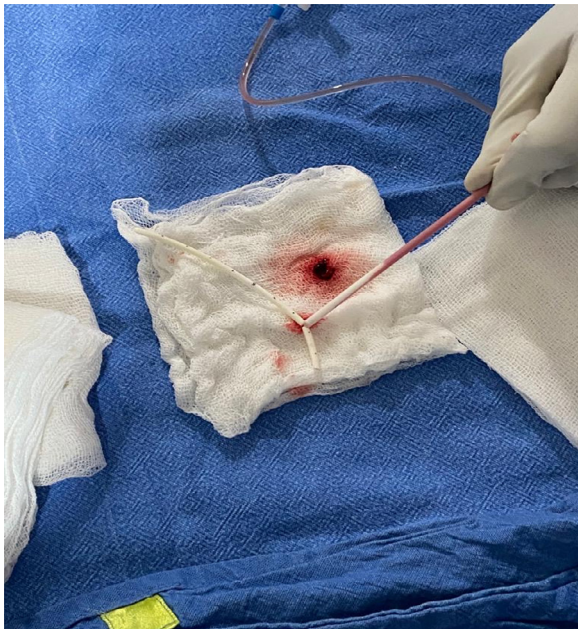
Fig. 10 – Extracted catheter fragment of Chemoport. Catheter fragment is approximately 8-9 cms.
