Magnetic resonance imaging of breast augmentation: a pictorial review

The increasing prevalence of breast augmentation presents new challenges in breast imaging interpretation. Magnetic resonance imaging (MRI) is recognized as the gold standard for the evaluation of augmented breasts. This article reviews the MRI features of different breast augmentation techniques, their associated complications, and the role of MRI in the assessment of concurrent breast abnormalities.

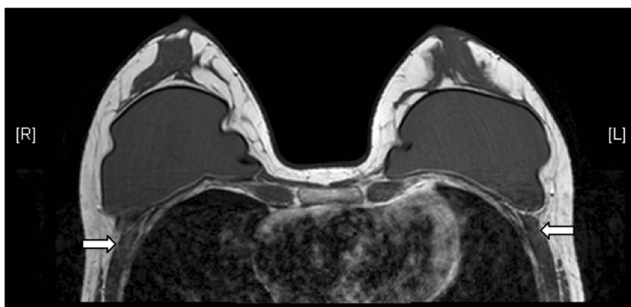
Fig. 1 Retrogladular position of implants. T1-weighted axial MR image shows the retrogladular position of bilateral silicone gel-filled implants, which are entirely anterior to the pectoralis muscles (arrows)

Numerous styles and types of breast implants have been used since it was first invented in 1962 [5]. The commonly used prosthetic breast implants nowadays can be categorized by the number of lumens and their filling materials. A single-lumen implant is a multilayered shell filled with silicone gel or, less commonly, saline solution. A standard double-lumen implant is filled with silicone gel in the inner lumen and with saline solution in the smaller outer lumen. An inverse double-lumen implant is filled with saline solution in the inner lumen, which can be expanded as necessary, and with silicone gel in the outer lumen. The implant can be placed in a subglandular (retrogladular) location, which is anterior to pectoralis major muscle (Fig. 1) or in a subpectoral (retropectoral) location (Fig. 2) [6].

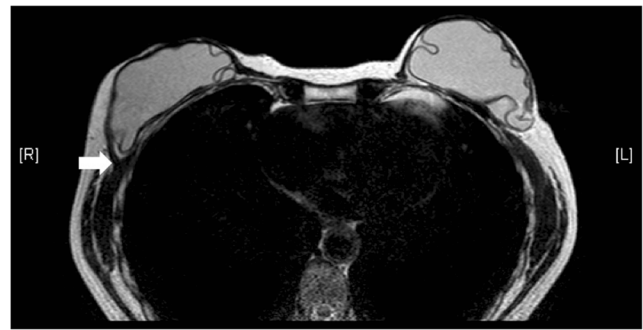
Fig. 2 Retropectoral position of implants. T2-weighted MR image on axial plane demonstrates the retropectoral position of the right silicone gel-filled implant. Note the right pectoralis muscle (arrow) is split by the implant

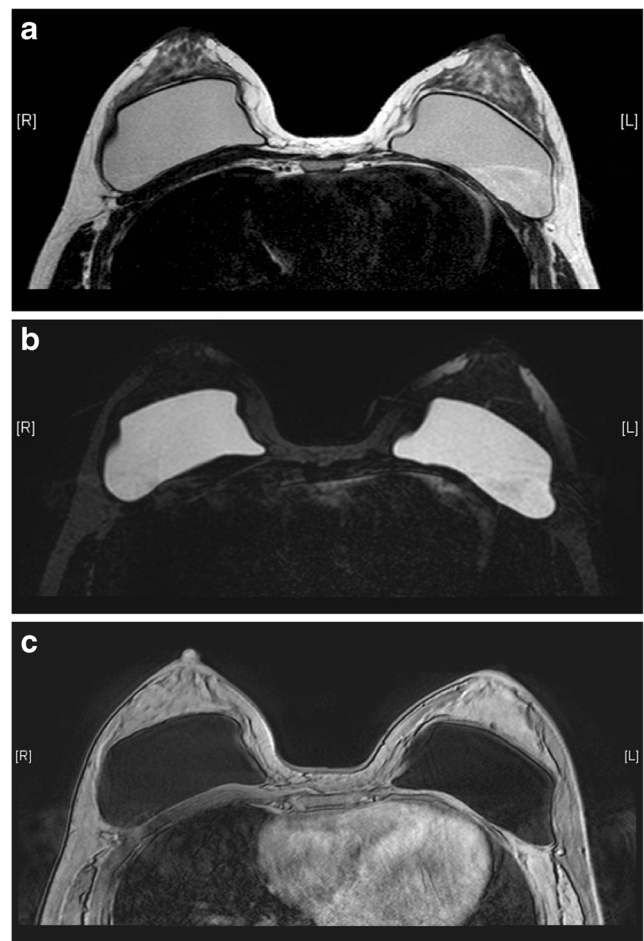
Fig. 3 Silicone gel-filled implants. T2-weighted (a), silicone-only (b), and silicone-saturated (c) axial MR images show the specific signal intensities of silicone, thus rendering the differentiation between silicone gel-filled and saline-filled implants possible

(silicone hyperintense, water hypointense), and silicone-saturated sequence (silicone hypointense, water hyperintense). Saline and silicone give different signal intensities depending on the pulse sequences, enabling their differentiation and localization (Figs. 3 and 4).

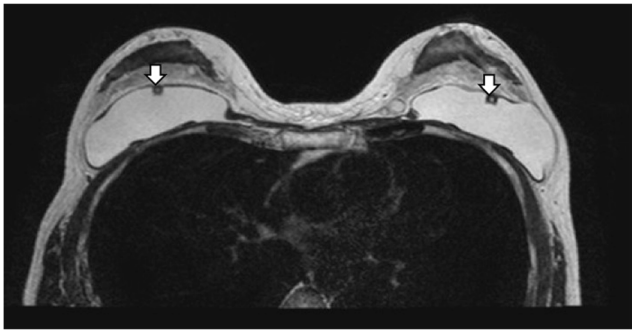
Fig. 4 Saline-filled implants. High signal intensity identical to water is seen in saline-filled implants on T2-weighted sequence. Note the valves (arrows) at the anterior aspect of the shells, which are characteristic of saline-filled implants, but not silicone gel-filled implants

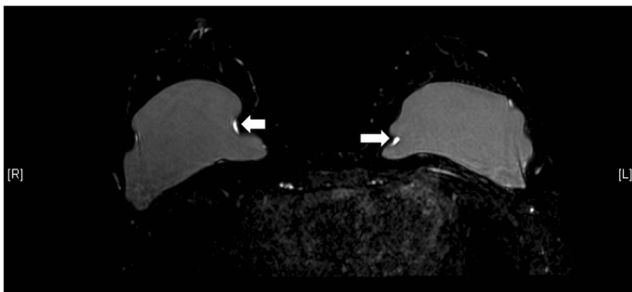
Fig. 5 Periprosthetic fluid. T2-weighted fat-saturated axial MR image shows trace amount of periprosthetic fluid bilaterally (arrows), which is a common normal finding

In a normal implant, the shell is intact with a surrounding thin, fibrous capsule. It is common to find a small to moderate amount of peri-prosthetic fluid, which is reactive in nature (Fig. 5). The presence of radial folds is normal. They are perpendicular infoldings of the shell into the silicone gel or saline solution, extending inwards from the periphery (Fig. 6). This can be mistaken as implant rupture by the inexperienced eye.

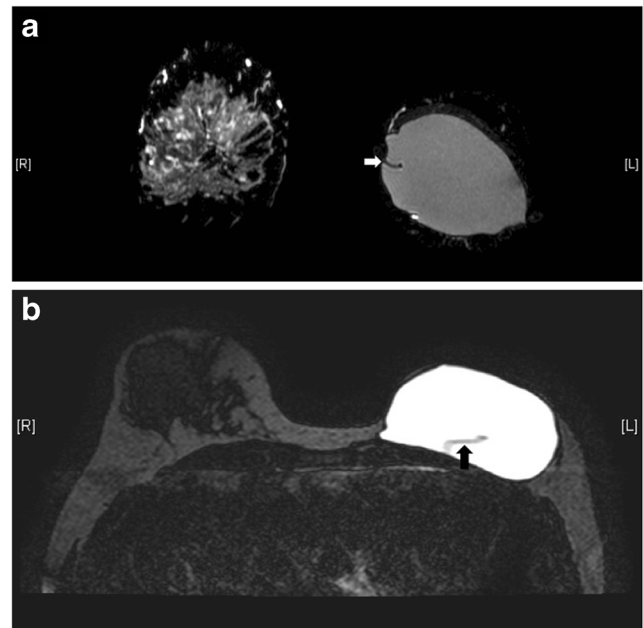
Fig. 6 Radial folds. T2-weighted fat-saturated coronal (a) and silicone-only axial (b) MR images of the same patient with silicone gel-filled implants show a hypointense line running from the periphery, which is perpendicular to the normal intact left silicone gel-filled implant shell, suggestive of a radial fold (arrow)

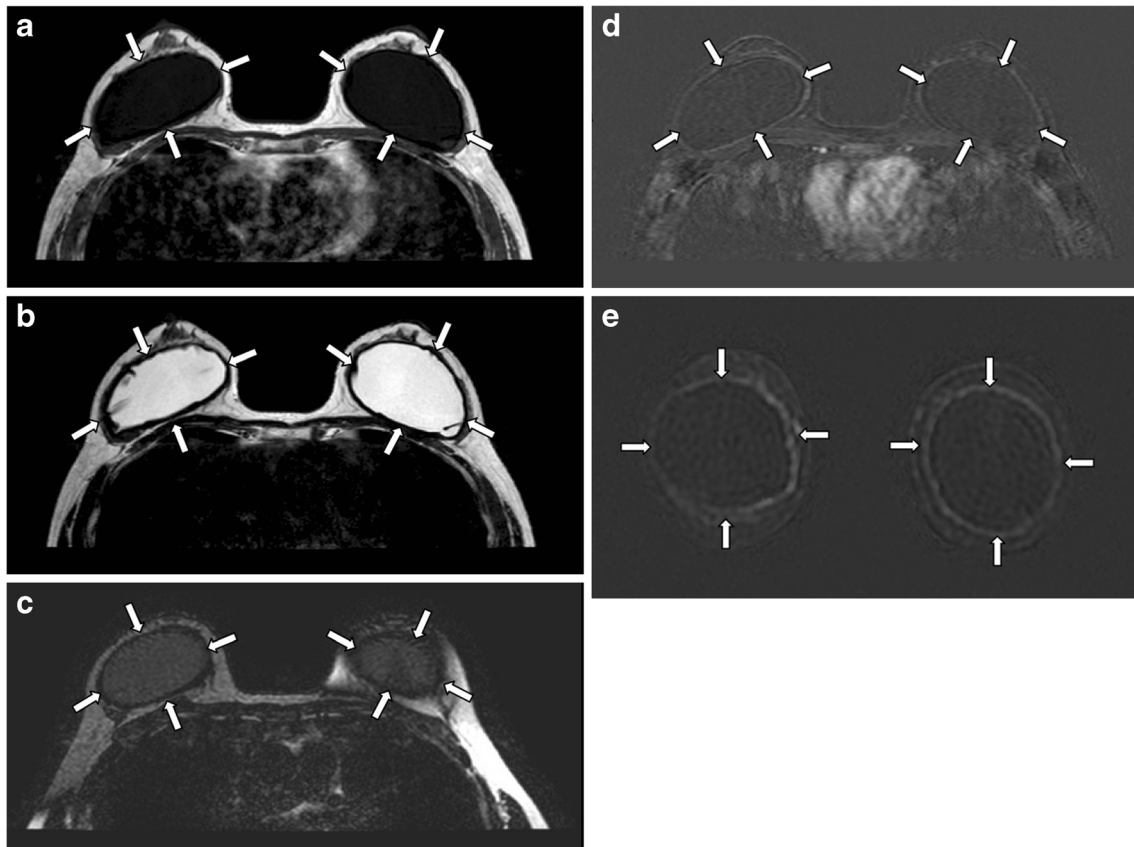
Fig. 7 Capsular contracture. Axial MR images of T1-weighted (a), T2-weighted (b), and silicone-only (c) sequences show thick low signal fibrous capsules surrounding both implant shells (arrows). Note that the implant material signal is low on silicone-only sequence (c), which

suggests that these are saline-filled implants. T1-weighted post contrast images with subtraction on axial (d) and coronal (e) plane show enhancement of the pseudocapsules

The thin, fibrous capsule surrounding the implant, as previously mentioned, is a normal finding. The capsule should be elastic and clinically impalpable. Excessive scarring will result in capsular contracture, which is one of the most common complications of prosthetic implants [3]. It can occur anytime post-operatively, but usually within the first few months. This condition is best diagnosed clinically [7], with the patient complaining of pain and breast disfigurement. On examination, the thick, fibrous tissue may become fixed and palpable. Although not always present, possible imaging findings include alteration of implant contour, which becomes asymmetrical, irregular, and more spherical in shape, with infoldings or tenting. Coarse peri-implant calcification and peripheral enhancement may also be seen [3, 6] (Fig. 7).

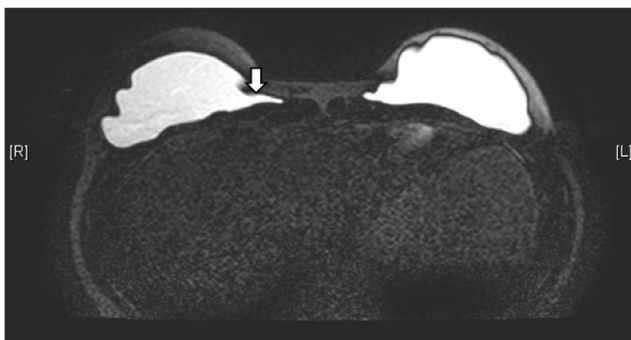
Fig. 8 Rat tail sign. T2-weighted, fat-saturated axial MR image shows protrusion of the implant shell through a focally weakened part of the fibrous capsule at medial aspect of right breast, simulating a rat tail (arrow)

This describes protrusion of the implant shell through a focal weakened or torn part of the fibrous capsule. It is called the “rat-tail sign” if very pronounced. This can potentially lead to rupture [2, 3] (Fig. 8)

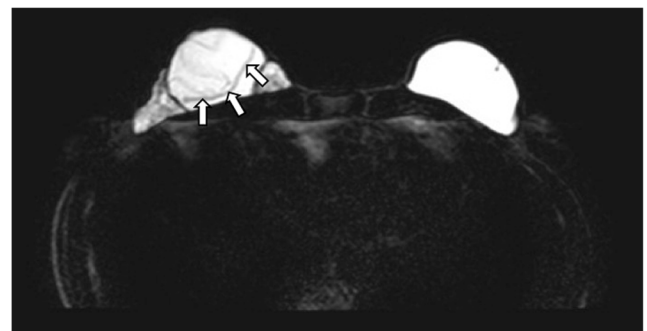
Fig. 9 Subcapsular line sign. Silicone-only axial MR image shows a hypointense line (arrow) running almost parallel to and just beneath the fibrous capsule in right breast, due to a thin layer of silicone between the shell and the fibrous capsule

- “Subcapsular line sign”. A hypointense line is noted running almost parallel to and just beneath the fibrous capsule due to a thin layer of implant material between the shell and the fibrous capsule [2, 3] (Fig. 9).
- “Pull away”, “open loop”, or “undercapsular streaks” sign. This refers to the presence of hypointense lines, which are characteristically parallel to the capsule, due to localized leakage of implant material. This causes a small displacement of the capsule [2].
- “Keyhole”, “noose”, or “inverted-loop” sign. It appears when there is further progression of the “pull away sign”. It is the leakage of implant material into the invaginated implant shell, with

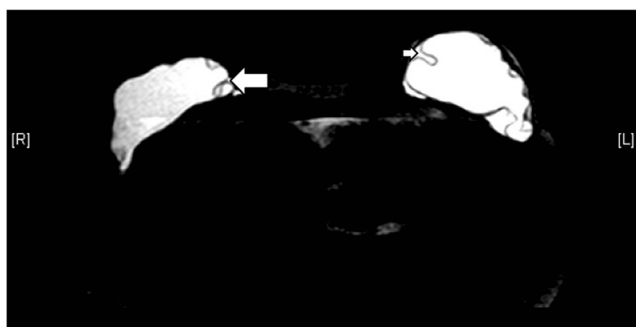
Fig. 10 Keyhole sign (left breast) and teardrop sign (right breast). Silicone-only axial MR image shows keyhole sign (small arrow) at left breast. The invaginations of implant shell do not touch each other. Teardrop sign is seen at right breast (large arrow), with the invaginated membranes contacting one another

the two membranes not touching each other [2, 3] (Fig. 10).

- “Tear-drop sign” differs from “keyhole sign” in that the invaginated membranes contact one another (Fig. 10).

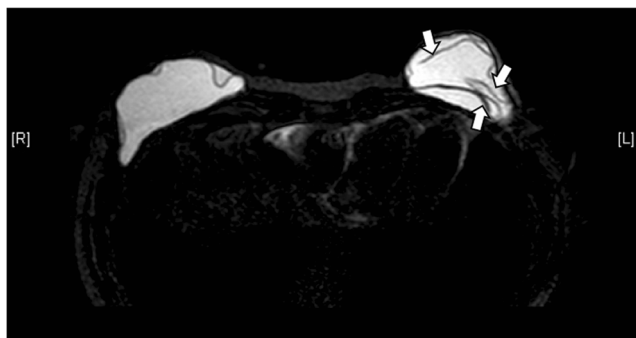
Fig. 11 Linguine sign. Silicone-only axial MR image shows curvilinear hypointense lines (arrows) in the left breast implant, compatible with the collapsed shell floating in the high-signal silicone gel. This is called the linguine sign

“Linguine sign” is the presence of curvilinear hypointense lines, which represents the collapsed shell, floating in the high-signal intensity silicone gel [3] (Fig. 11). This sign is only present in collapsed intracapsular rupture.

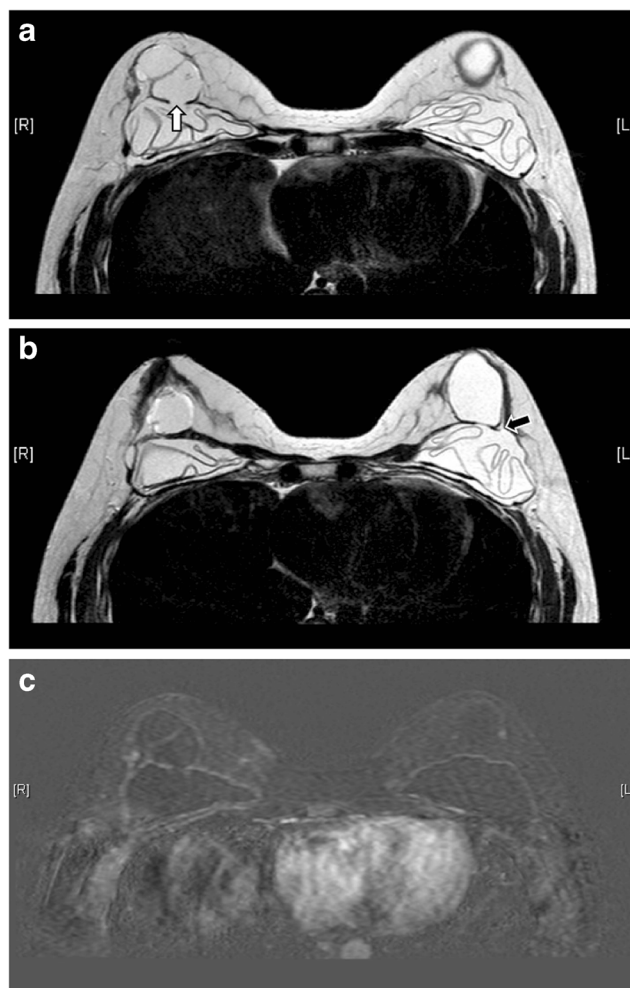
Fig. 12 Extracapsular rupture. T2-weighted axial MR images (a, b) show bilateral extracapsular ruptures. Defects are seen at bilateral fibrous capsules (white arrow on the right and black arrow on the left). Both collapsed implants demonstrate the linguine sign. On the T1-weighted post-contrast image with subtraction (c) there is a thin reactive rim of enhancement surrounding the collapsed implants

Extracapsular rupture means the leakage of the implant material beyond the fibrous capsule into the surrounding tissues. It happens when both the implant shell and the fibrous capsule are ruptured (Figs. 12 and 13). Free silicone can be seen as discrete foci, usually with identical signal intensity as the silicone gel inside the implant (Fig. 14). They appear isointense to hypointense on T1-weighted, fat-suppressed images and is of high signal intensity on water-suppressed T2-weighted images [6]. With time, silicone granuloma formation may occur, showing enhancement that may mimic breast carcinoma. Differentiation solely on the basis of imaging can be difficult. Therefore, pathological diagnosis by biopsy is warranted if there is suspicion [6]. In the

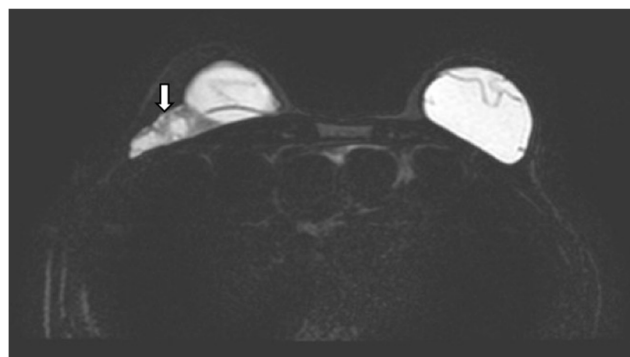
Fig. 13 Extracapsular rupture of the right silicone gel-filled implant. Silicone-only axial MR image shows extracapsular rupture of the right silicone gel-filled implant (arrow)

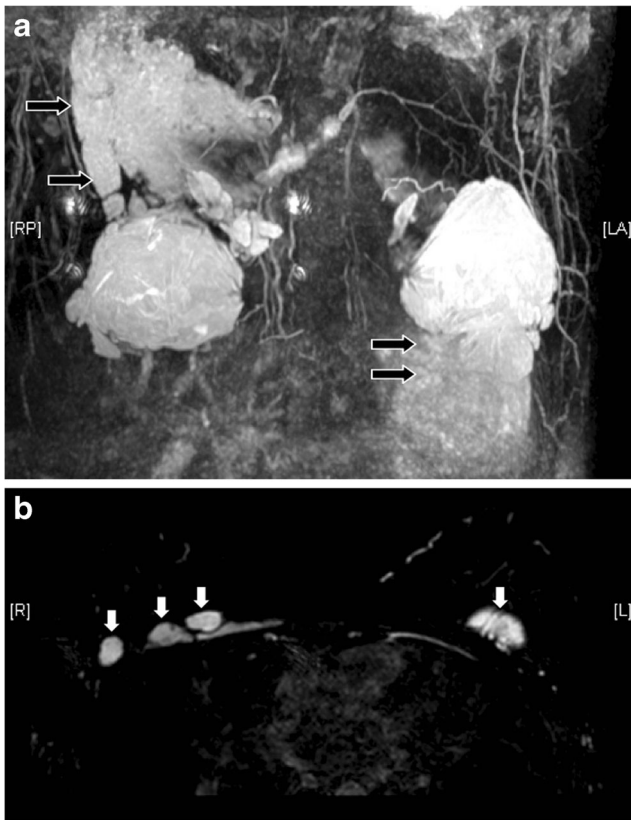
Fig. 14 Free silicone at chest wall. Reconstructed T2 coronal MR image with MIP (a) reveals extensive silicone leakage (black arrows) from bilateral silicone gel-filled implants. The free silicone has identical signal with the silicone gel inside the implants. On T2-weighted, fat-saturated axial image (b) discrete free silicone foci are seen over the chest wall (white arrows)

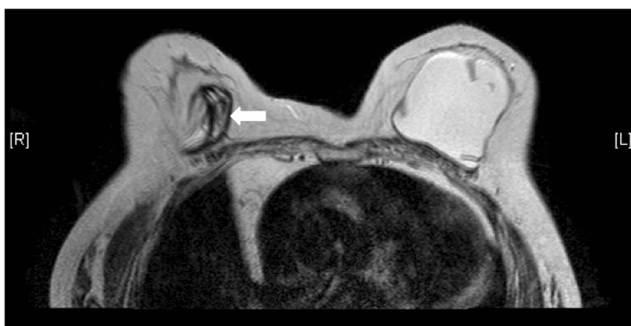
Fig. 15 Collapsed right saline-filled implant. T2-weighted axial MR image shows collapsed right implant shell (arrow). The leaked hydrosaline solution has been resorbed

case of saline-filled implant extracapsular rupture, free hydrosaline solution is usually resorbed by the body, with the remaining collapsed implant shell being the only imaging clue (Fig. 15).

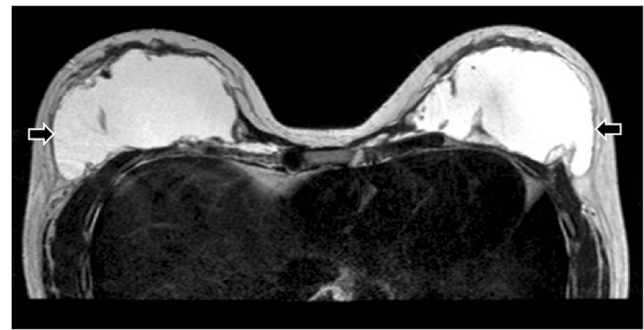
Fig. 16 Desirable retroglandular position of PAAG. T2-weighted axial MR image demonstrates uncomplicated PAAG injection, with a collection of homogeneous T2 hyperintense material (arrows) at the retroglandular region of each breast, located anterior to the pectoral muscles

For uncomplicated injections, PAAG should appear as a large collection of homogeneous T2 hyperintense signal in the retroglandular region, anterior to the pectoral muscles [9] (Fig. 16). PAAG does not induce as much physiological response to foreign body as other injectable augmentation materials. It, therefore, tends to lack a thick surrounding fibrous capsule. It was reported that injected gel were unable to form a single blob in 81.5 % of augmented breasts [9]. As the injection procedure is performed blindly without image guidance, there is a high risk of gel migration if the gel is undesirably injected outside of the retroglandular space. This can potentially lead to breast asymmetry related to gel migration or due to the difference in the amount of gel injected (Fig. 17). Breast asymmetry was found in 20–52.9 % in previous studies [9, 10].

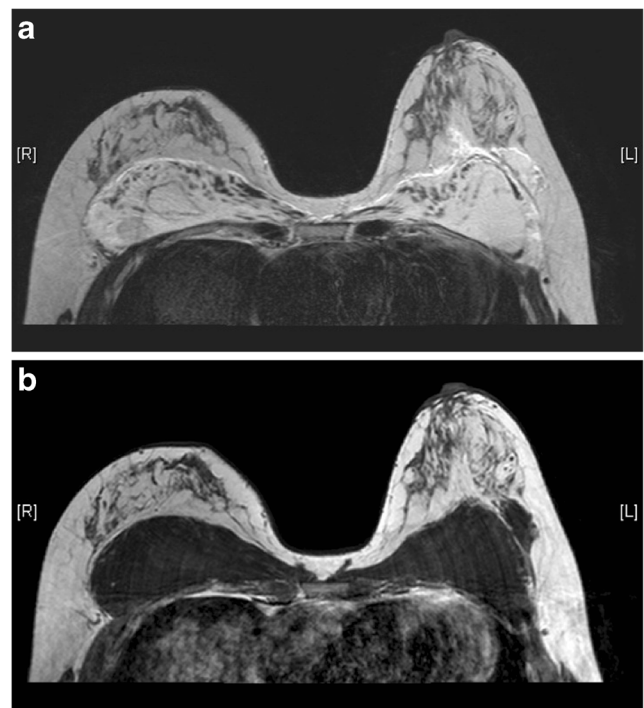
Fig. 17 Asymmetric breasts after PAAG injection. T2-weighted (a) and T1-weighted (b) axial MR images show the undesirable outcome of breast asymmetry after augmentation by PAAG injection

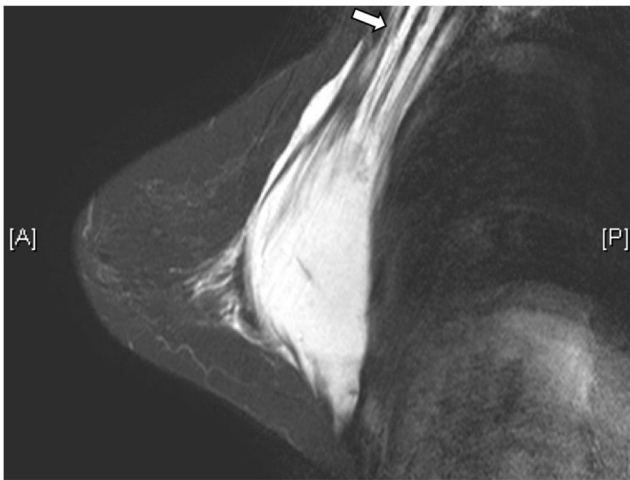
Fig. 18 Intrapectoral migration of PAAG. T2-weighted, fat-saturated sagittal MR image reveals PAAG tracking along fascial planes of the pectoral muscle (arrow)

Outside the retroglandular space, PAAG tends not to coalesce but forms multiple small loculations. In the intrapectoral region, the gel can track along musculofacial planes (Fig. 18). In the retropectoral region, it may extend into the intrathoracic or extra pleural space. It can form nodules subcutaneously, particularly at the common sites of injection, namely the inframammary crease or axillary region. Sometimes it can migrate medially to the pre-sternal region (Fig. 19) and up to shoulder and infraclavicular region. Nodal involvement is not

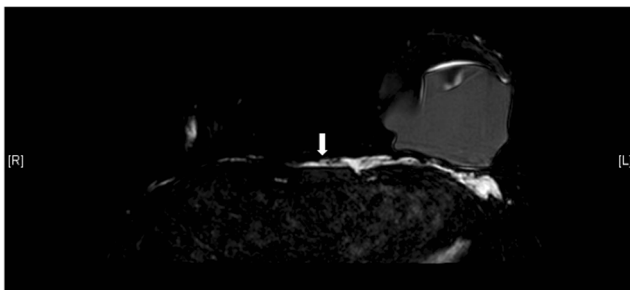
Fig. 19 Chest wall extension of PAAG in a patient with history of left breast augmentation by PAAG injection and silicone gel-filled implant. Extension of PAAG to chest wall is clearly shown on this T2-weighted, fat-saturated MR axial image. Silicone is of low signal while PAAG is of high signal on this sequence. Medial extension of PAAG to pre-sternal region is noted (arrow)

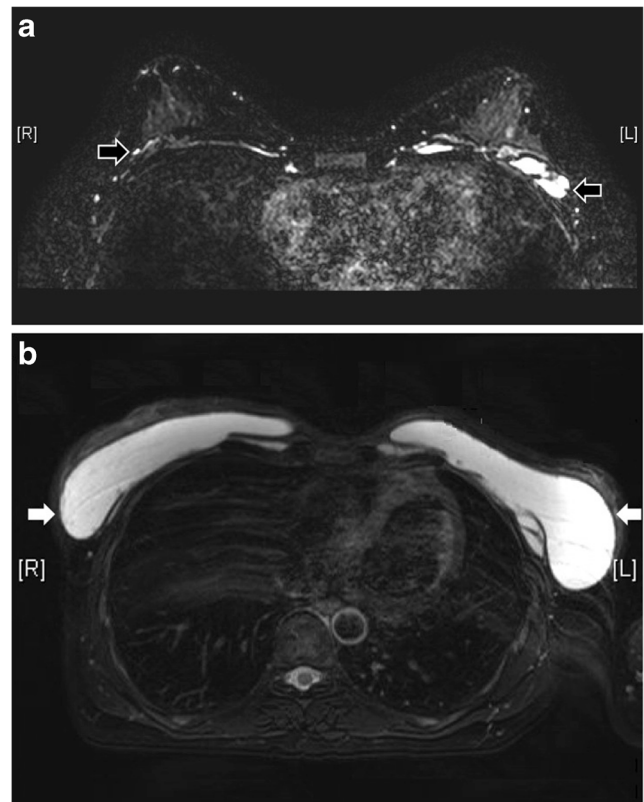
Fig. 20 PAAG at anterior abdominal wall. Axial T2-weighted fat-suppressed image show there is minimal PAAG in bilateral retroglandular spaces (black arrows) (a). Instead, the main collections are found over anterior abdominal wall (white arrows) (b)

uncommon. Extension to the abdominal wall (Fig. 20) is sometimes encountered. If injected to the intraglandular region, PAAG can cause glandular atrophy and skin necrosis as well [11]. Such propensity of gel migration often leads to incomplete surgical removal. Distant gel migration was detected in 8.9 % of patients after PAAG injection [10].

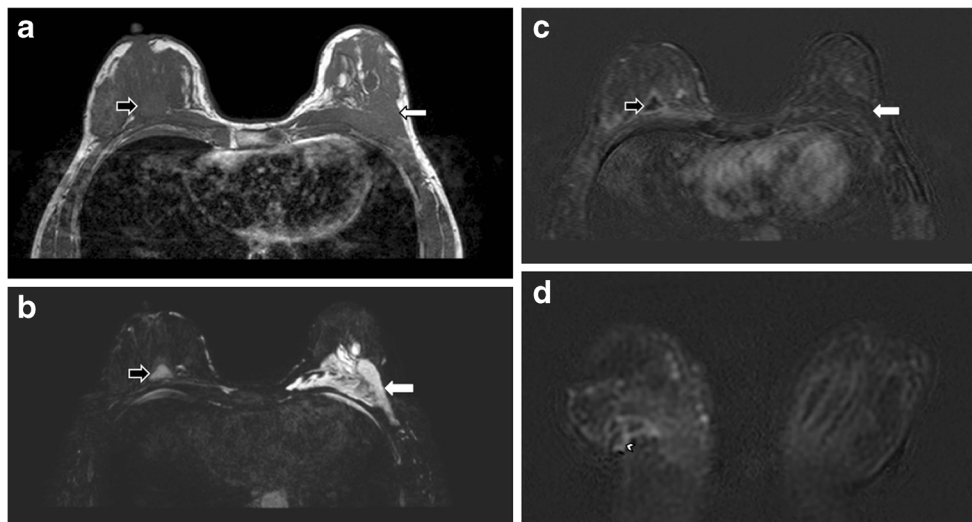
Fig. 21 PAAG injection complicated with recurrent right breast abscess. Axial MR images of T1-weighted (**a**) and T2-weighted, fat-saturated (**b**) sequences depict a T1 hypointense and T2 hyperintense collection (black arrows) at the right breast. It shows rim enhancement after contrast injection (**c**). A sinus tract (arrowhead) is demonstrated at the lower

outer aspect of the collection on the T1-weighted post-contrast coronal image with subtraction (**d**). Note the T1 low signal (**a**), T2 high signal (**b**) PAAG collection without any enhancement at the left retroglanular region (white arrows) (**c**)

Infection and abscess formation are common complications, especially if the procedure is performed without sterile technique. Of PAAG augmentation mammoplasty, 14.7 % was reported to be complicated with infection [9]. In the acute phase, the augmented breast is enlarged, with internal low-signal intensity foci inside the gel on T2-weighted MRI images, signifying pus formation. Contrast-enhanced MRI shows a thick nodular and irregular rim of contrast enhancement, which is helpful in delineating the extent of infection. For chronic infection, sinus formation may be seen (Fig. 21).

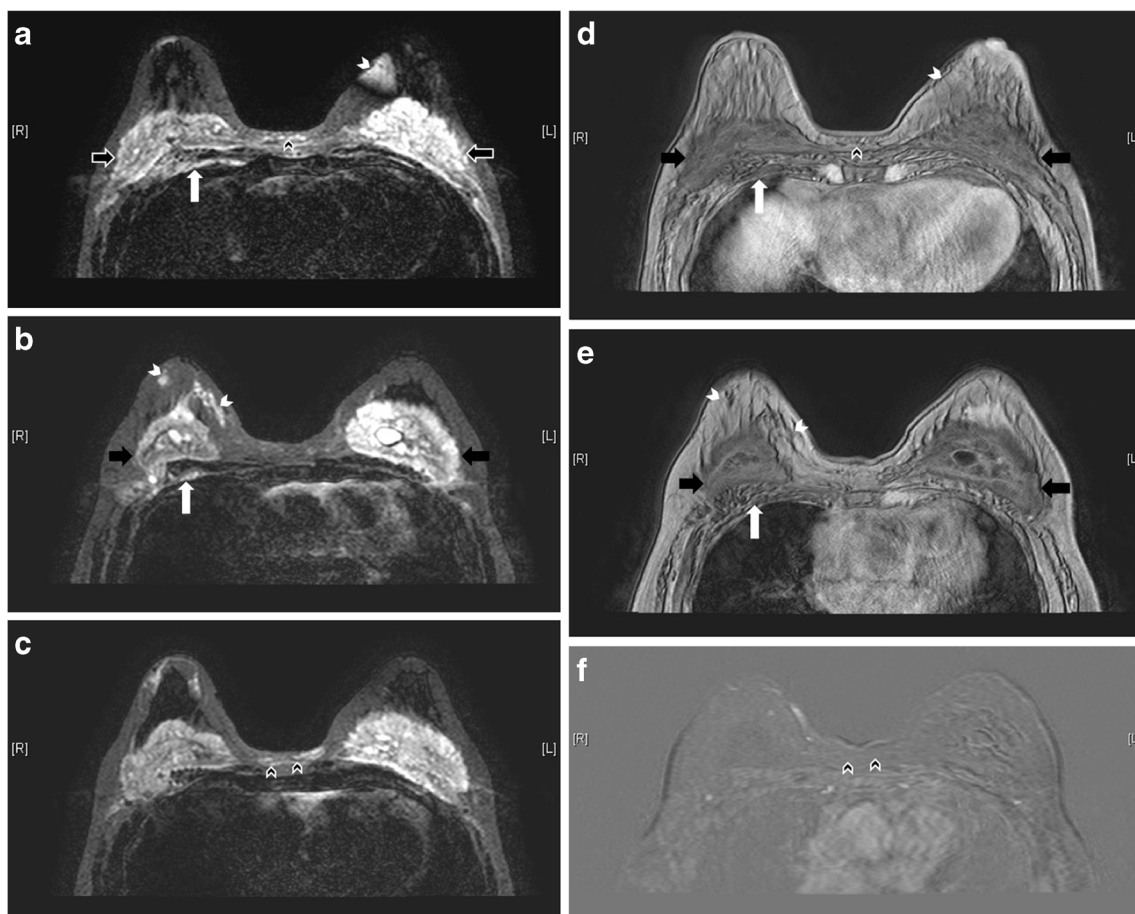
Fig. 22 Free silicone injection. High signal collections (black arrows) are noted at the retroglanular regions of both breasts on these axial MR images of silicone-only sequence (**a–c**), compatible with free silicone. Collections are also seen in premammary fat (white arrowheads),

retropectoral region (white arrows), and pre-sternal region (black arrowheads). They are suppressed on silicone-saturated sequence (**d, e**). No enhancement is noted over the pre-sternal collection (black arrowheads) on T1-weighted post-contrast image with subtraction (**f**)

This augmentation technique was introduced in 1940s and is now banned in view of its adverse effects. The free silicone is injected into the breast parenchyma, pectoralis muscles, or both (Fig. 22). Complications of liquid silicone injection include skin necrosis, silicone migration, embolism, infection, lymphadenopathy, and granuloma formation. Pathologically, silicone granulomas are nodules that contain small silicone parts associated with abundant fibrous reaction [12]. Their typical imaging appearance is that of a spherical nodule with peripheral calcifications. They can occasionally mimic malignancy, with spiculated borders [6]. Their signal intensity on MRI is related to the impurities in the silicone preparation [12]. Sometimes there may be mixed signals for injected silicone due to the formation of fibrous tissue, which results in low signal, or the presence of silicone granulomas, which decrease the signal intensity on T2-weighted sequence.

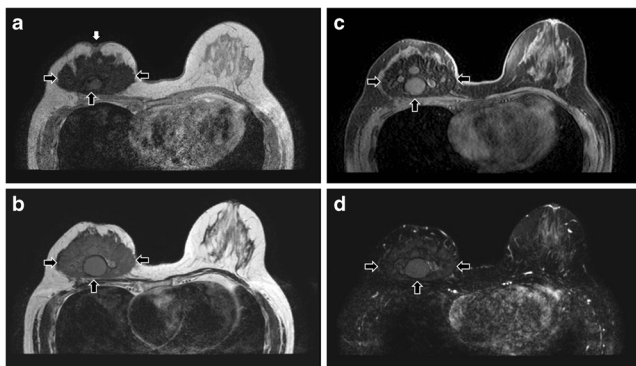
Fig. 23 Unilateral right breast paraffin injection. T1-weighted (a), T2-weighted (b), T2-weighted, fat-saturated (c), and T1-weighted, fat-saturated, post-contrast (d) axial MR images show a right breast mass (black arrows) with T1 and T2 low to intermediate signals and minimal contrast enhancement. Nipple retraction (white arrow) is observed (a)

It was once a popular breast augmentation method in the early 1900s, but it is abandoned nowadays owing to serious complications. Paraffinoma formation is common [6]. Its MRI signals and fat-saturated features vary with the purity of the injected materials and depend on whether the paraffin is in liquid or semi-solid state, which is related to the age of injection [13] (Fig. 23). Other complications of paraffin injection include migration,

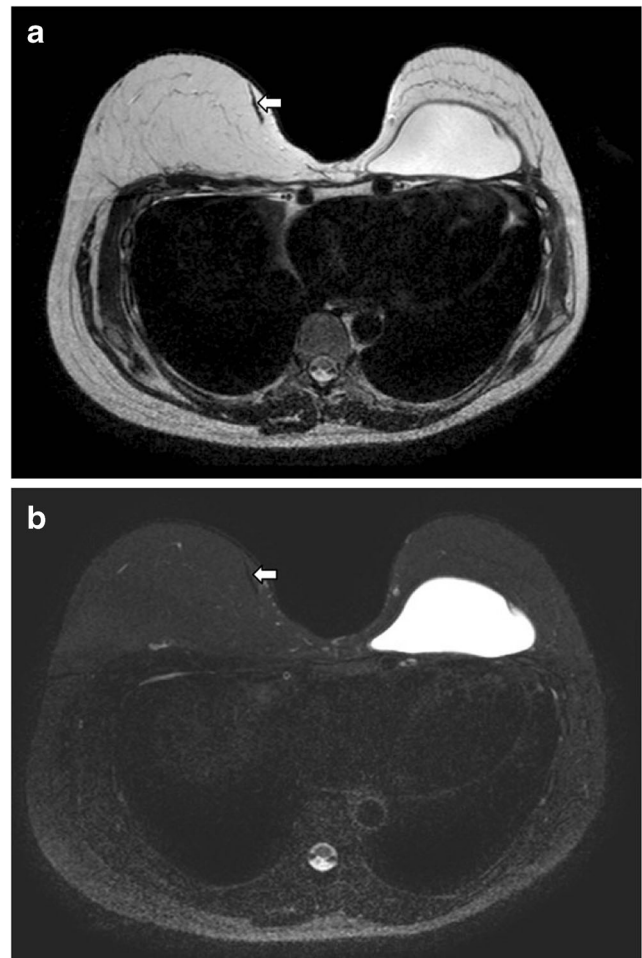
Fig. 24 Myocutaneous flaps. These are MR images of a patient with history of bilateral mastectomy and breast reconstruction with TRAM flap at right breast and latissimus dorsi flap plus saline-filled implant at left breast, in order to maintain breasts symmetry. T2-weighted (a) and T2-weighted fat-saturated (b) axial MR images reveal the complete fatty composition of both breasts without normal glandular tissue, except over the region of saline-filled implant. The denuded dermal layer of the abdominal tissue (arrow) is seen parallel to the skin of right breast

Myocutaneous flap is commonly used in breast reconstruction after surgical removal of breast cancer. The most commonly used flaps are latissimus dorsi and transverse rectus abdominis myocutaneous (TRAM) flaps (Fig. 24). Latissimus dorsi flap consists of latissimus dorsi muscle and its overlying skin and fat. On MRI, the muscle flap has a tailed appearance at the lateral breast, with the overlying skin and fat flipped and tunnelled from the back to the neobreast.

TRAM flap can be categorized into pedicled flap and free flap, depending on the vascular supply. It consists of the rectus abdominis muscle along with the subcutaneous soft tissue. The atrophied rectus abdominis muscle is located in the centre of the anterior chest wall, in contrast to the eccentric location of the latissimus dorsi flap. On MRI, TRAM flap shows the same signal intensity as fat, with an enhancing contact zone between the flap and the mastectomy site [14].

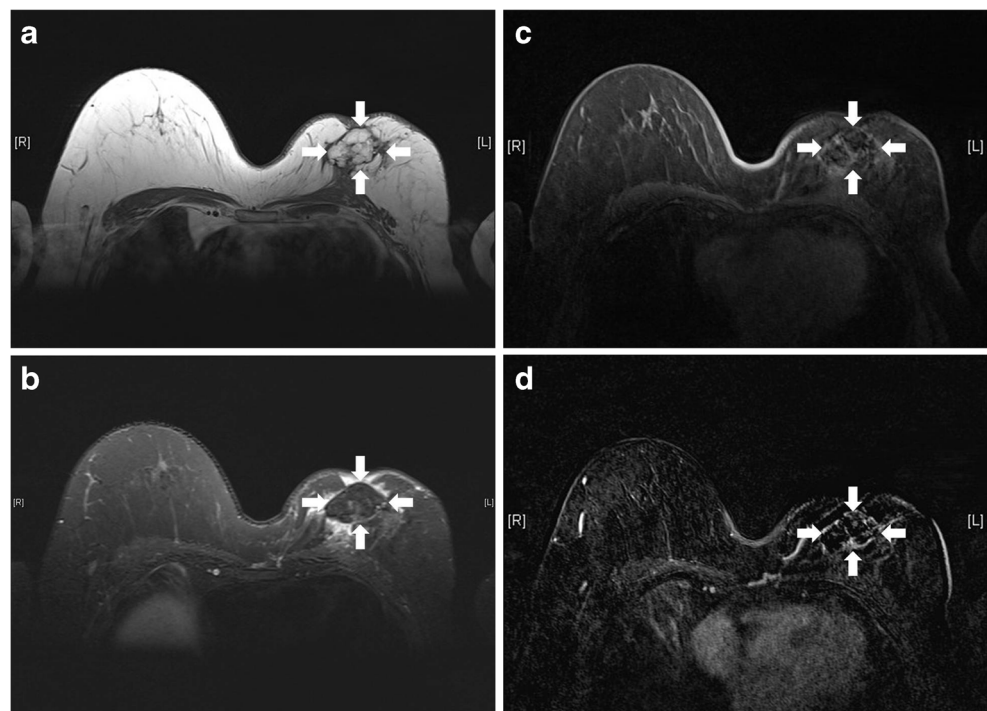
Fig. 25 Fat necrosis after autologous fat implant. T1-weighted (a), T2-weighted, fat-saturated (b), and T1-weighted, fat-saturated (c) axial MR images show a multilobulated lesion (arrows) with signal identical to fat in the left breast. Mild perifocal edema is noted (b). T1-weighted, post-contrast axial MR image with subtraction (d) shows the non-enhancing nature of the fatty masses. A thin rim of enhancement surrounding them is likely due to post-operative changes

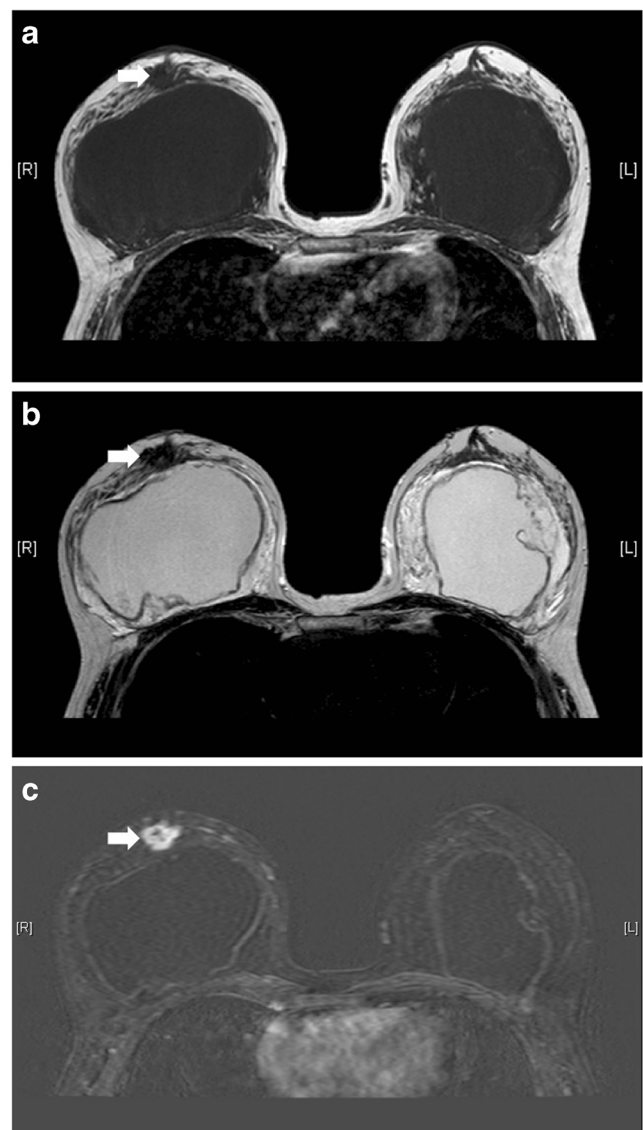
Fig. 26 Concurrent breast tumour anterior to right breast implant. T1-weighted (a), T2-weighted (b), and T1-weighted, post-contrast with subtraction (c) axial MR images show a T1 and T2 hypointense lesion with contrast enhancement (arrow) anterior to right breast implant. It was pathologically proven to be invasive ductal carcinoma
