# Effect of Glass Fiber Hybridization on the Durability in Salt-Fog Environment of Pinned Flax Composites

**Abstract:** The aim of the present paper is to evaluate the effect of the hybridization with external layers of glass fibers on the durability of flax fiber reinforced composites in severe aging conditions. To this scope, full glass, full flax and hybrid glass–flax pinned laminates were exposed to a salt-fog environment for up to 60 days. Double-lap pinned joint tests were performed to assess the pin-hole joints performances at varying the laminate stacking sequence. In order to better discriminate the relationship between the mechanical behavior and the fracture mechanisms of joints at increasing the aging time, different geometries (i.e., by varying both the hole diameter  $D$  and the free edge distance from the center of the hole  $E$ ) were investigated after 0 (i.e., unaged samples), 30 and 60 days of salt-fog exposition. It was shown that the hybridization positively affects the mechanical performance as well as the stability of pinned composites: i.e., improvements in both strength and durability against the salt-fog environment were evidenced. Indeed, the hybrid lam

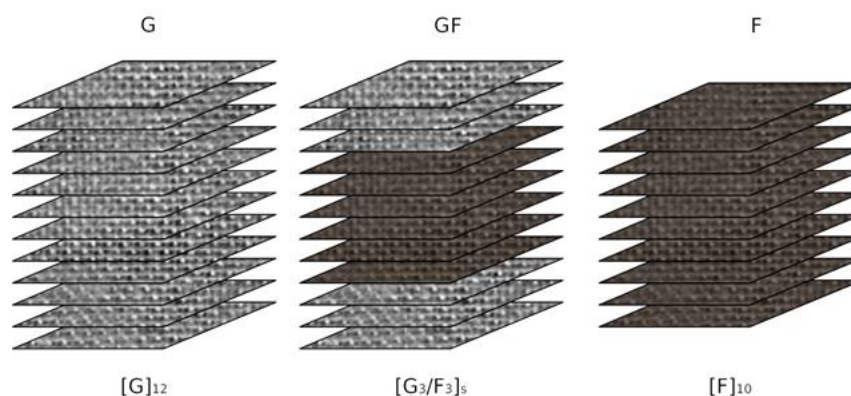
**Figure 1.** Schematization of stacking sequences of glass, glass/flax and flax laminates.

Each panel was cured for 24 h at 25 °C and then post-cured for further 8 h at 50 °C in the open air. A commercial epoxy resin SX8 EVO (viscosity equal to 500–600 mPas at 25 °C), supplied by Mates Italiana s.r.l., (Segrate, Italy) mixed with its own amine-based hardener (100:30 by weight) was used as matrix. Used as reinforcement were 2 × 2 twill weave woven flax fabrics with nominal areal weight of 318 g/m<sup>2</sup> (Lineo, Valliquerville, France) and plain weave woven glass fabrics with nominal areal weight of 200 g/m<sup>2</sup> (Mike Compositi, Milano, Italy). Figure 1 shows the schematization of the stacking sequences of the resulting composites [35–37].

All samples were codified by using a prefix composed by a first letter “G”, “F” or “GF” indicating the kind of composite (i.e., glass, flax or glass–flax reinforced, respectively) followed by a second letter “A”, “B” or “C” depending on the salt-fog exposition time (i.e., 0, 30 or 60 days, respectively). For instance, the code F-B designates the flax fiber reinforced composite aged for 30 days.

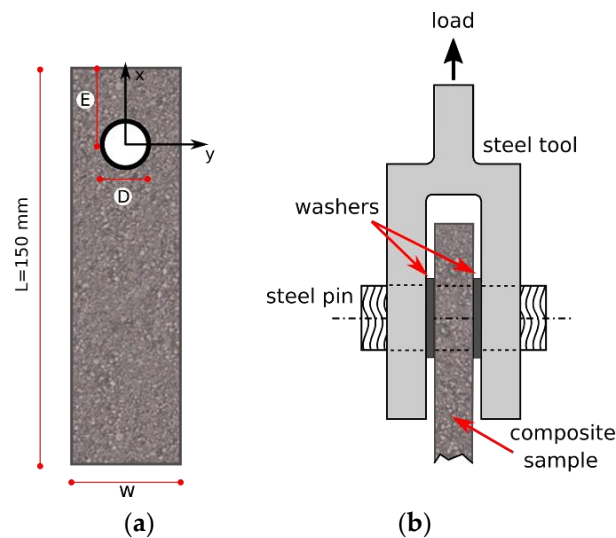
**Figure 2.** (a) Joint geometry and (b) scheme of bearing test setup (adapted from [24]).

Figure 2 shows the main geometrical parameters of pinned samples in addition to schematize the pin-hole bearing test setup. For each bearing test, the specimen was bolted by using a steel pin with a specially designed steel plate, in order to reduce its rotation. In particular, the stainless steel pin was positioned in the hole, and then double-lap pinned joint tests were performed by applying a displacement in the direction parallel to the symmetry plane of the composite laminate to hinder undesired moments and rotations. All joints were codified coupling the previous prefix with three numbers related to the joint geometrical configuration. In particular, the three numbers referred to the values in mm of hole diameter (D), free edge distance from the hole (E) and laminate width (W), respectively.

In order to have an adequate amount of geometrical condition to investigate, the hole diameter and edge distance were modified within the ranges 4–10 mm and 2–20 mm, respectively. At least 30 joint configurations were characterized for each aging condition, with a total of about 270 specimens.

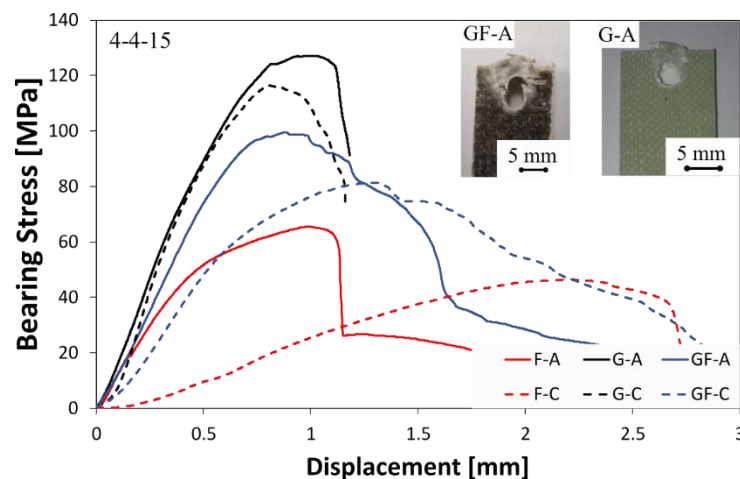
**Figure 3.** Typical stress–displacement curves of unaged (solid lines) and aged (dotted lines) pinned laminates with  $D = 4$  mm and  $E = 4$  mm.

Figure 3 shows some typical stress–displacement curves of pinned laminates with hole diameter ( $D$ ) and the laminate free edge ( $E$ ) both equal to 4 mm, for unaged (solid lines) and aged (dotted lines) samples. This joint configuration was in order to evaluate the mechanical behavior and damage evolution in joints having the pin (or hole) close to the free edge. A clear dependence of the mechanical joint behavior from the stacking sequence can be identified by observing the stress–displacement curves of unaged samples (solid lines).

Regardless of the stacking sequence, all curves exhibit at low displacement values a linear trend related to the composite joint stiffness. The fiberglass laminate (i.e., G-A) shows the highest slope until a maximum bearing stress is reached. Then, a sudden stress drop takes place due to a premature fracture activation by shear-out.

Laminates having flax fibers in their stacking sequence also showed a shear-out fracture mode. Nevertheless, the presence of flax fabrics leads to a stiffness decrease, as evidenced by the reduction in the stress–displacement slope for GF-A and F-A samples, in comparison to G-A. This is a quite predictable result since the presence of natural fibers such as flax in the composite stacking sequence obviously exalts a nonlinear behavior of the pinned joint.

It is worth noting that the exposition to an aggressive environment such as a salt-fog spray condition noticeably influences the bearing mechanical behavior of composites containing flax fibers in their stacking sequences. Indeed, despite the stress–displacement curves of fiberglass composites not showing clear change due to the salt-fog exposition (i.e., just a slight decrease in the maximum stress value can be noticed by comparing G-A and G-C samples), both GF and F composites experienced evident worsening of their bearing performances. In particular, remarkable decrements in the bearing maximum stress and stiffness, as well as a noteworthy increase in the elongation at break, occurred for flax and glass–flax hybrid-reinforced composites. The higher is the flax fibers content in the composite stacking sequence, the greater are these behavior changes. Although the maximum stretching values of F-C and GF-C batches are quite similar (i.e., about 2.7 mm), noticeable differences can be identified in their stress evolution at increasing the displacement. This is mainly due to the larger softening phenomenon experienced by the F-C sample in comparison to GF-C.

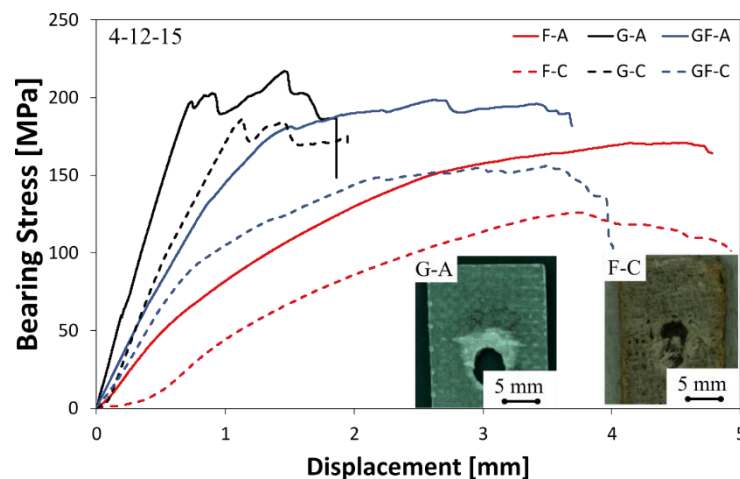
**Figure 4.** Typical stress–displacement curves of unaged (solid lines) and aged (dotted lines) pinned laminates with  $D = 4$  mm and  $E = 12$  mm.

A joint geometry having a high free edge distance  $E$  tends to inhibit a premature shear-out fracture phenomenon (see Section 3.1.1). The choice of this configuration can represent a suitable approach to bring out new fracture mechanisms such as bearing, as well as to evaluate how these mechanisms are influenced by the stacking sequence and aging conditions. In this regard, Figure 4 compares some typical stress–displacement curves of glass, flax and hybrid pinned laminates with  $D = 4$  mm and  $E = 12$  mm.

For this joint configuration, bearing or net-tension fractures can occur depending on the tensile or compressive limit stress of the laminate [44]. Even in this case, the mechanical behavior of unaged pinned laminates is clearly influenced by the stacking sequence. Indeed, by observing the stress–displacement curves of unaged samples (solid lines), it can be noticed that the fiberglass laminate showed the highest bearing maximum stress and stiffness values as well as the lowest elongation at break among the compared composites. On the other hand, the poorest mechanical response (i.e., in terms of maximum

All samples exposed for 60 days to salt-fog, exhibited a worsening of their mechanical performances, regardless of their stacking sequence. The applied aging cycle brings a decrease in the stiffness in addition to a slight increase in the elongation at break. This effect is more evident for F batch, for which a relevant nonlinear behavior can be identified. Due to the long exposition to the salt-fog environment, the full flax laminate suffered a reduction in the failure stress equal to 26.2%.

Further considerations can be argued comparing the occurred fracture mode when varying the stacking sequence and aging conditions. Figure 4 reports the fracture image of G-A sample. All the other unaged samples showed a similar fracture mode.

In particular, this photo clearly evidences that the unaged sample fails on the bearing mode, due to a large compression collapse, probably by the kinking mode [49] of the composite laminate on the pin/hole surface contact area [37]. The local collapse of this reinforced area triggers delamination and matrix cracking, extending the failure zone [50]. During the bearing collapse of the pinned joint, different competing damage mechanisms (i.e., fiber kink bands, delamination, interfacial and shear cracking) occur simultaneously, inducing a premature mechanical instability of the joint [35,51].

In particular, due to long exposure times in a salt-fog environment, the fracture mechanism observed for GF-C and F-C batches is a mixed bearing and net-tension (i.e., the latter dominating over the former—see image in Figure 4 referred to as reference to F-C). The contribution of the catastrophic net-tension mechanism favors the reduction in the displacement at failure, which does not undergo a significant increase due to aging.

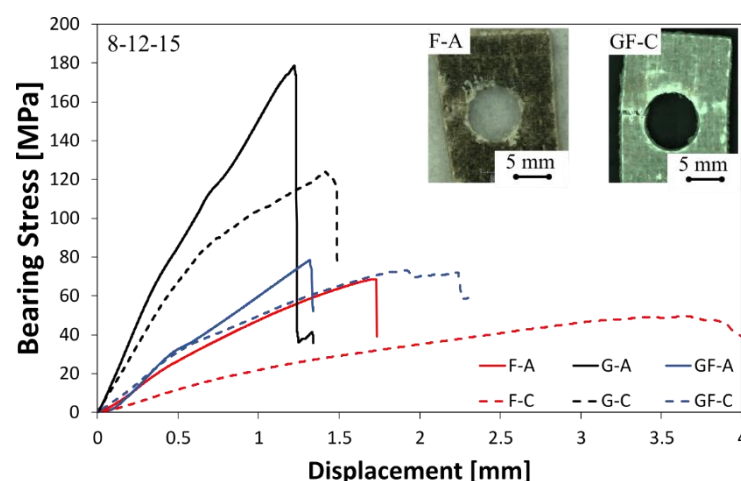
**Figure 5.** Typical stress–displacement curves of unaged (solid lines) and aged (dotted lines) pinned laminates with  $D = 8$  mm and  $E = 12$  mm.

Figure 5 shows typical stress–displacement curves for pinned laminates with  $D = 8$  mm and  $E = 12$  mm when varying the stacking sequence for unaged and aged samples. The increase in the pin/hole diameter  $D$  allows completion of the preliminary investigation of geometrical variables investigated in this campaign, thus providing a preliminary overview of the main damage modes for these classes of materials. The choice of a large hole diameter leads to a significant reduction in the cross-section in the pinned area. Consequently, relevant tensile stresses along the load direction on the pinned transverse plane take place.

As predicted, the reduced cross-section favors premature tensile fractures of the laminate. All samples (some representative curves are compared in Figure 5) showed, therefore, fractures by net-tension mode. This mechanism occurred regardless of both the stacking sequence and the exposure time in the salt spray chamber. Further considerations concerning the mechanical behavior of joints can be argued by evaluating their stress–displacement curves. In comparison to the progressive fracture mainly by the bearing mode observed in Figure 4, all samples having  $D = 8$  mm and  $E = 12$  mm exhibit an abrupt collapse in the stress at break at lower values, due to the occurrence of catastrophic fractures by the net-tension mode. Regardless of the aging time, this brittle behavior is all the more evident the higher the glass fiber content in the laminate. Moreover, significant reductions in joint stiffness and strength can be noticed for the 60-days-aged samples, which lead to a reduction in the performances variance among all batches. Only batch F shows an evident plasticization, which involves a significant increase in the displacement at break. The limited mechanical stability of flax fibers exposed to the humid environment led to the activation of softening and degradation phenomena for this geometric configuration

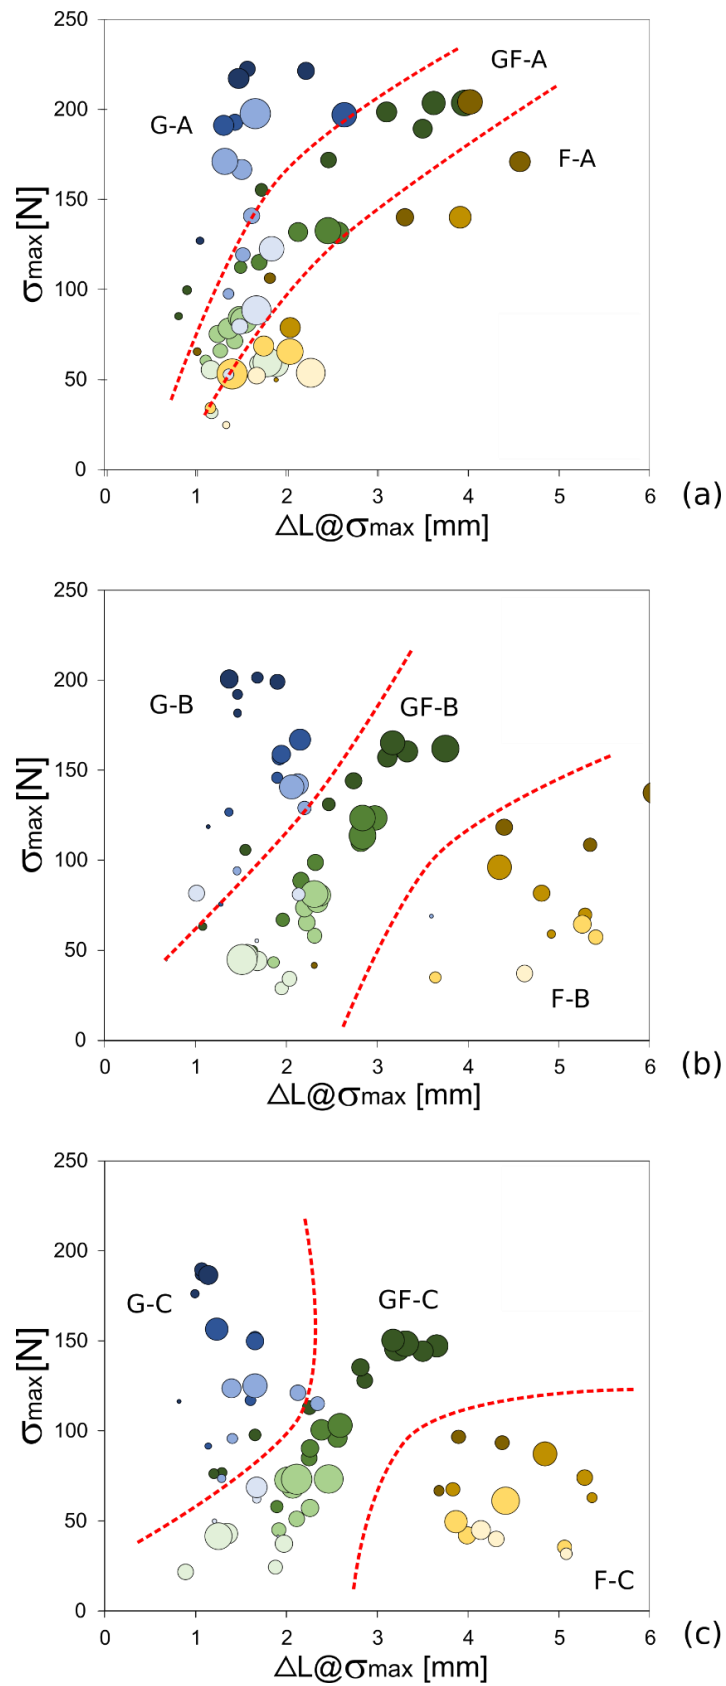
**Figure 6.** Maximum bearing stress ( $\sigma_{max}$ ) vs displacement at maximum stress ( $\Delta L@ \sigma_{max}$ ) curves for all composite batches at varying the salt-fog exposition time: (a) batches A (unaged samples), (b) batches B (aging time: 30 days) and (c) batches C (aging time: 60 days).

A noteworthy descending shift of the markers' trend can be observed starting from G-A toward GF-A and F-A batches. These latter batches, natural fiber-based composites, show lower maximum load values and larger  $\Delta L@_{\sigma_{\max}}$  than the G-A batch.

Glass fibers, due to their high strength and noticeable brittleness, can achieve high maximum stresses and low displacement upon failure of the related composites. This implies that the point cloud of the G-A batch is located in the upper left corner of Figure 6a. Conversely, the presence of flax fibers in the composite laminate induces a significant decrease in both composites' strength and stiffness. This is revealed in the full flax batch (F-A), for which the markers are shifted in the right side of the figure.

A similar trend can be found in Figure 6b,c referred to samples exposed to salt-fog for 30 and 60 days, respectively. Already after 30 days of aging in the chamber (Figure 6b), the F-B laminate exhibits a significantly lower mechanical behavior compared to the unaged one. The points related to F-B batch are placed at the bottom right of the graph, indicating that the composite material has undergone a significant plasticization phenomenon with a clear reduction in the maximum stress as well as an evident increase in the deformation at maximum stress.

Furthermore, there is a clear deviation in performance compared to the G-A and GF-A batches (markers of these batches are positioned much higher on the left in Figure 6a) for which an acceptable stability of the mechanical behavior is noticed. Flax fibers, due to their hydrophilic nature, are strongly affected even after a short exposition to humid environments. The absorption of water in flax fibers is significant [46,47,53] and conveys diffusion phenomena, both in the matrix and at the fiber-matrix interface. Thus, the softening and plasticization of the NFRP occur prematurely with a significant decrease in performance.

Quite interestingly, all batch areas are located slightly at lower stress values. Furthermore, there is no significant increase in  $\Delta L @ \sigma_{max}$  values compared to batches B. This means that the degradation phenomena activated in the composite laminates, at first leads to a significant increase in the composites flexibility, and then to the stiffness reduction. In other words, the water absorption experienced by flax fibers, which could be considered as the main cause of this phenomenon, takes place at short immersion times [54]. For longer aging times, kinetically slow diffusion phenomena such as water permeation take place through both the matrix bulk and at the fiber/matrix interface. These last phenomena are responsible for the further decay of the mechanical performance of the pinned composite joint. This behavior is mainly evidenced by the batch F-C, which is located in the narrow area at the lower right of Figure 6c.

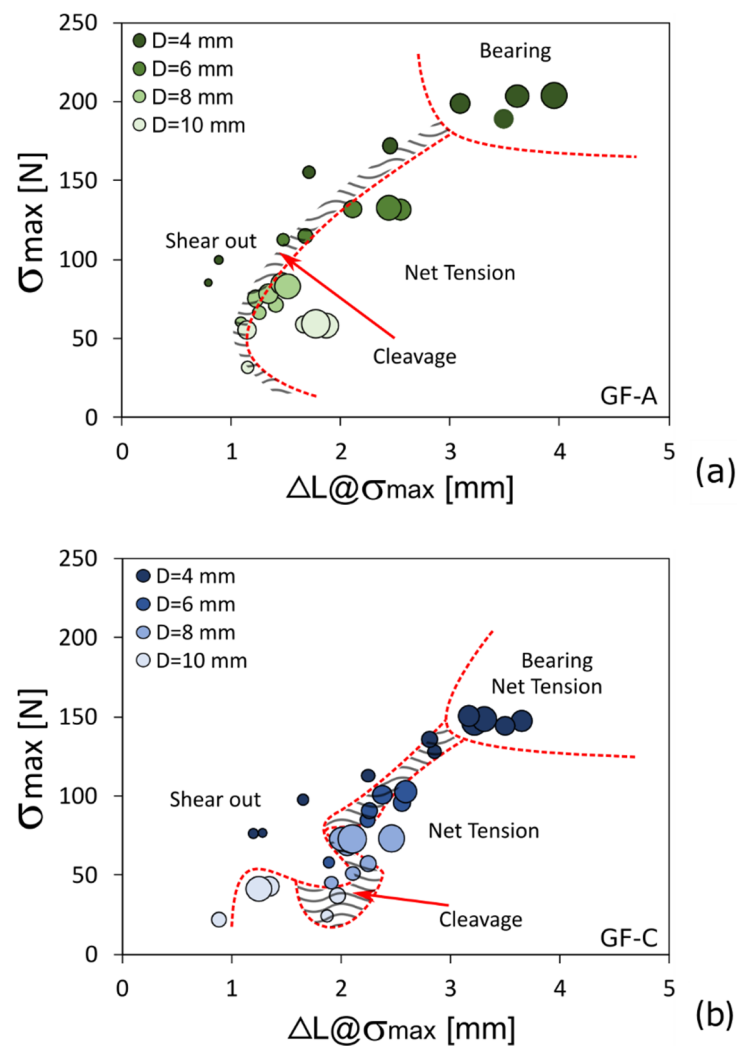
**Figure 7.** Failure mechanisms evolution in  $\sigma_{\max}$  vs  $\Delta L @ \sigma_{\max}$  plot at varying the salt-fog exposition time: (a) batch A (unaged samples) and (b) batch C (aging time: 60 days) for hybrid laminate, as reference.

The degradation phenomena induced by salt-fog exposition do not only involve a change in the laminate performance but they also affect, depending on the joint geometry, the failure mode [55]. In this regard, Figure 7 shows the experimental data of hybridized composite joints, at varying their geometry, clustered based on the fracture mechanisms that take place. Similarly to the previous figure, the marker size and color brightness indicate the free edge distance E and pin/hole diameter D, respectively. Dotted red lines were graphically added to discriminate better the failure mode transition.

Analyzing Figure 7a, referring to the GF-A batch, it can be observed that a good discrimination of clusters associated with the main fracture mechanisms is identifiable. In particular, the bearing is characterized by the highest strength and the greatest deformation at the maximum stress. This is attributable to the progressive compressive collapse of the composite that characterizes this fracture mechanism that favors a large displacement at break. Conversely, catastrophic fracture mechanisms such as net-tension and shear-out, can be associated with clusters located at lower  $\Delta L @ \sigma_{\max}$  values. In the transition zone between these two fracture mechanisms, a mixed fracture due to cleavage is detected. A similar topological map could also be found for the other batches.

Figure 7b refers to the GF-C batch, exposed for 60 days to salt-fog environment. Albeit the map topology is preserved, significant differences can be found. A clear shift of the failure mechanism clusters at higher  $\sigma_{\max}$  and lower  $\Delta L @ \sigma_{\max}$  values occurs. Furthermore, greater irregularity in the distribution of catastrophic fracture typologies takes place. Net-tension and shear-out exhibit occasionally interconnected clusters. Even the cleavage cluster expands, and it extends in a disordered way in the border area between the two mechanisms. This behavior indicates that aging conditions significantly affect the mechanical stability of the joint and the related fracture mechanisms. This implies that an explicit discrimination is detectable only between progressive (i.e., bearing) and catastrophic (i.e., shear-out and net-tension) mechanisms. The latter, although locally

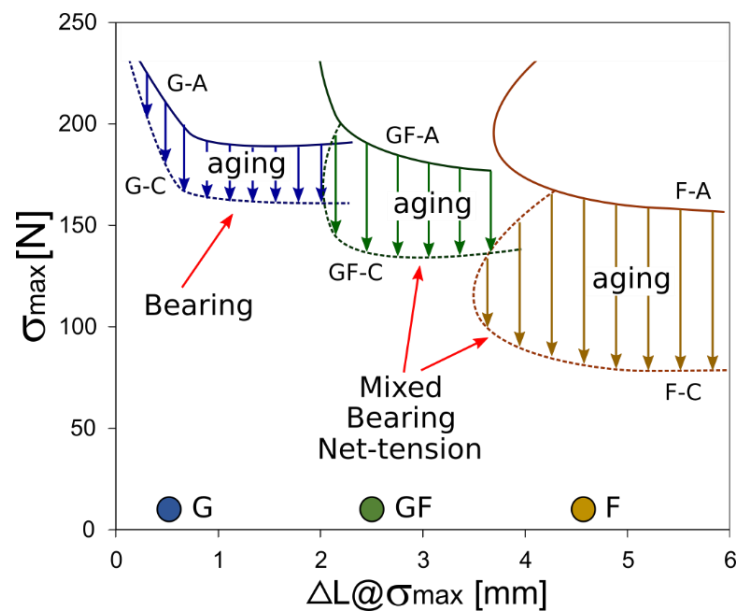
**Figure 8.** Bearing failure mechanism modification due to aging in  $\sigma_{\max}$  vs  $\Delta L@_{\sigma_{\max}}$  plot at varying stacking sequence.

In order to obtain further insights into the effect of the hybridization on the durability, in a salt-fog environment, of pinned composites, Figure 8 compares the progressive bearing failure modification area due to the aging in the maximum bearing stress ( $\sigma_{\max}$ ) vs displacement at maximum stress ( $\Delta L@_{\sigma_{\max}}$ ) plot. It is important to specify that a transition from bearing to a mixed bearing/net-tension mode occurred for the GF batch. On the other hand, no bearing fractures were observed for the F batch even at long aging times. Even for joints with low D and high E values, the fracture occurred by a mixed mode between bearing and net-tension mechanisms.

For the G batch, the bearing failure transition suffered a limited modification due to aging. Comparing the unaged state (solid blue line) with the aged one (dotted blue line) a slight reduction in performance can be identified (the arrows refer to the reduction induced by aging). The natural flax composite (i.e., F batch) shows an almost different behavior. Due to aging, the bearing area significantly decreased in magnitude, reaching  $\sigma_{\max}$  value of about 75 MPa, about 50% lower than the unaged one. It is worth nothing that the observed joint fracture was a mixed bearing and net-tension both in aged and unaged conditions.

The hybridization with glass fibers induced a beneficial effect on the bearing strength and failure mechanism in the flax laminate. The GF batch exhibited, in the aged condition, a bearing fracture mode with acceptable failure stress (above 170 MPa—solid green line). However, after 60 days of exposure in a salt spray condition, the composite underwent a mechanical decay, albeit limited, which led to a mixed bearing net-tension fracture and stress values approximately 20% lower than the unaged one. The evidence of the net-tension fracture can be associated with the reduction in the tensile strength of the flax natural fibers that tend to reduce, especially due to an environmental degradation, the failure strength limit due to this fracture mode [23]. Nevertheless, the hybridization allows preserving, partially, an acceptable mechanical stability of the joint. It is a suitable compromise in performance and durability between the full glass and full flax laminates (G and F batches, respectively).

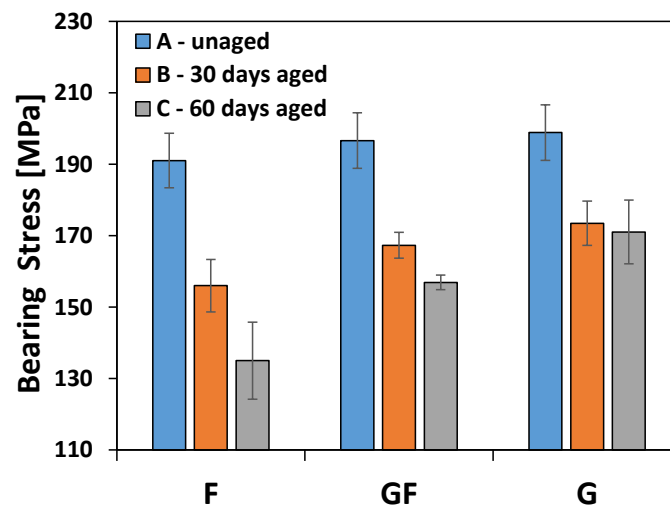
**Figure 9.** Bearing stress limits experimentally determined for all pinned laminates when varying the salt-fog exposition time.

Figure 9 shows the evolution of the stress limits for bearing fractures when increasing the exposition time to the salt-fog environment (i.e., 0, 30 and 60 aging days for batches A,

B and C, respectively) for all pinned laminates. This limit bearing stress was defined as the average maximum strength value considering only joint configurations that failed through bearing mode. In particular, this average value was determined for each batch and for each aging time.

A relationship between the bearing stress and aging time can be clearly identified. The bearing limit stress of F-B batch (i.e., aged for 30 days in the salt-fog environment) showed a reduction of about 18% compared to the unaged one (F-A batch). Furthermore, no bearing fracture was observed after 60 days of exposition in the salt-fog environment (batch F-C). All samples, in this batch, exhibited only a premature and catastrophic fracture by shear-out or net-tension modes, confirming the detrimental effect of the hostile environment on the mechanical stability and durability of joints. On the other hand, the full glass laminate exhibited a quite stable behavior. A reduction in bearing stress is identifiable of a maximum of about 14% due to 60 days of aging.

The hybrid unaged laminate (i.e., GF-A batch) is characterized by an intermediate average limit stress at bearing fracture among the investigated laminates. Nevertheless, it is worth noting that the limit bearing stresses of unaged samples are slightly different. Its mechanical performances undergo a clear decay induced by the degradative phenomena that are triggered during the salt-fog exposition. However, the presence of external glass skins in the stacking sequence allows to acquire an effective shielding action against the diffusion of water. This is confirmed by the non-catastrophic decay of performance as observed for the flax batch. Furthermore, a progressive bearing fracture occurs even at long aging times (i.e., batch C), thus avoiding the premature activation of unwanted catastrophic fractures (i.e., net-tension and shear-out).
