Polyethylene Luxation in an Oxinium Fixed-bearing Unicompartmental Knee Replacement Leading to Metallosis: A Case Reports for an Early and a Late Presentation

Introduction: Polyethylene (PE) subluxation is a rare complication after fixed-bearing unicompartmental knee replacement. We present two cases of PE luxation with a rapid onset of metallosis in a unicompartmental knee replacement made of Oxinium, one early presentation 3 months after surgery and the other case 6 years after.

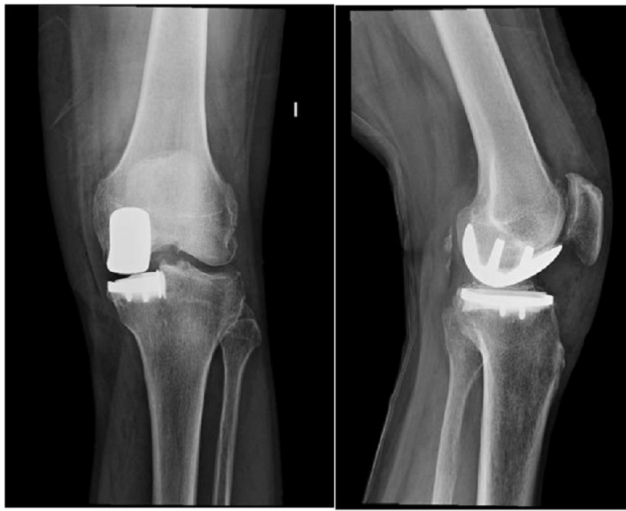
Figure 1: Case N°1 left knee anteroposterior and lateral view after medial fixed bearing UKA.

Smith and Nephew Inc., Cordova, TN, USA) (Fig. 1). Standard surgery was carried out with robotic assistance (NAVIO System, Blue Belt Technologies, Plymouth, MN), no complications were observed, and the patient was discharged 2 days later. He initiated standard rehabilitation, using two canes, weight-bearing as tolerated, and a full range of motion was encouraged.

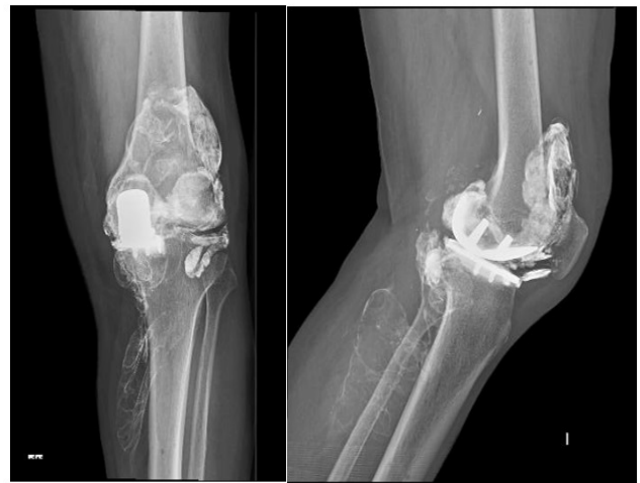
Figure 2: Case N°1 radiograph 3 months after UKA surgery. The PE is in the anterior knee compartment, and a radiopaque "cloud" is seen that compromises all knees and extends to the leg's posteromedial compartment, suggesting metallosis.

Three months after surgery, he requested an urgent consultation due to the acute onset of pain, while descending a stair, in the anterior portion of his left knee that compromises his ability to walk and knee flexion. A physical exam showed a swelling in the anteromedial compartment and a locked knee at 30° of flexion. Radiographs showed that the PE was luxated anteriorly and a radiopaque “cloud” that blurs the vision of the implants suggesting metallosis. Moreover, the radiopaque cloud extends to the posteromedial portion of the leg (Fig. 2). The patient did not report systemic symptoms associated with metallosis, and no signs of systemic involvement were found. The presence of metallosis suggests that the polyethylene (PE) could have been partially dislocated (subluxated) since the time of surgery, and the completion of its dislocation occurred when the patient experienced acute pain. This subluxation contributed to the accelerated wear that led to metallosis within a span of <3 months.

implants. The screening of ions in serum and urine has been proposed to evaluate the systemic compromise of metallosis, but it is not a widespread exam [4]. Nevertheless, until the last follow-up, both patients did not complain of these symptoms. There were signs of extra-articular metallosis in the radiograph (Fig. 2), the reason why there is concern about the eventual systemic compromise. However, there was no evidence of a direct relationship between systemic symptoms and extra-articular compromise of metallosis in an oxinium prosthesis [4].

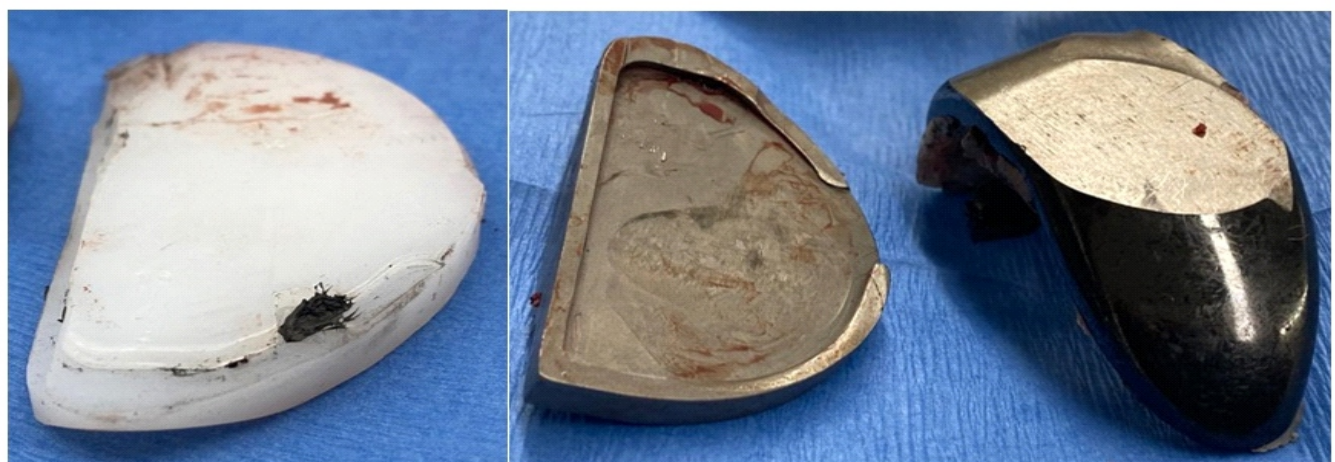
Figure 3: PE and tibial and femur components. The tibial component – in the middle – shows extensive wear, especially in the posterior aspect, and destruction of the engagement system of the PE.

Revision surgery was indicated. After the arthrotomy, abundant blackish liquid and metallic-like debris were deposited in the synovial tissue and capsule around the knee. The remaining polyethylene (PE) was extracted from the knee through the anterolateral portal. The tibial and femoral components presented extensive wear areas, suggesting extensive metal-to-metal contact, especially in the posterior and central parts (Fig. 3). The anchoring mechanism of the PE to the tibial component

was destroyed. Both components were removed, a wide synovectomy was performed, and a posterior stabilized total knee prosthesis was placed. The patient has evolved positively. Two months after the surgery, he presented with full extension, flexion greater than 110°, and walking without assistance.

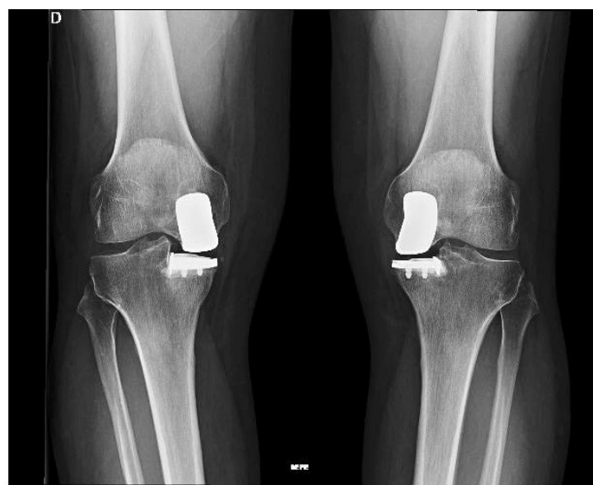
Figure 4: Case N°2 anteroposterior view after successful bilateral fixed bear UKA.

A 50-year-old male patient underwent a successful fixed-bearing medial UKA (Journey I, Smith and Nephew Inc., Cordova, TN, USA) (Fig. 4). After 6 years, he complained of an insidious onset of pain in the posteromedial side of his left knee. The pain progressively increased until it compromised his quality of life and limited the knee extension. Radiographs show similar findings than in case 1, but the radiopaque “cloud” was limited to the knee (Fig. 5), miming an arthrogram. The patient did not report systemic symptoms associated with metallosis, and no signs of systemic involvement were found.

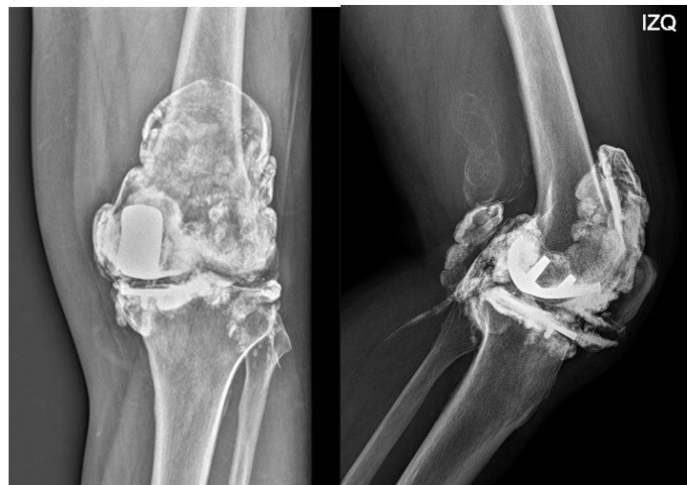
Figure 5: Case N°2 anteroposterior and lateral view after 6 years of medial fixed bear UKA. An extensive radiopaque cloud is shown that compromises the entire knee, and the PE can be seen in the anterior compartment of the knee.

Revision surgery was indicated. The PE was removed from the anterior compartment, an extensive synovectomy was performed, and both components were removed. The tibial and femur components had extensive wear, especially in the postero-central portion. A posterior stabilized total knee prosthesis was used.
