Case report

Total hip replacement failure due to adverse local tissue reaction from both ceramic abrasive wear and trunnion corrosion

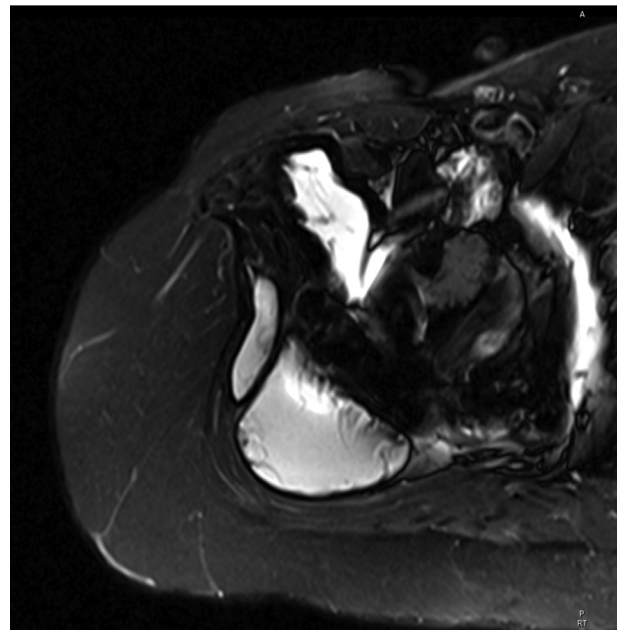
Figure 3. Pre-operative magnetic resonance imaging: axial T2 magnetic resonance imaging with hyperintense, complex, multiloculated, and heterogeneous cystic soft tissue tumor involving the right hip abductors. The pseudotumor measured $4.4 \times 6.2 \times 10$ cm at its largest dimension.
