Endourology

Thulium laser extraction of angioembolization coils in patient presenting with nephrolithiasis: A case report

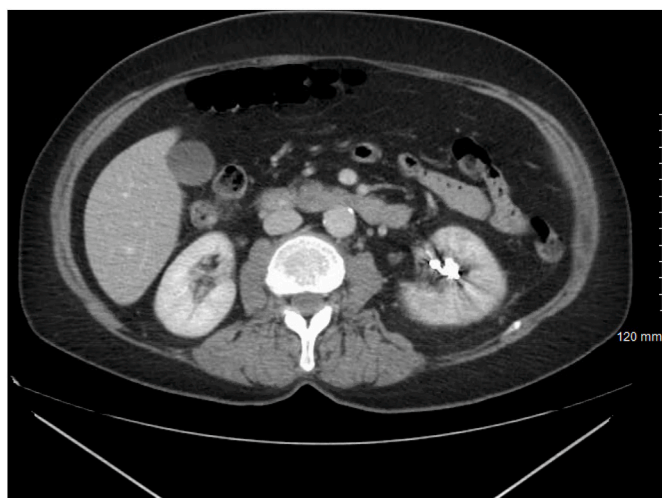
Fig. 1. Axial Standard CT showing 1cm renal stone in the lower pole of the left kidney.

The patient is a 66-year-old female with a history of nephrolithiasis, and prior PCNL complicated by AV fistula formation was admitted to the hospital secondary to obstructive pyelonephritis and a left lower pole collecting system stone just over 1 cm shown on CT scan (Fig. 1). Following her previous PCNL, she required subsequent selective renal artery angioembolization using metal coils due to AV fistula formation.

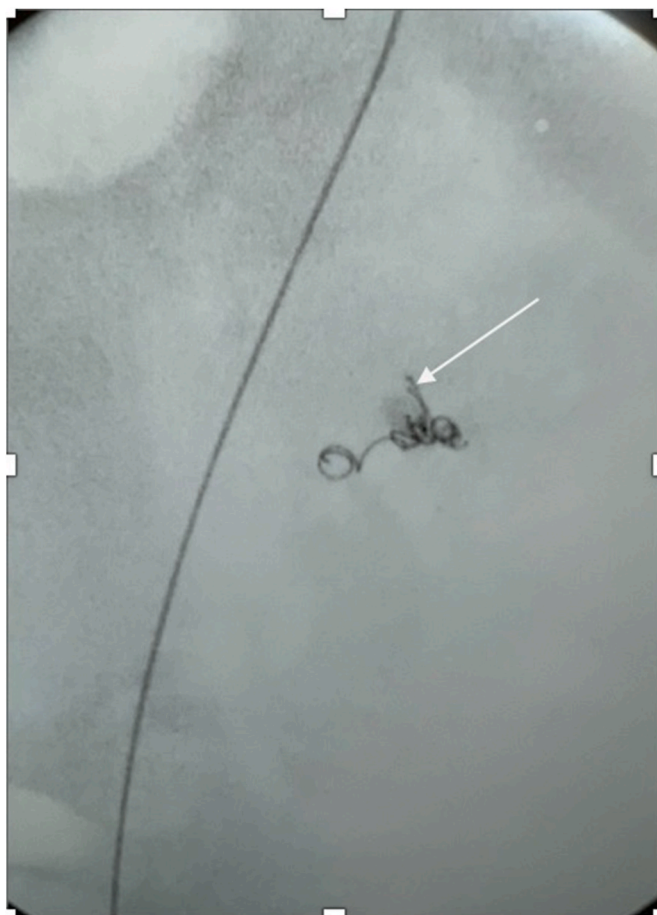
Fig. 4. Retrograde Pyelogram showing the same angioembolization coils after the initial laser lithotripsy. Arrow shows the tine which had erupted during lasering of adjacent stone now projecting up.

poly calyx. The thulium laser was employed for stone fragmentation within the lower pole calyx. During fragmentation, metal was found within the stone, which immediately raised concern for migration of the RAE coil. While fragmenting the edge of the stone that surrounded the metal, a portion of the stone was broken, exposing two metal tines projecting out of the renal tissue with the tips embedded in stone as well (Fig. 3). There were also two tines identified entering the lateral portion of the stone. At this point, the case was discontinued due to concern for potential significant renal injury caused by the metal tines of the angioembolization coils. The retrograde pyelogram at the end of the case showed the displacement of the metal tines that had erupted during the lasering of the stone (Fig. 4).
