# Anchor Site Fracture Following Arthroscopic Rotator Cuff Repair – A Case Report and Review of the Literature

**Introduction:** Fractures at the anchor site following arthroscopic rotator cuff repair are rare and only a few case reports have been described. We report two additional well-documented cases of this uncommon post-operative complication and provide a review of the current literature.

**Case Report:** A 48-year-old male underwent arthroscopic rotator cuff repair (ARCR) due to a massive rotator cuff tear. Nine weeks postoperatively, the patient suffered a humeral head fracture at the anchor site of the ARCR after trauma. Despite subsequent surgical treatment with open reduction and internal fixation, the patient demonstrates with excellent functional outcome scores at 2-year follow-up.

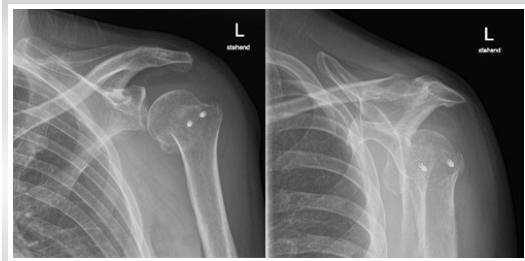
**Figure 1:** Radiographic examination in a.p. (a) and Neer view (b) showing an anatomical neck fracture of the proximal humerus (AO/OTA 11C1.3, Neer Type II) with a fracture line through the anchor site.

At 6-week follow-up, the patient showed an adequate range of passive motion and no signs of shoulder stiffness. Nine weeks postoperatively, the patient suffered a low-velocity trauma to his left shoulder. He presented to the emergency room with immobilizing pain rated 9/10 on the numeric analog scale. Radiographic examination (Fig. 1a, b) and a computer tomography scan (CT, Fig. 2a, b) revealed an isolated fracture of the proximal humeral head (AO/OTA fracture and dislocation classification 11C1.3) [16]. The fracture line was located right at the lateral site of the suture bridge construct close to the anatomic neck (Neer Type II, [17]). Due to a displacement of 1 cm, surgical re-fixation was advised.

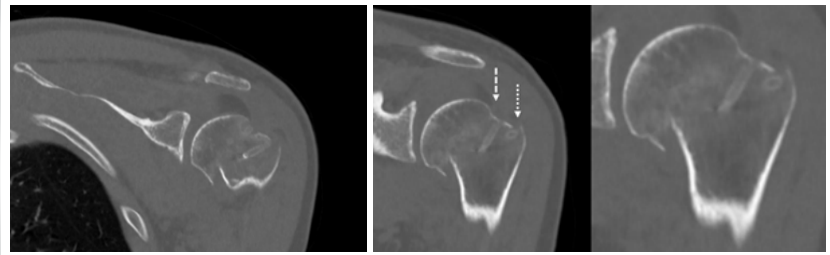
**Figure 2:** (a) CT scans in coronar sequence confirming the isolated fracture of the anatomical neck. While medial anchor site is covered in stable cortical bone (b, dashed arrow), the fracture line runs right along the lateral anchor site (b, dotted arrow).

Furthermore, since rotator cuff anchors were not implanted after drilling but pushing a punch into the bone, thermic osteonecrosis cannot explain the osseous instability at the anchor site. In osteosynthesis studies, a drill hole of 20% of the diameter of the bone is reported to reduce the bony stability by 40% [26]. In the presented case, the fracture lines accurately

passed through the anchor site. Conveniently, the use of two anchors at lateral site of the SB combines to a ratio of >20% of the bone dimension just below fracture line  $((2 \text{ mm} \times 5.5 \text{ mm})/39.3 \text{ mmCT-coronar} = 0.28; (2 \text{ mm} \times 5.5 \text{ mm})/33.7 \text{ mmCT-sagittal} = 0.33)$ .

The lateral anchor site seems to be weaker than its medial counterpart at least in SutureBridge technique [10]. While changes of the individual osseous structure unlikely play a role – the patient was younger than 50 years and male [27] – biomechanically, two factors may contribute to osseous damage even in younger patients: Strauss et al. reported that anchor positioning in Deadman's angle (45° to bone surface) not only leads to lesser pull-out strength and this may have contributed to an unfavorable force transmission in our case [28]. Considering correct position, bone quality and cortical thickness were best 15–21 mm below the summit of the greater tubercle in a CT microanalysis study of 13 specimens and therefore offer highest stability for anchor implantation. One may argue that this was not achieved in our case (approx. 8–10 mm below summit) and may have favored instability at a much weaker site [29]. Interestingly, the anchors with a larger diameter were used within the lateral row in our patient (5.5 mm vs. 4.75 mm, read above).

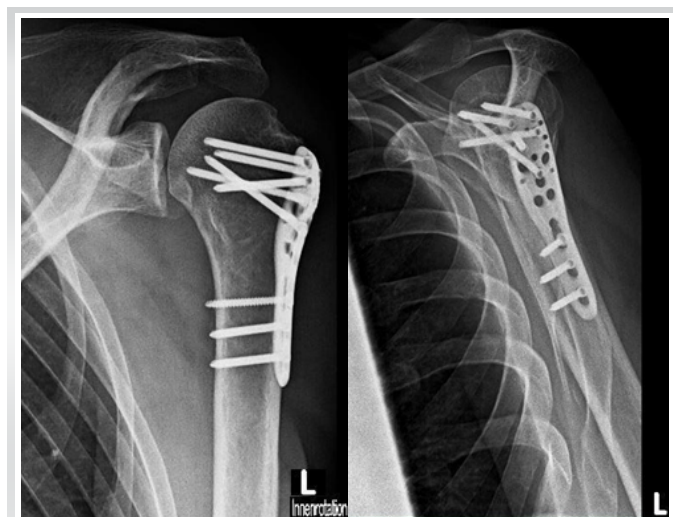
**Figure 3:** Radiographic examination in a.p. view (a: +internal rotation) and Neer view (b) showing osseous consolidation and anatomical alignment at 12-month follow-up.

At 3-month follow-up, the fracture healed anatomically with the patient’s passive range of motion already within normal limits. Constant score was 68 and improved to 92 points at 1-year and 2-year follow-up. Radiographic examination at 1-year follow-up revealed adequate fracture consolidation (Fig. 3a, b).
