Study on Microstructure and Mechanical Properties of Laser Welded Dissimilar Joint of P91 Steel and INCOLOY 800HT Nickel Alloy

Abstract: This investigation attempts to explore the weld characteristics of a laser welded dissimilar joint of ferritic/martensitic 9Cr-1Mo-V-Nb (P91) steel and Incoloy 800HT austenitic nickel alloy. This dissimilar joint is essential in power generating nuclear and thermal plants operating at 600–650 °C. In such critical operating conditions, it is essential for a dissimilar joint to preserve its characteristics and be free from any kind of defect. The difference between the physical properties of P91 and Incoloy 800HT makes their weldability challenging. Thus, the need for detailed characterization of this dissimilar weld arises. The present work intends to explore the usage of an unconventional welding process (i.e., laser beam welding) and its effect on the joint's characteristics. The single-pass laser welding technique was employed to obtain maximum penetration through the keyhole mode. The welded joint morphology and mechanical properties were studied in as-welded (AW) and post-weld heat treatment (PWHT) conditions. The macro-optical examination sh

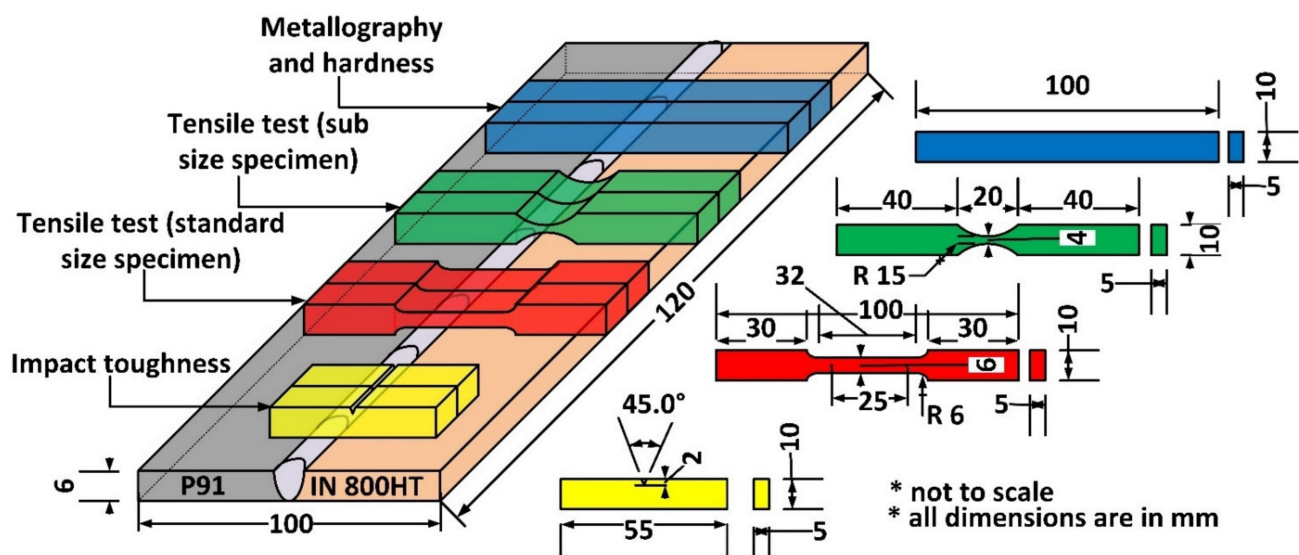
Figure 1. Schematic representing the extracted specimen's dimensions.

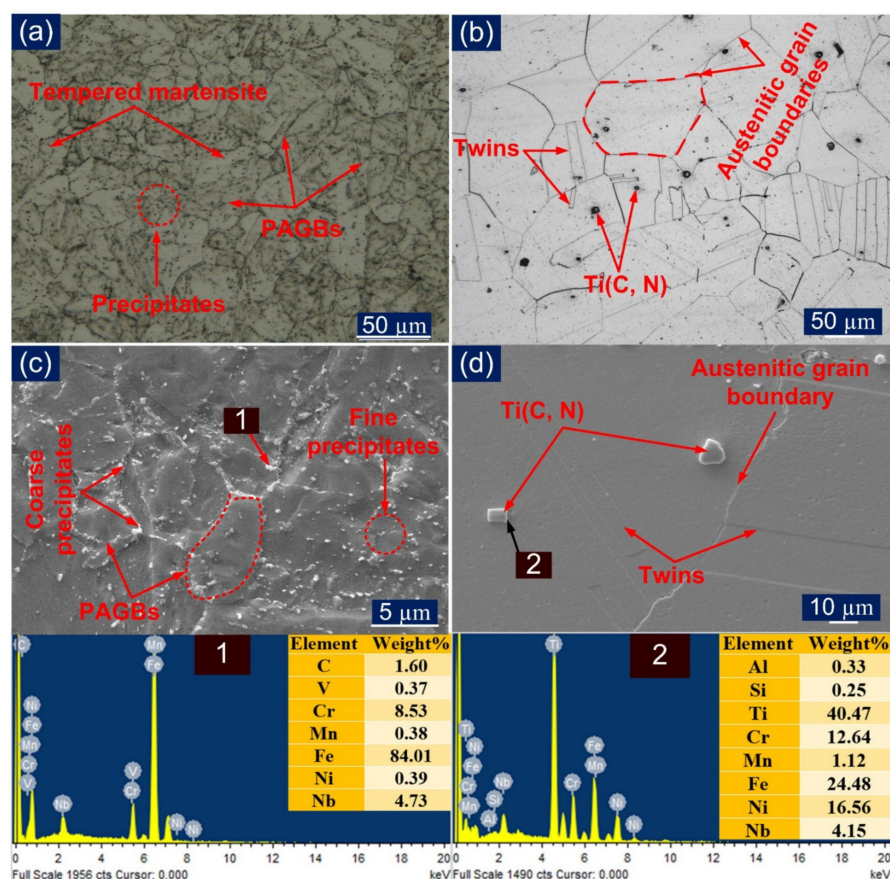
Figure 2. (a) P91 base metal optical microstructure; (b) Incoloy 800HT base metal optical microstructure; (c) P91 base metal microstructure under SEM with EDS spectra of the precipitate; (d) Incoloy 800HT base metal microstructure under SEM with EDS spectra of the precipitate.

The microstructure of the as-received material was observed under an optical microscope and SEM. The microstructure of P91 is shown in Figure 2a,c. This confirms the presence of the martensitic structure, which was obtained during the normalizing and

For Incoloy 800HT, the grain structure is presented in Figure 2b,d and was found to consist of a homogeneous and austenitic matrix phase. Somewhat larger grains were observed with an austenitic structure and abundant annealed twin formations [17]. The mechanical properties of both P91 and Incoloy 800HT are presented in Table 3. The large grain size in Incoloy 800HT is attributed to the solution annealed condition, which imparts a high strength, creep resistance, and high resistance to rupture at elevated operating temperatures.

Different precipitate particles were spotted in the matrix. The matrix was free from any detriment impurities, delta-ferrites, and sigma phase. The EDX analysis of precipitates found in the base Incoloy 800HT is shown in Figure 2d. The average grain size for Incoloy 800HT was found out to be $75.7 \pm 10 \mu\text{m}$ and the average size of PAGs of P91 was $13 \pm 5 \mu\text{m}$.

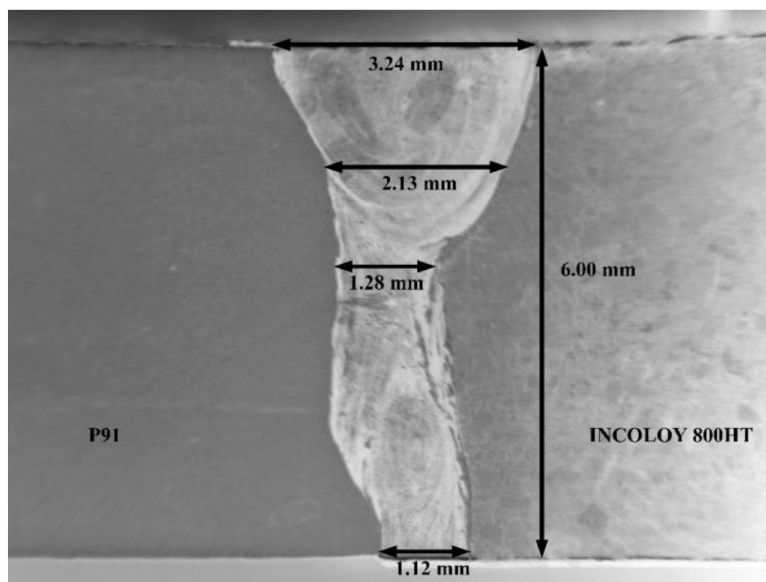
**Figure 3.** Macrograph of the laser weld bead.

The macrograph of the weld cross-section representing the weld bead geometry in Figure 3 hints at the keyhole mode of penetration caused by vapor pressure under high heat energy input in laser welding. Complete penetration with a narrow weld bead was obtained, as per the macrograph. Due to heat transfer and conduction, a grain size gradient was formed along the weldments. The weldment obtained and its different zones can be further characterized in detail.

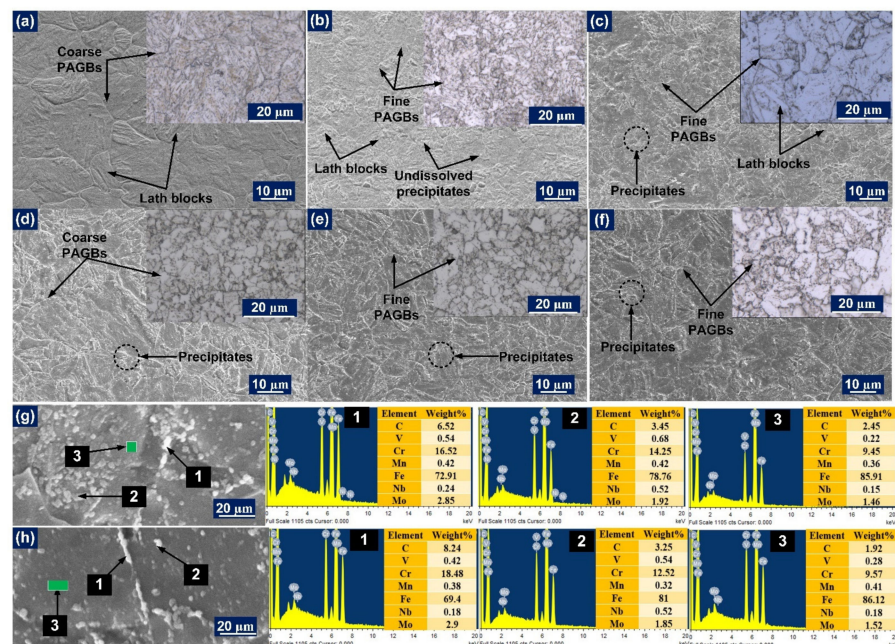
Figure 4. P91 HAZs in AW condition: (a) CGHAZ; (b) FGHAZ; (c) ICHAZ; after PWHT (d) CGHAZ; (e) FGHAZ; (f) ICHAZ; ICHAZ at higher magnification showing the location for EDS spectrum for (g) AW; (h) PWHT condition.

The micrograph of the P91 steel HAZ next to the WFZ consists of three different regions with an inhomogeneous microstructure. On the basis of the peak temperature experienced and phase transformations during the weld thermal cycle, the P91 HAZ typically consists of the coarse-grained HAZ (CGHAZ), fine-grained HAZ (FGHAZ), and inter-critical HAZ (ICHAZ) [41]. The microstructure of the CGHAZ adjacent to the WFZ experiences a much higher peak temperature than the A_{c3} , and, due to exposure at such a high temperature, precipitates are dissolved, which contributes to the reduction of the pinning force at the grain boundaries and results in grain coarsening, as shown in Figure 4a. The optical image Figure 4a shows the presence of the lath blocks and coarse grains in CGHAZ, which were also observed in the SE image. The SE image of CGHAZ also shows the complete dissolution of the particles. The region of FGHAZ and ICHAZ both have fine-grain structures and were difficult to distinguish by optical image, as shown in Figure 4b–d. However, the peak temperature experienced by the FGHAZ was higher or close to A_{c3} , and, for ICHAZ, it was in the range of A_{c1} to A_{c3} . That difference in peak temperature experienced by the FGHAZ/ICHAZ leads to the variation in the overall fraction area of the precipitates and final microstructure. FGHAZ exhibits the untempered

martensitic microstructure and partial dissolution of the carbide precipitates due to the lower peak temperature and results in the formation of the fine PAGs compared to CGHAZ Figure 4b. The undissolved carbide precipitates in FGHAZ show the coarsening nature and are marked in Figure 4b. In ICHAZ, the lower peak temperature results in the partial transformation of the austenite and the negligible dissolution of the carbide precipitates. This results in the final ICHAZ microstructure which exhibits the complex structure of the untempered martensite and austenite transform products (ATP), as given in Figure 4c. Although all of the regions of P91 HAZ of the weldments differ significantly in their PAGs, the fraction area of the precipitates, and the final microstructure, after PWHT the phase of each zone was basically the same and consisted of the ferritic-carbide mixture, i.e., tempered martensite and carbide precipitates with different tempering degree depending on the peak temperature experienced during the welding cycle. The region of the HAZs of P91 steel after the PWHT is mentioned in Figure 4d–f. After PWHT, however, more precipitates evolved at the grain boundaries and matrix. This caused softening across the HAZ due to a reduction in solid solution hardening [42]. The CGHAZ, after PWHT, exhibit the coarse PAGs in the tempered martensitic matrix (Figure 4d: optical image) along with newly evolved carbide and carbonitrides precipitates along the boundaries and inside the matrix (Figure 4d). The evolution of the new precipitates was also observed in FGHAZ and ICHAZ, as given in Figure 4e,f. The higher magnification image was captured in the ICHAZ for both AW (Figure 4g) and PWHT (Figure 4h) conditions to observe the decoration of the particles along the boundaries and inside the matrix. The image also shows the morphology and distribution of the precipitates inside the matrix and is also utilized for the EDS spectrum. The EDS spectrum of the white particles (Figure 4g: AW) decorated along the PAGBs shows the higher weight percentage of the Cr (16.52%) and Mo (2.85%) which ensure the presence of the secondary phase carbide particles that are enriched with Cr and Mo. The white particles inside the matrix show chromium (Cr) and molybdenum (Mo) as major elements, along with vanadium (V) and niobium (Nb). The EDS spectrum of the matrix is represented at point 3. A similar observation was also observed after the PWHT and is represented in Figure 4h. It is also well known from other studies that P91 steel contains mainly intragranular MX precipitates enriched with V and Nb, and intergranular $M_{23}C_6$ precipitates at PAGBs and sub-grain boundaries mainly enriched with Cr and Mo.

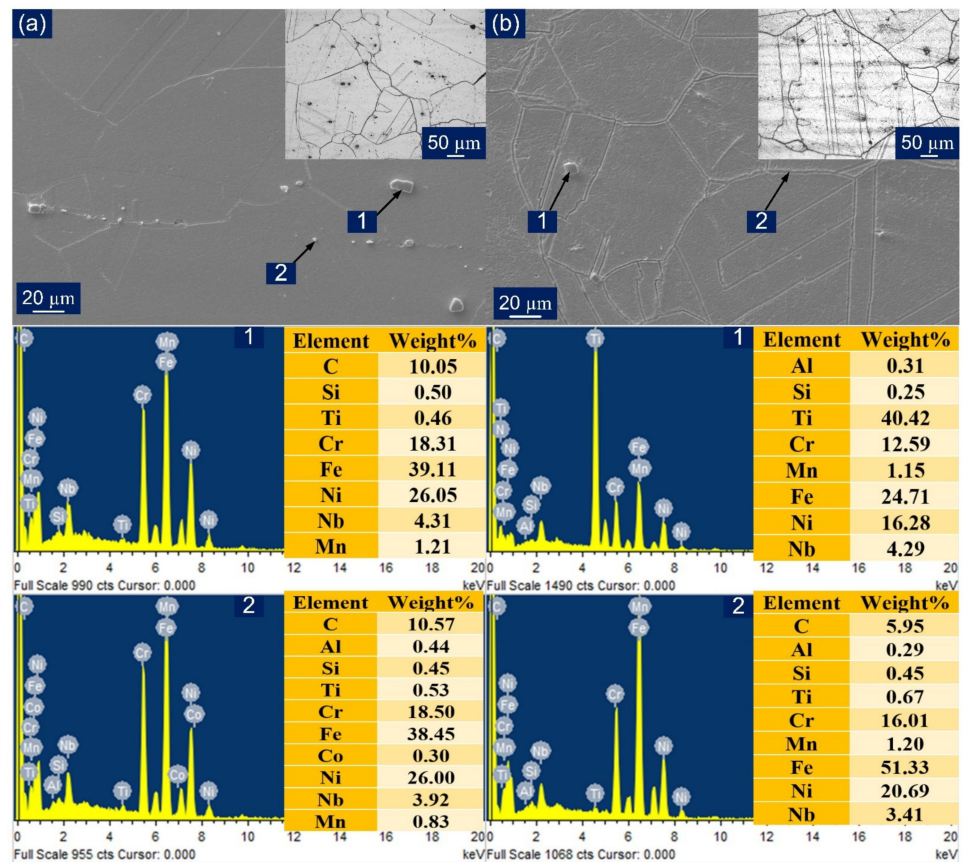
Figure 5. (a) Incoloy 800HT HAZ in AW condition with EDS spectrum for precipitate observed in AW condition; (b) Incoloy 800HT HAZ in PWHT condition with EDS spectrum for precipitate observed in PWHT condition.

While a coarse grain can be observed near the weld fusion boundary of Incoloy 800HT, a very narrow and indistinguishable HAZ was formed owing to its comparatively lower heat conductivity. The microstructure of Incoloy 800HT was found to be constant and homogenous in the welded state. The grains that are near to the weld fusion boundary of Incoloy 800HT are classified as CGHAZ (Figure 5a,b: optical). The presence of Ti(C,N) is visibly peaked in Figure 5a. The EDS spectra result for the thickened grain boundary with the possibility of grain boundary liquation is shown in Figure 5b via spectrum at point 2; a high Cr percentage can be inferred to the formation of $M_{23}C_6$ precipitate near grain boundaries. However, the PWHT performed for this study has not shown any effect on the Incoloy 800HT base metal and weld fusion boundary, as the recommended PWHT temperature for this is 820 °C, which is higher than the recommended and performed PWHT temperature for P91 weldments [43]. The presence of Cr, Fe, Al, Ti, and Nb in the alloying composition of Incoloy 800HT contributes to solid solution hardening. In addition, the controlled presence of the γ' phase along with the existence of different carbide phases contributes to precipitation hardening.

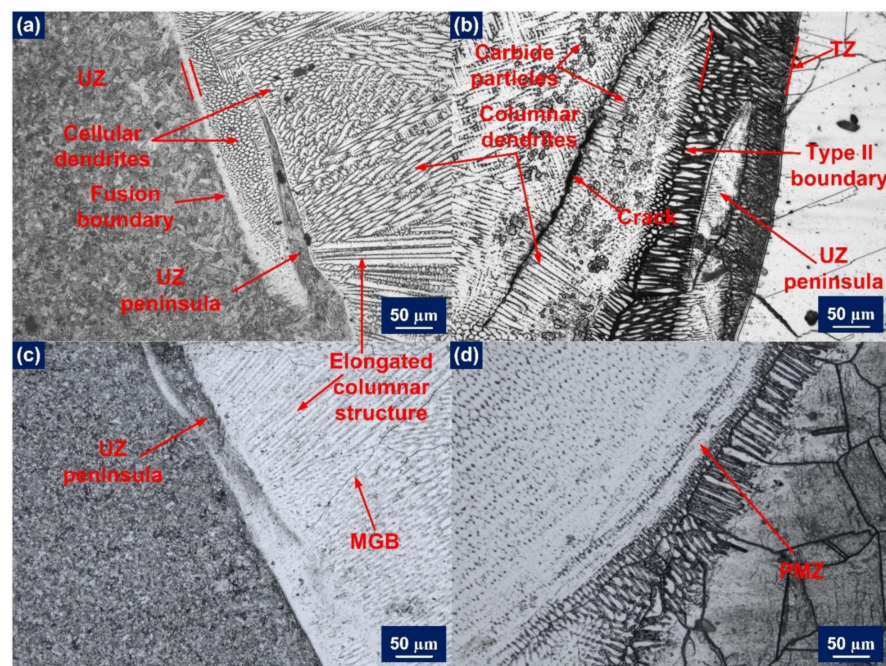
Figure 6. Optical image showing weld fusion boundary of (a) AW P91 side; (b) AW Incoloy 800HT side; (c) PWHT P91 side; (d) PWHT Incoloy 800HT side.

The solute segregation phenomenon can be observed at the macroscopic level near the fusion boundary during constitutional supercooling. There is a noticeable inhomogeneity present in chemical composition distribution and microstructure near the weld metal fusion boundary. Every autogenous weld is known to exhibit epitaxial growth, but the nature of a dissimilar weld between austenitic (FCC) metal and martensitic (BCC) metal leads to the formation of a Type II boundary parallel to a fusion boundary that reduces the possibility of epitaxial growth [44]. Figure 6a gives a clear illustration of the AW P91 weld interface in which the fusion boundary, beach or unmixed zone formation, and growth of cells and dendrites can be clearly acknowledged. The presence of macrosegregation can also be established in the form of a peninsula, islands, and beaches. In Figure 6b, the AW Incoloy 800HT weld fusion boundary is illustrated. The illustrated weld fusion boundary has a comparatively thicker transition zone (TZ) after the fusion line [45]. It also has a columnar structure, peninsula, and unmixed or partially mixed zone (PMZ) formation. The difference in the melting temperature of the employed base metals causes the formation of UZ or PMZ. The Incoloy 800HT HAZ has shown thickening of the grain boundaries very adjacent to the fusion line, leading to precipitation of the Ti enriched particles [46]. Similar results were confirmed in the PWHT state. As presented in Figure 6c, the PWHT P91 weld fusion boundary has the unmixed zone and UZ peninsula formation. And in Figure 6d, PWHT Incoloy 800HT weld fusion boundary has explicit PMZ formation and HAZ grain boundary thickening. PWHT does not have any effect on the weld fusion boundary at both sides but only tempers the P91 HAZ martensite.

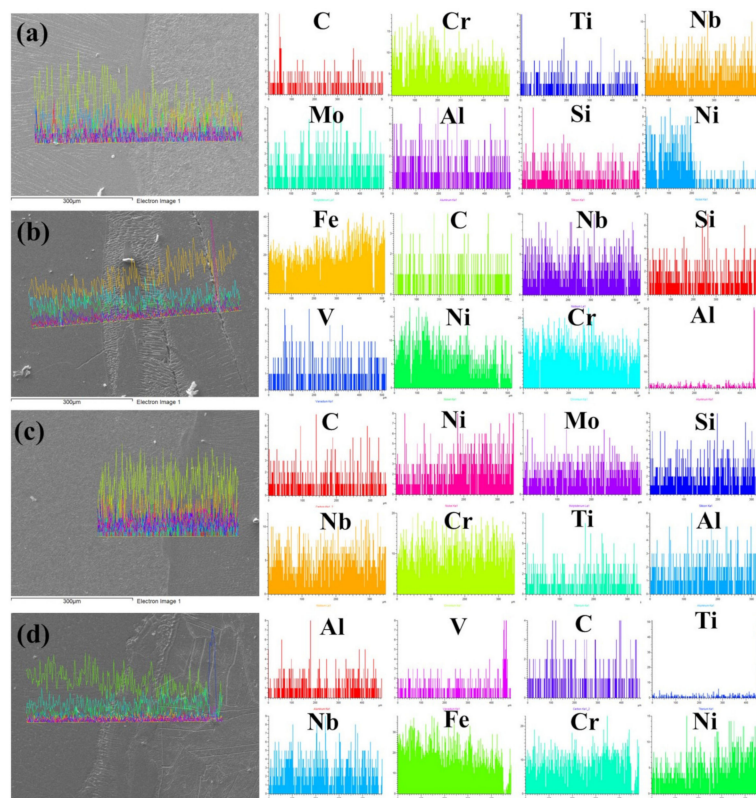
Figure 7. Line map EDS analyses along (a) AW P91 weld fusion boundary; (b) AW Incoloy 800HT weld fusion boundary; (c) PWHT P91 weld fusion boundary; and (d) PWHT Incoloy 800HT weld fusion boundary.

As weld fusion boundaries are crucial sites for solute segregation to occur, further analysis of elemental distribution across them was done through EDS linear spectra. Figure 7a has shown a decrease in nickel and chromium composition from weld to base metal P91 in the AW condition, which corresponds to the P91 composition. A slightly increased Mo concentration in the unmixed zone near the fusion boundary was observed. A sudden carbon peak suggests the presence of carbide particle precipitate in the weld zone. If this is noticed to be corresponding to a carbon peak, there is Si peak emerging which could be indicative of M_6C formation. In the Incoloy 800HT interface, as shown in Figure 7b,

expected peaks were obtained for Ni, Cr, and Fe, as per the metal composition. A sudden increased appearance of Al could confirm the presence of the γ' phase. Interestingly, the PWHT weld fusion boundary of P91, shown in Figure 7c, does not show any significant change in compositional behavior, but a constant distribution of chromium across the weld fusion boundary was witnessed. In the PWHT weld fusion boundary of Incoloy 800HT (Figure 7d), all elements confirm the discussed behavior, and no particular change corresponding to the PWHT was observed. However, in Incoloy 800HT HAZ, a rise in V and Ti can be seen at the spotted precipitate, but no change or peak in carbon concentration was present corresponding to a Ti rise. This confirms the presence of the TiN particles.

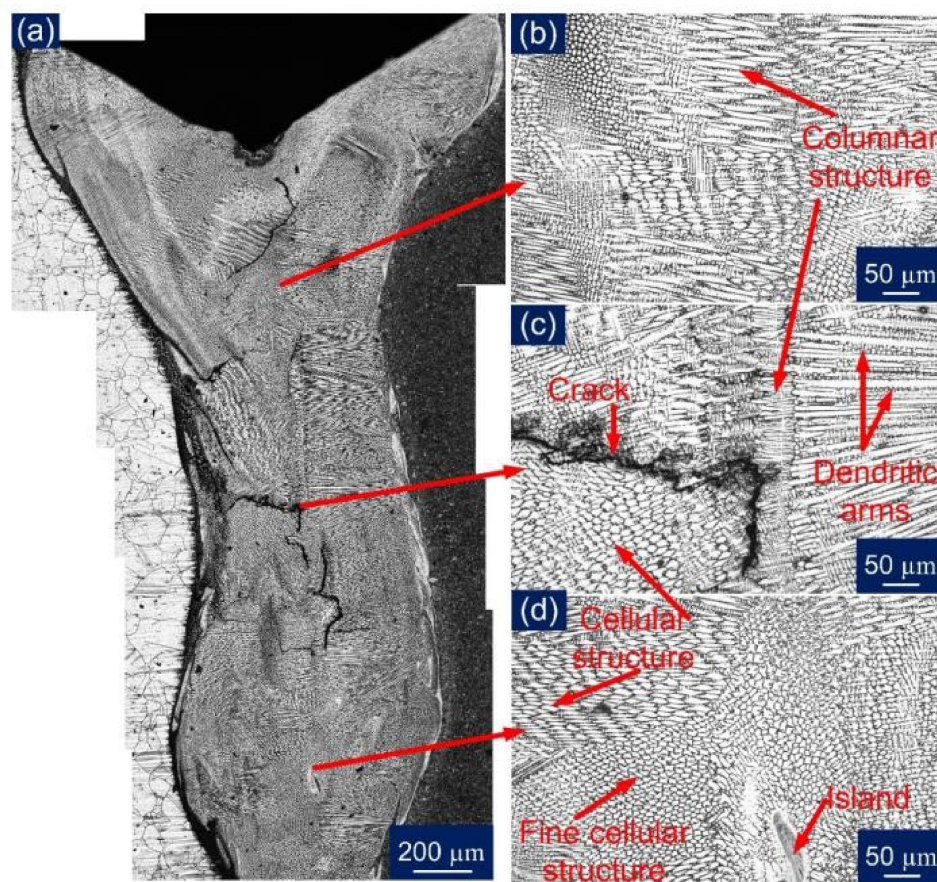
Figure 8. Optical images for: (a) WFZ in AW condition; (b) top WFZ; (c) WFZ mixed zone; (d) bottom WFZ.

The optical images were captured for the entire WFZ for detailed analysis, as shown in Figure 8. The different austenitic structures obtained in the austenitic matrix of the WFZ can be categorized on the basis of the solidification mode. The solidified microstructure in the WFZ is controlled by the growth rate (R), temperature gradient (G), degree of the constitutional supercooling, and alloy composition. The ratio G/R determines the solidification mode, and G^*R influences the size of the structure. The growth occurs from unmelted solid grains of the base metal; hence the G/R ratio is higher at the fusion boundary. The degree of constitutional supercooling affects the temperature gradient, transforming the solidification mode to form cellular, columnar, and equiaxed dendrites. The solidification tends to proceed from the interface to the WFZ. Similarly, different dendritic structures were obtained in the WFZ. It can be perceived, from Figure 8a, that in the formation of the different structures throughout the WFZ, the columnar growth predominated near the base metal interface, and the solidification mode then changed to the cellular and fine cellular structure in the WFZ. Figure 8b depicts a mixed zone in the WFZ where different dendritic morphologies exist. The dendritic arms and inter-dendritic cores

can also be observed where segregation of alloying elements occurs. Figure 8c illustrates the solidification cracking phenomenon observed along the solidified grain boundary (SGB). The dominant presence of different cellular structures and an unmixed zone ‘island’ (Figure 8d) were also spotted near the bottom of the WFZ. The different cells or dendrites were separated by a boundary that has a different composition from the bulk weld fusion zone, due to solute redistribution known as the solidification subgrain boundary (SSGB). The intersection boundary of such a similar group of subgrains or cells can be described as a solidification grain boundary. At the same time, a high-angle misorientation SGB whose crystallographic component migrates away from its compositional component can be described as a migrated grain boundary (MGB).

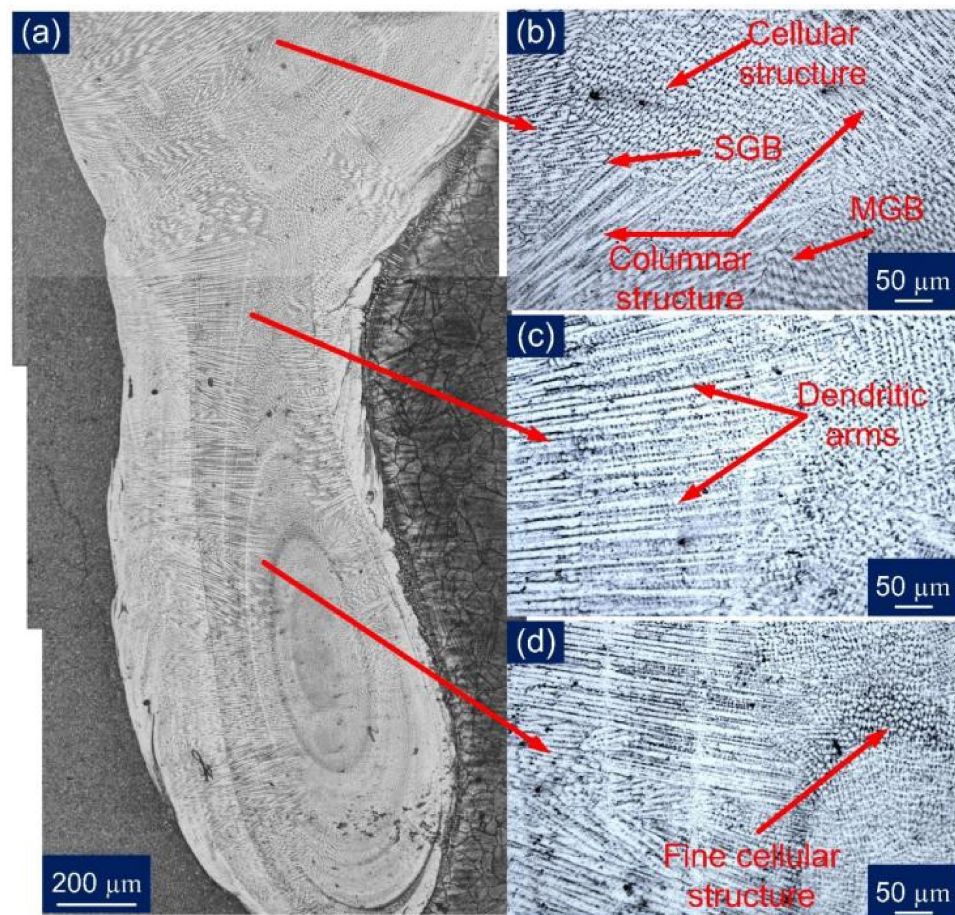
Figure 9. Optical images for: (a) WFZ in PWHT condition; (b) top of the WFZ; (c) WFZ mixed zone; (d) bottom WFZ.

Further, the comparative analysis was completed for a PWHT WFZ. However, being austenitic in nature, it did not respond to PWHT. From a stitched Figure 9a, though, it can be assumed that cracks were not present along the overall weld length, as no sign of cracks were there in the few specimens observed. Figure 9b–d also confirms the presence of discussed solidification modes as in the observed top WFZ groups of cellular and columnar structures are indicated with SGB and MGB. It was concluded, from the optical image study, that inhomogeneity was present in the WFZ to a significant extent; hence the inter-dendritic areas were further characterized using EDS analysis.

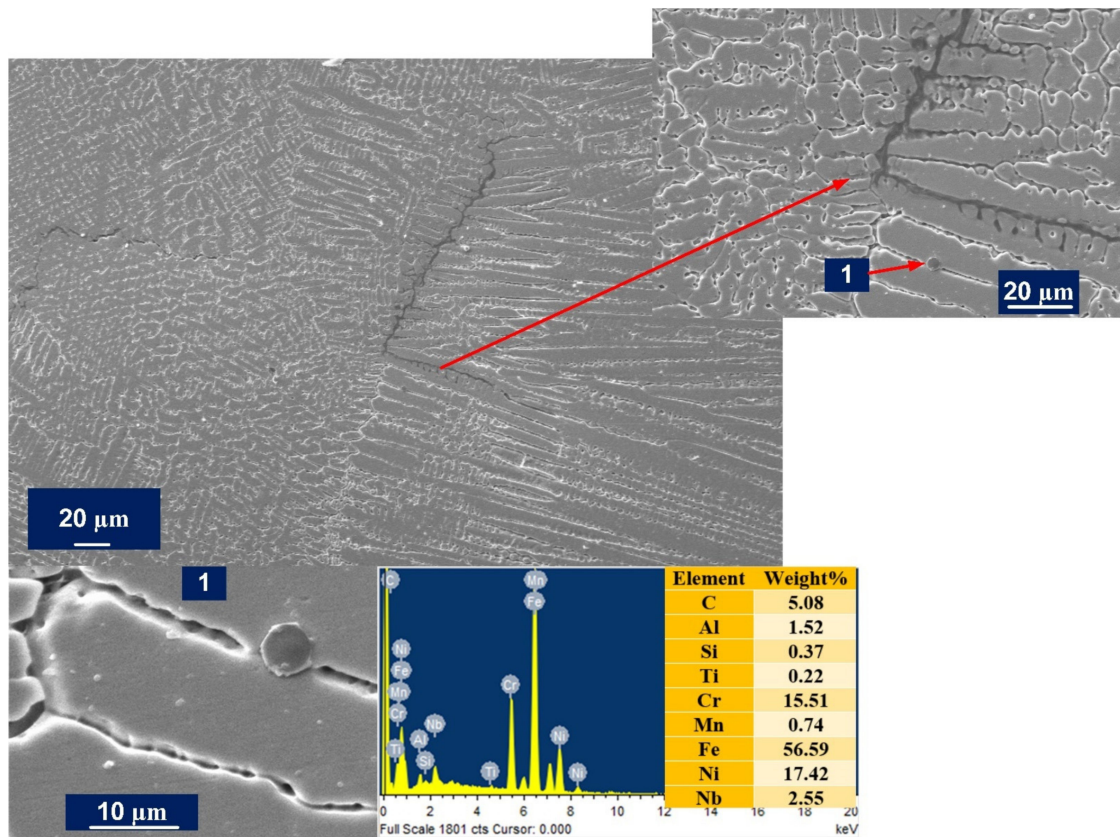
Figure 10. SEM micrograph cracks in AW specimen WFZ and EDS spectra of precipitate observed in the dendritic core region.

The solidification cracks were observed in the WFZ along the grain boundaries, as shown in Figure 10, and the EDS analysis suggests the particle might be a chromium carbide. However, Figure 9a indicates no cracks in the WFZ. This could suggest the cracks were not uniformly distributed along the welded joint. In Figure 8a, the crater at the very top indicates that, under the sudden shock of the high temperature at the start, the initial location under the focus of the laser beam—the area to be joined—might have

experienced cracking, possibly in a limited area only. The major cause for this could be the presence of low melting eutectic constituents forming elements, i.e., Nb, Ti, and Si. However, no liquation cracking was observed in the HAZ, due to the fine and coarse microstructural differences of the base metals. During solidification, the segregation of Nb occurred in the dendritic areas, as shown in Figure 11. As the eutectic reaction occurs, the formation of γ /NbC and γ /Laves constituents is reported to take place and this expands the solidification temperature range, leading to uneven cooling and cracking [47]. Nickel has a high affinity for sulfur to form nickel sulfide (NiS) along the grain boundaries and is considered to be the main cause of hot cracking in Incoloy 800HT during welding [17]. Type 1A cracks were observed in the weld region only, and no crack formation was witnessed in the HAZ regions of either parent metal. More cracks were observed in the weld region near to Incoloy 800HT side interface, which again reflects the susceptibility of Incoloy 800HT to hot cracking.

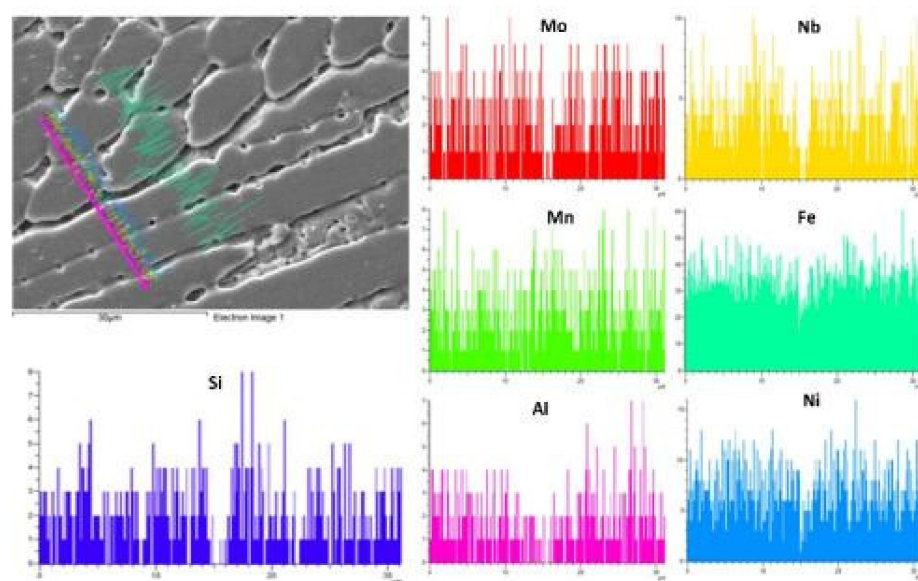
Figure 11. Line map EDS analysis across the interdendritic cores in the weld region.

In Figure 11, the microsegregation of Mo, Si, and Fe along dendritic core and subgrain boundaries in the interdendritic region can be observed. Meanwhile, the P91 side of WFZ majorly evolved elongated cellular and columnar dendrites. The fusion structures were formed as per the solidification rate, which is affected by the material's physical and chemical properties and, also, the keyhole mode. Rapid heating and cooling causes the cellular structure to change into a dendritic structure. The keyhole causes a low transfer of heat through the interface to the base metal, which also creates thermally generated stresses. In the weld region, grain boundaries were found to be rich in Ti, Si, and Nb concentrations. These elements tend to produce complex solidification temperature changes at the grain boundaries. Si concentration which was segregated, as shown in Figure 11, was found in

higher concentrations in fusion zone, and this plays a crucial role in hot cracking. As the columnar dendritic structure was observed in the WFZ in a large quantity, it is possible that the cracks were observed alongside them, as depicted in Figure 10. Carbon affects the formation of a higher columnar dendritic structure, which causes partial dissolution of precipitates. Fewer precipitates were observed in the WFZ as Ti consumed C present and its carbide transferred in the molten pool and accumulated near the Type II boundary.

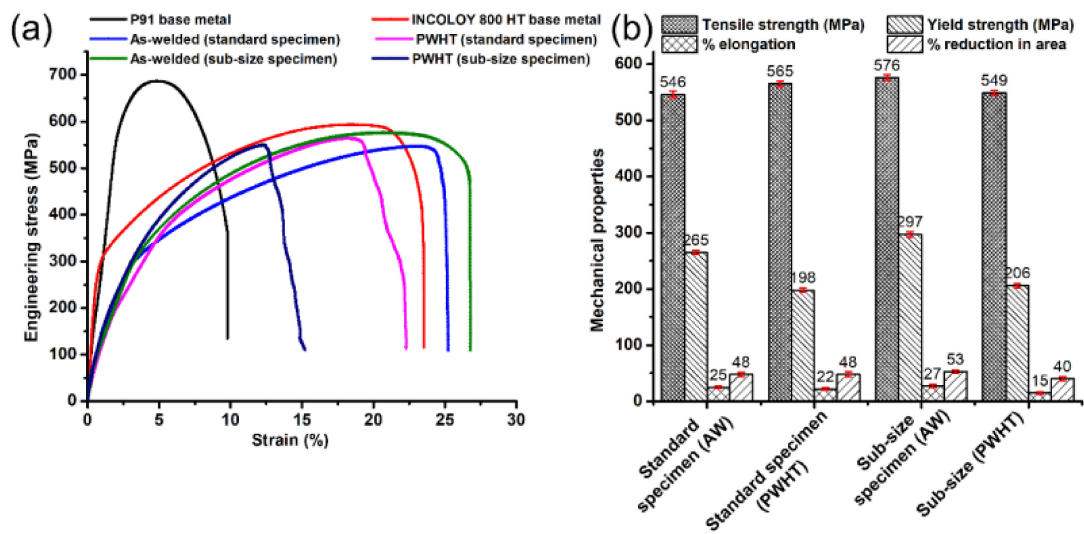
Figure 12. (a) Engineering stress-strain curves for performed tensile tests, (b) variation in mechanical properties for different conditions of the welded joint.

The tensile tests were conducted on the transverse tensile specimen, and the test results are mentioned in Table 4. The trend of stress and strain can be observed and compared through the engineering stress-strain obtained, as shown in Figure 12a. The variation in tensile properties is shown in Figure 12b. The tensile strength of the AW joint (standard specimen) was measured 546 ± 6 MPa, which was lower than the tensile strength of both the base metal P91 (687 ± 8 MPa) and Incoloy 800HT (593 ± 5 MPa). In the AW condition, the fracture was observed in the region of the Incoloy 800HT HAZ, as shown in Table 5. After the PWHT, the fracture occurred in the region of the Incoloy 800 HT base metal with a tensile strength of 576 ± 5 MPa, which was still lower than the P91 and Incoloy 800 HT base metal. However, a fracture from the region of the Incoloy 800 HT base metal ensures that the joint is safe for USC boiler service after the PWHT. The percentage (%) elongation of the welded joint was also measured and found to be higher than the Incoloy 800 HT base metal for both AW ($25 \pm 2\%$) and PWHT ($27 \pm 3\%$) conditions. The yield strength of the welded joint was measured as 265 ± 4 MPa and 297 ± 5 MPa for the AW and PWHT joint, which was close to the yield strength value of the Incoloy 800HT base metal (285 ± 4 MPa). Base metals exhibited the highest tensile and yield strength, while the welded specimens have shown resembling results, which are reported in another study [48]. For a sub-size specimen, the fracture was observed in the center region of the WFZ, and the strength was measured as 565 ± 5 MPa and 549 ± 4 MPa for AW and PWHT conditions, respectively. The failure from the center region of the WFZ might be due to the presence of the solidification cracks, which showed the sudden propagation just after the yielding. Still, with the lower yield strength observed in AW and PWHT conditions, tensile strength was obtained in the reported range. This might suggest that the cracks were only dominant near the starting region of the weld bead due to the instability caused by the initiation of the keyhole and high heat input, or the liquid metal may have filled the cracks to slightly heal them, as represented in Figure 13a. It can be visualized from Figure 13b that there was backfilling as the major compositional elements in the area mapping analysis were evenly distributed in the region. Figure 14a–c depicts the crack along with the columnar dendritic microstructure, and the magnified view of the region shows the re-solidification in the crack Figure 14b–d [44]. The percentage of elongation measured for sub-size specimens were 198 ± 3 MPa and 206 ± 4 MPa for AW and PWHT, respectively, which was lower than the corresponding values of a standard tensile specimen. The percentage of elongation was also measured as lower than the standard tensile specimen, and was $22 \pm 2\%$ and $15 \pm 2\%$ for the AW and PWHT joint (Figure 12b).

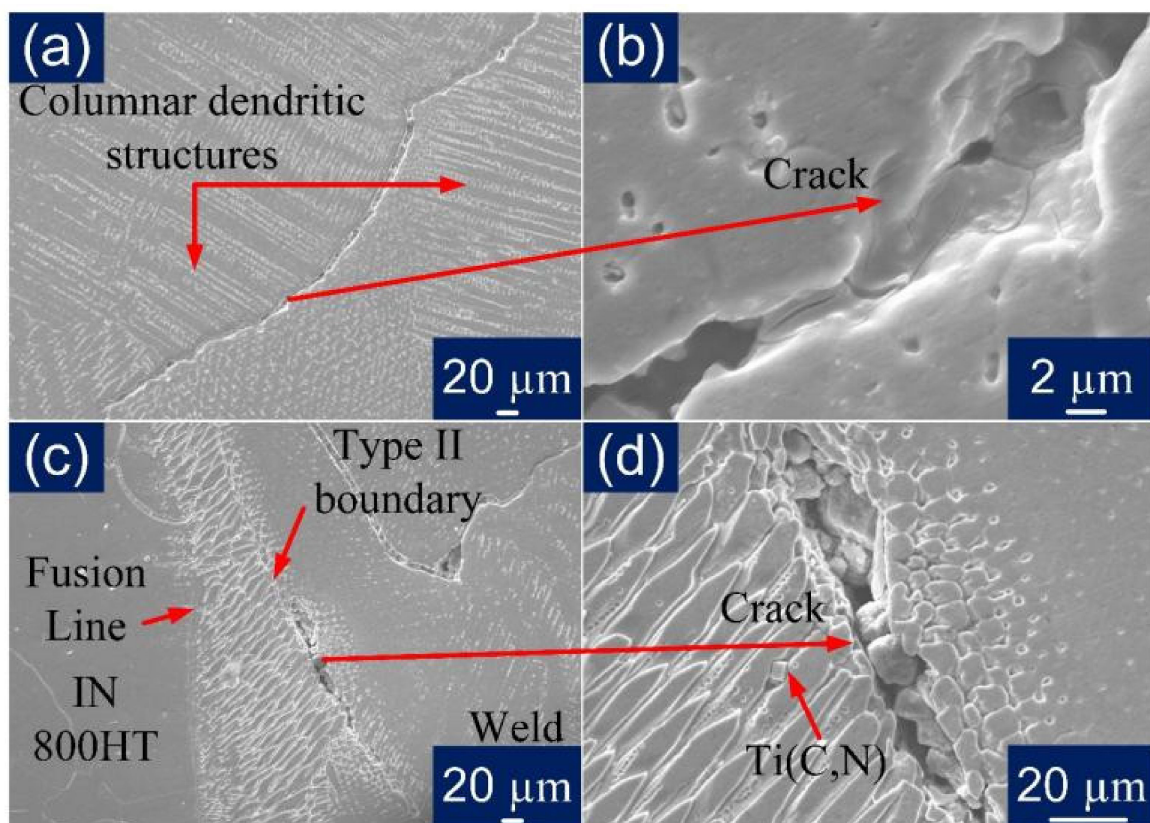
Figure 14. SEM micrograph for PWHT specimen (a) WFZ, (b) crack along SGB, (c) PWHT Incoloy 800HT fusion boundary, (d) crack along Type II fusion boundary.

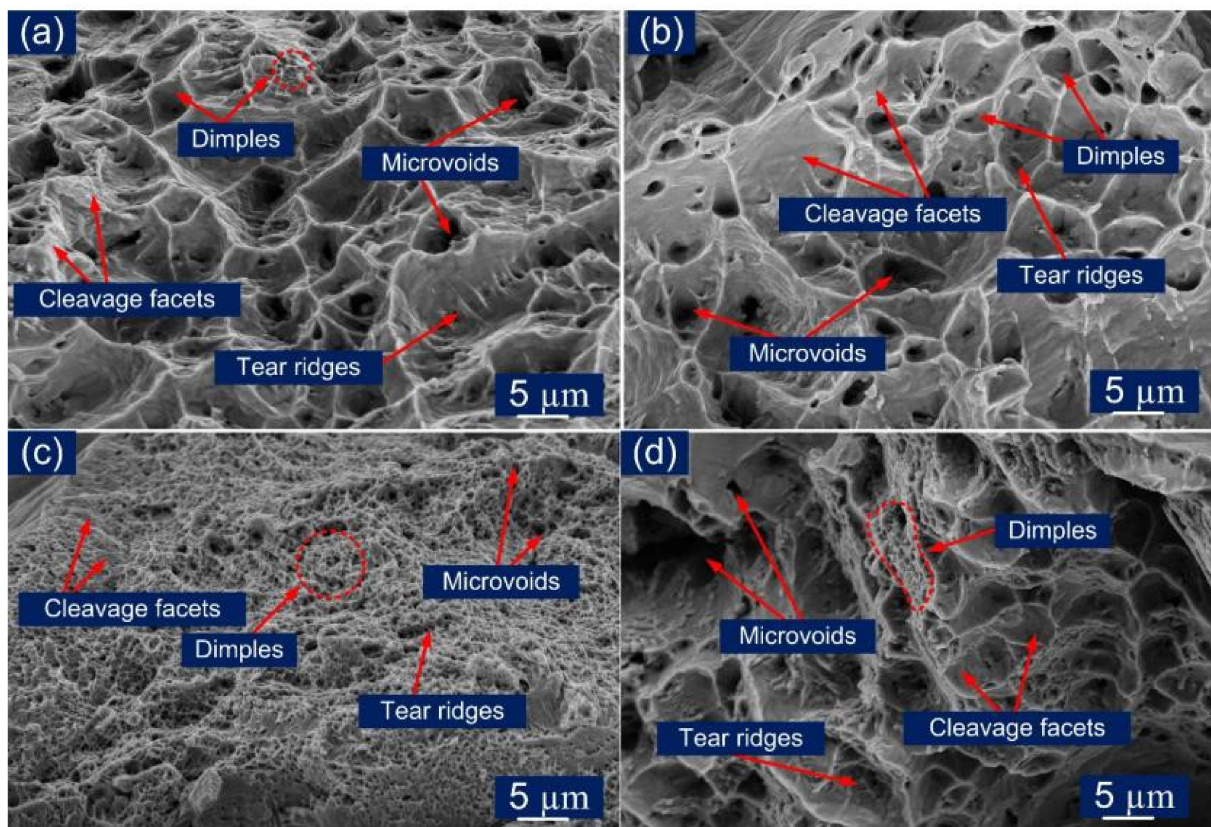
Figure 15. SEM fractography micrographs of (a) standard AW specimen, (b) standard PWHT specimen, (c) sub-size AW specimen, (d) sub-size PWHT specimen.

The fractured tensile specimen was also analyzed using the FE-SEM and is presented in Figure 15. The presence of the dimples at the fracture surface also supports the results (% elongation) that were obtained through the tensile tests. Figure 15a,b shows that failure from a ductile mode of fracture occurs in standard size specimens with Incoloy 800HT HAZ (AW) and the base metal (PWHT), as dimples were uniformly distributed. The fractured specimen in AW and PWHT conditions exhibits ductile dimples of varying size and depth, microvoids of varying size and depth, and tear ridges. The PWHT fractured specimen also shows the presence of a few brittle areas, i.e., cleavage facets (Figure 15b). While sub-size AW and PWHT specimens failing due to weld had experienced the intergranular and transgranular types of fracture, the presence of fewer dimples suggests slight ductile behavior (Figure 15c,d). The appearance of the fracture surface also supports the tensile test results. The fracture surface for the AW specimen exhibits a large area of the cleavage facets (Figure 15c), while after the PWHT, both fine dimples and microvoids were observed, along with the cleavage facets (Figure 15d).

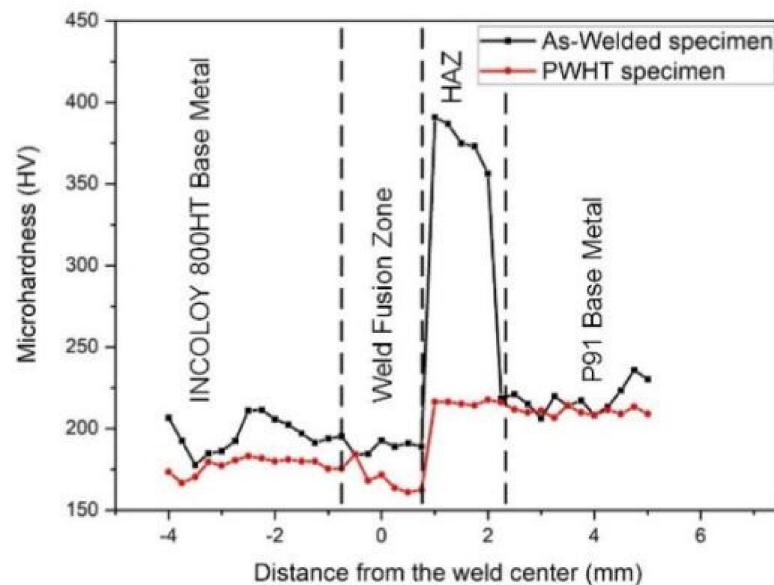
Figure 16. Microhardness variation obtained for AW and PWHT weldments.

The inhomogeneity in the microstructure obtained, due to the welding of dissimilar metals, impacts the mechanical property of the welds joint. Hence, microhardness analysis was conducted for the categorized welding zones. The comparison was done in the AW and PWHT states, as illustrated in Figure 16. The obtained microhardness for the base P91 and Incoloy 800HT was 245 ± 5 HV and 189 ± 5 HV, respectively. A comparatively lower hardness of 187 ± 3 HV was observed in the weld fusion zone of the AW joint, which was attributed to the austenitic microstructure and segregation of the alloying elements at the inter-dendritic boundaries. A uniform hardness variation was measured in the WFZ except for the Incoloy 800HT, which showed a slight increase in hardness that could be attributed to the formation of the unmixed zone due to differences in melting temperatures of parent base metals. As is apparent in the illustration, a notable variation in the measured hardness is evident along the weldment. The AW P91 side HAZ showed a significant increment in hardness with a peak hardness of 391 HV near the fusion boundary, i.e., CGHAZ. With the P91 CGHAZ being martensitic in nature, a higher hardness due to the presence of a slightly higher alloying concentration of Mo, W, C, and N was shown. The complete dissolution of MX and $M_{23}C_6$ precipitates in the region P91 CGHAZ formed under high temperature ($\gg A_{c3}$) increases the percentage of carbon and nitrogen in the solution matrix, hence causing the increase in hardness by solid solution strengthening. A similar observation has also been reported for P91 CGHAZ [36,49]. However, the hardness of P91 CGHAZ in the fusion welded joint was reported as much higher than the laser beam welded joint [29,50,51]. Gradually, a lower hardness in P91 FGHAZ was observed, varying from 387 HV to 356 HV with an average of 373 ± 12 . The incomplete dissolution of the precipitates in FGHAZ as a result of the lower peak temperature ($\geq A_{c3}$) might be the cause of the poorer hardness in P91 FGHAZ than in the P91 CGHAZ. The minimum hardness in P91 HAZ was measured in ICHAZ, which experienced the temperature in between A_{c1}

and A_{c3} . The poor hardness of 218 HV in P91 ICHAZ was attributed to the re-tempering of martensite, grain and precipitate coarsening. In the AW condition, the carbide and nitride precipitates imparted the hardness to Incoloy 800HT, but being austenitic in nature, it exhibited a comparatively lower hardness than P91 and did not show any significant variation. Owing to this property of Incoloy 800HT, the HAZ hardness was measured as 195 HV, which is closely comparable to the Incoloy 800HT base metal hardness.

The tempering of the welded joint showed a significant effect on the hardness value of the P91 HAZ, while the hardness of the WFZ and Incoloy 800HT HAZ remained unaffected. After PWHT, the lowering in the hardness of P91 HAZ was significantly due to the tempering of martensite. The dissolved precipitates in the AW condition resurfaced while tempering. Hence, the CGHAZ of P91 after PWHT depicted a sharp decline of 174 HV in hardness compared to the AW state. A drastic reduction in the hardness of the P91 FGHAZ was also measured, with a hardness of 356 HV. However, the hardness of the P91 ICHAZ remains unaffected, and it was 218 HV. A similar trend of the hardness variation in P91 HAZ was also reported by Pandey et al. [52]. While theoretically, austenitic Incoloy 800HT and WFZ do not respond to PWHT, a slight reduction can be observed in the Incoloy 800HT side and even in the WFZ. This might be due to softening by carbide dissolution [44]. In addition, it might be argued that this reduction in hardness is due to ageing [45]. It can be concluded that PWHT is successful in reducing the hardness in the martensitic HAZ and reducing the hardness variation along the weldment.

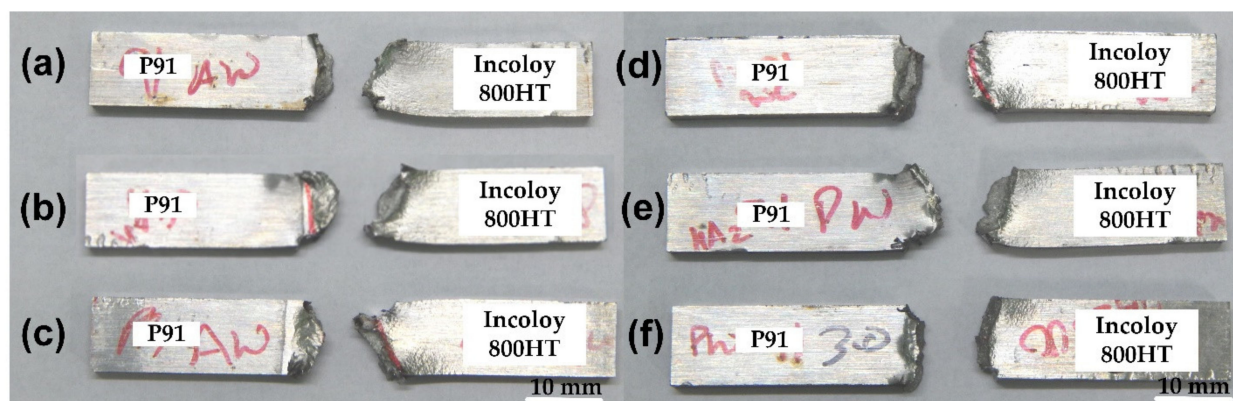
Figure 17. Samples fractured under Charpy impact testing from (a) WFZ (b) HAZ P91; (c) HAZ Incoloy 800HT; (d) PWHT WFZ; (e) PWHT HAZ P91; (f) PWHT Incoloy HAZ.

The energy absorbing capacity of the welded joint was evaluated by performing the Charpy impact toughness test at room temperature, and the results are shown in Table 6. The fractured impact tested specimen is shown in Figure 17. The impact toughness of the WFZ was measured as 65 ± 4 J in the AW condition, which was very low compared with the impact toughness of the P91 base metal (105 ± 4 J) and Incoloy 800 HT base metal (102 ± 5 J). The poor impact toughness value for the WFZ was attributed to the presence of solidification cracks along the SGBs and MGBs in the weld and segregation of the alloying elements, along with the inter-dendritic areas. However, the impact toughness of the WFZ obtained for the AW joint met the standard recommended value of 41 J (ASME standard) and >47 J (EN 1599:1997 standard) [53], which ensured that the impact toughness of the dissimilar laser welded joint of P91 and Incoloy 800 HT was qualified

for boiler requirements. The fractured impact specimen showed the complete fracture of the specimen into two parts for both AW and PWHT joints (Figure 17). In dissimilar weldments, the results showed the maximum impact toughness for the P91 base metal compared to the WFZ and Incoloy 800 HT base metal. Meanwhile, the impact toughness of the P91 HAZ and Incoloy 800HT HAZ were measured as 102 ± 5 J and 75 ± 3 J, respectively (Table 6). The lower Incoloy 800HT HAZ impact toughness, in contrast with the P91 HAZ, was highly unexpected and suggested the formation of secondary carbide particles in the intergranular region due to the segregation of the alloying elements near the HAZ region [54]. The presence of precipitation in Incoloy 800HT HAZ hindered the dislocation movement, hence lowering the ductility and toughness [45]. In P91 HAZ, the impact toughness was measured as close to the P91 base metal. However, a dissimilar weld of P91 with austenitic grade steel with fusion-welded A-TIG and M-TIG process produced poor impact toughness, and it did not qualify the USC boiler requirements [50,55,56]. The PWHT showed an increase in the impact toughness of the P91 HAZ, and was measured at 108 ± 6 , while a drastic reduction was observed in the WFZ and Incoloy 800 HT HAZ. The impact toughness in the WFZ and Incoloy 800 HT HAZ were measured at 55 ± 2 J and 45 ± 3 J, respectively. The increase in impact toughness might be due to the tempering of the martensite. The increase in impact toughness of the WM after the PWHT was also reported in the previous study [56]. The impact toughness of the P91 HAZ was measured as higher than the P91 base metal. The much-reduced toughness value in Incoloy 800HT HAZ could be due to slight ageing, as the intergranular fracture mode was observed and is frequently due to the formation of secondary carbides in the matrix, dissolution of primary carbides, and phase transformation of TiC to $Cr_{23}C_6$ [23,54]. As illustrated in Figure 18a,b, the fractography analysis shows the formation of narrow and deep dimples, which confirms the ductile mode of failure mixed with the intragranular fracture. It seems complicated to comment on the loss of ductility. It could be due to either the presence of solidification cracks or due to the formation of secondary carbides.

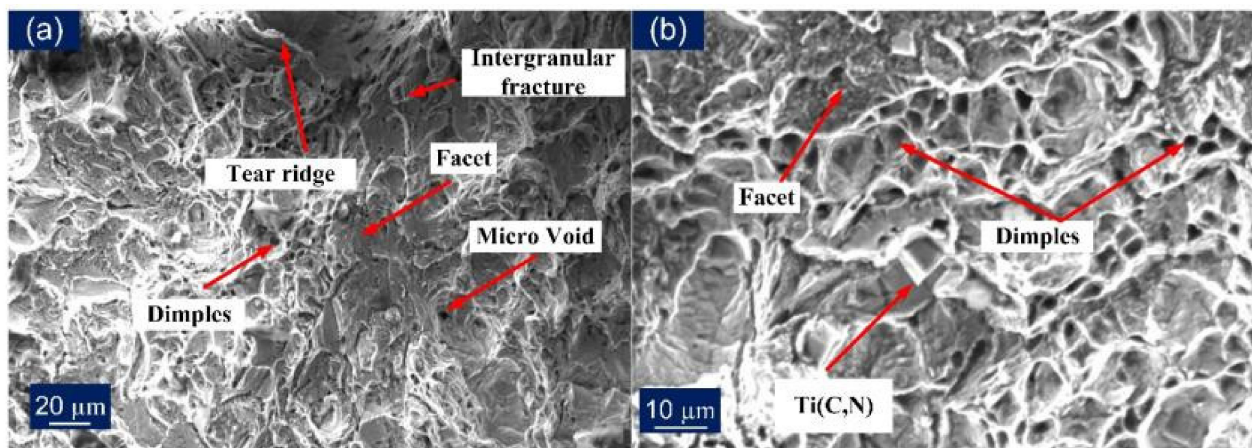
Figure 18. SEM fractography micrograph of specimens broken during Charpy impact toughness test (a) AW (impact at WFZ), (b) PWHT (impact at WFZ).
