Urology Case Reports

Endourology A knotted ureteral stent

Chak-Lam Cho

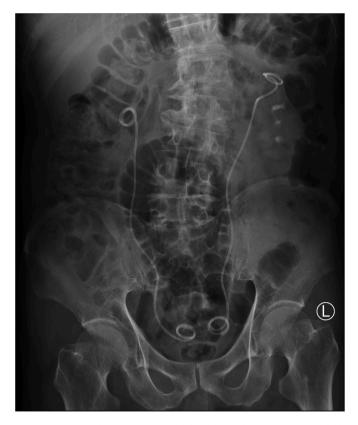
Fig. 1. Position and configuration of bilateral double-J stents after flexible ureterorenoscopy.

A 62-year-old man presented to our urology clinic with 1-month history of intermittent macroscopic haematuria. Computerized tomography scans demonstrated 7 mm right proximal ureteric stone and 22 mm left lower calyceal stone. Bilateral flexible ureterorenoscopy and laser lithotripsy was performed. Multilength 22-32cm 6 Fr Bard InLay Versafit double-J stents (C. R. BARD Inc., Covington, GA, USA) were inserted bilaterally at the end of the procedure under fluoroscopic guidance. Plain radiograph after the operation showed proper position and coiling of both ureteral stents (Fig. 1).

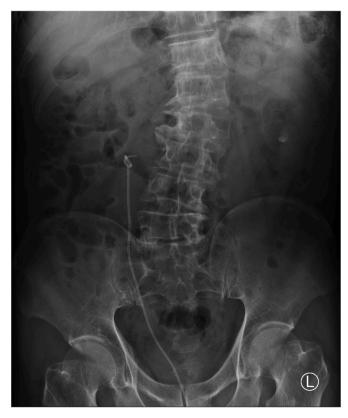
Fig. 2. Appearance of the knotted right double-J stent on plain radiograph.

Removal of bilateral double-J stents by flexible cystoscopy under intravenous sedation was scheduled 3 weeks after the first operation. The stent over the left side was removed smoothly by grasping forceps. Difficulty in retrieval was noted on the right side and distal tip of the ureteral stent could barely reach the urethral meatus after straightening the distal coil. Plain radiograph revealed a knotted stent lodged at ureteropelvic junction (UPJ) (Fig. 2). After the patient was transferred to an operating theatre, retrieval of the stent by gentle traction again failed

under general anaesthesia. A 0.38 mm straight tip guidewire was passed via the lumen of the stent but unable to untie the knot under fluoroscopic guidance. A 6 Fr semi-rigid ureteroscope was introduced and the knot was seen at UPJ but further manipulation was unsuccessful due to the limited space. The knot was pushed back into renal pelvis. Release of the knot was noted on real-time fluoroscopy with repeated probing by guidewire. The stent was removed without complication. Patient was discharged after overnight observation. Patient remained asymptomatic 3 months after the operation on follow up.
