Article

Experimental Study on Damage Identification of Nano-SiO₂ Concrete Filled GFRP Tube Column Using Piezoceramic Transducers

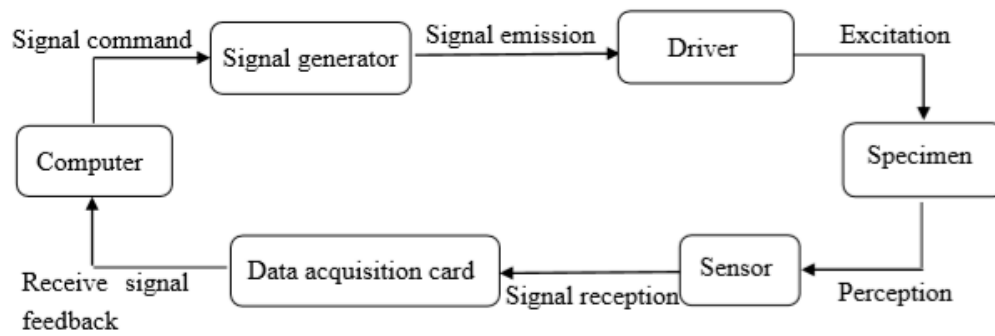
Figure 1. Block diagram of health monitoring system based on wave method.

In the use of piezoelectric materials for structural health monitoring and damage identification technology [60,61], there are mainly two methods of active health monitoring and passive health monitoring. The active monitoring method based on piezoelectric materials primarily focuses on impedance method and wave method [62]. The impedance method generally attaches the piezoceramic plate to the structural surface, which is easily affected by environmental factors, making the monitoring inaccurate and the internal damage of the structure difficult to monitor. Conversely, the wave method has the advantages of large monitoring interval, abundant parameters for damage analysis, and strong resistance to disturbance, and therefore it has been widely applied in the field of health monitoring. The basic principle of the wave method is to fabricate a pair of piezoceramic sensors into smart aggregate and embed them inside the structure. One sensor acts as a driver and emits stress waves which are transmitted inside the structure under test. Another piezoelectric ceramic sensor at a certain distance receives the stress waves and converts the measured stress waves into electrical signals for output. Figure 1 shows the basic composition of a health monitoring system based on the wave method. By comparing the parameters of the signal before and after damage, including the amplitude, energy, phase, and time delay of the signal, the health of the structure can be judged, and the damage location and degree of the structure can be confirmed [63]. On the basis of the principle of stress wave propagation in concrete, the stress wave energy decreases with the increase in the damage, so that the real-time damage monitoring of the structure can be carried out through the change trend of the stress wave energy during the process of damage development.

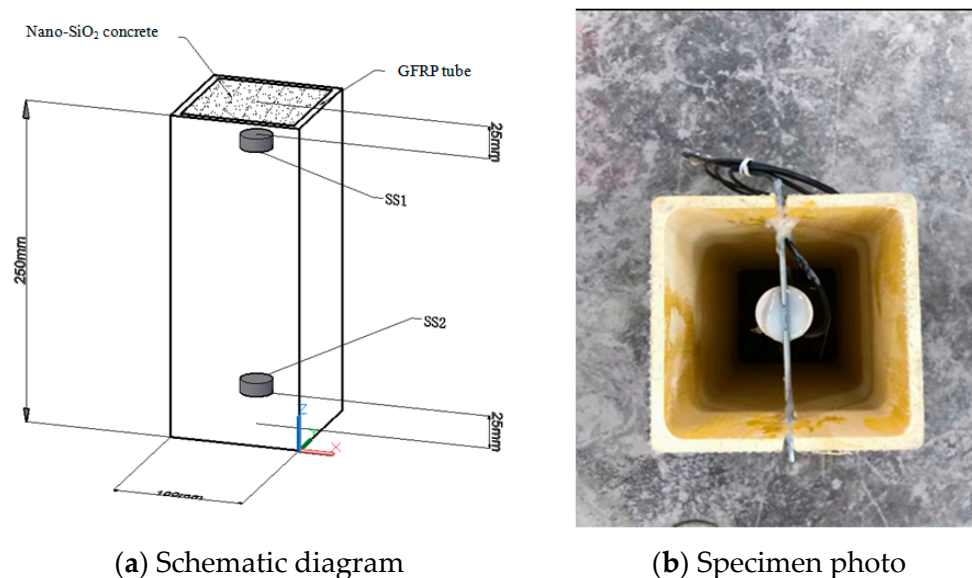
Figure 2. Schematic diagram and specimen photo of short glass fiber reinforced polymer (GFRP) concrete column.

In this experiment, a total of 13 nano-SiO₂ concrete filled GFRP tube column specimens were designed in line with different parameters, including concrete grade, nano-SiO₂ content, and superplasticizer content, among which the concrete grades include C10, C20, C30, and C40, and the nano-SiO₂ contents are 0%, 1%, and 3%, respectively. The content of the superplasticizer is 0.8%. The tested GFRP tube was produced by pultrusion process and made of E glass fiber and polyester resin, with a wall thickness (T) of 6 mm, a column height (H) of 250 mm, and a square cross section with side length (L) of 100 mm, as shown in Figure 2. The specimen number and specific parameters are shown in Table 1. Taking GC20-WRA1-NS1 as an example, G represents the GFRP tube, C20 represents a concrete grade of C20, WRA1 represents the superplasticizer included, and NS1 represents 1% of nano-SiO₂ content. A pair of piezoceramic sensors were made into smart aggregate and embedded in the concrete of GFRP tube, of which one sensor, SS1, acted as an exciter to generate stress wave signals, and the other sensor, SS2, acted as a receiver to receive stress wave signals. The piezoceramic transducers are manufactured by Hengke Technology Co., Ltd., Qinhuangdao City, Hebei Province, China.

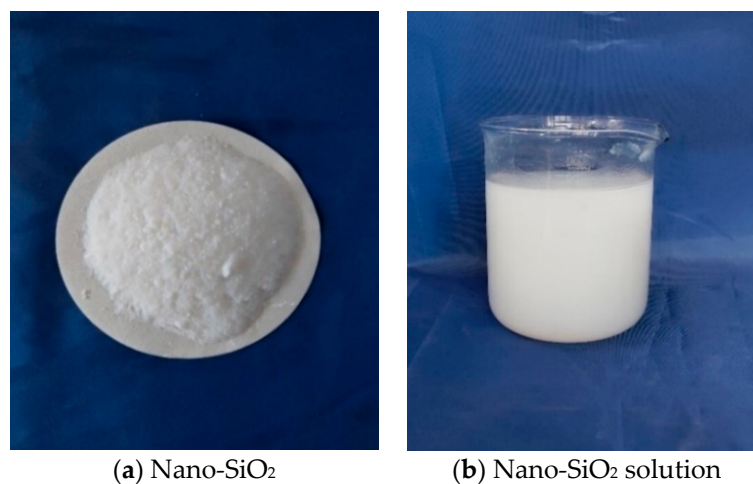
**Figure 3.** Nano-SiO₂ powder and solution.

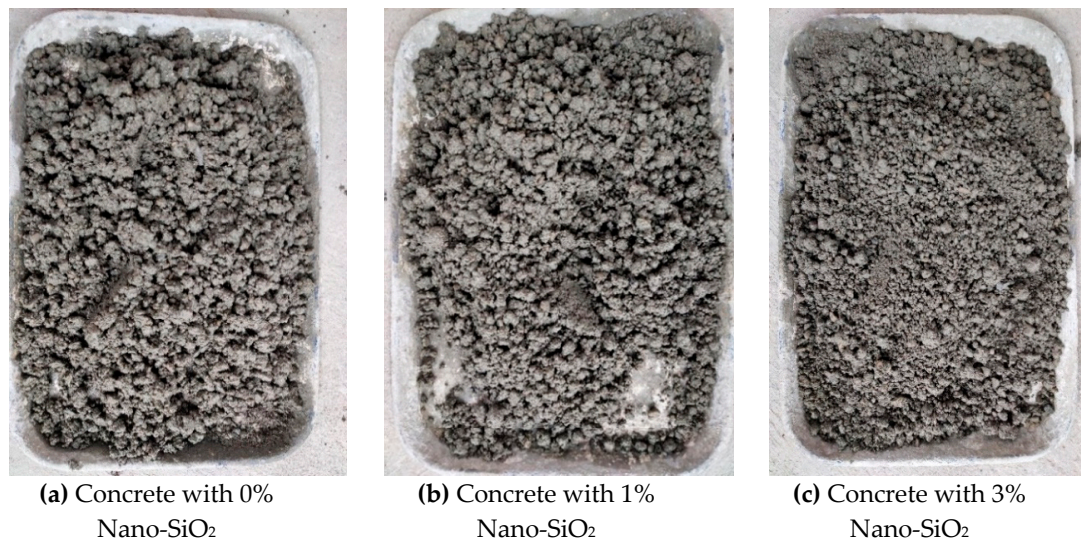
Figure 4. Concrete with different nano-SiO₂ contents.

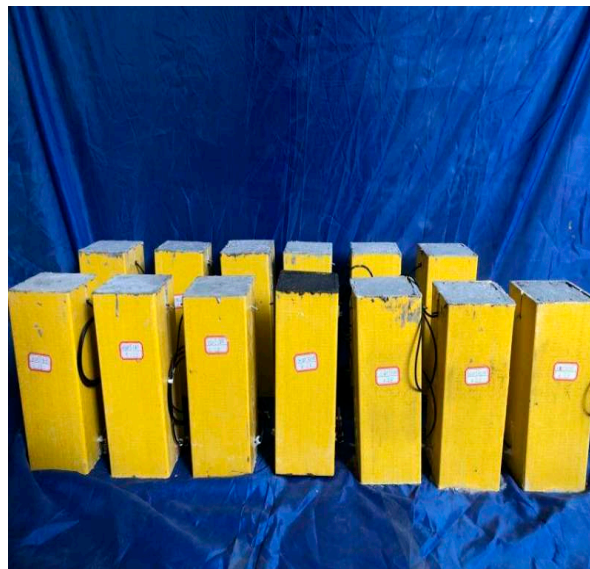
Figure 5. Short GFRP tube concrete column with nano-SiO₂.

In accordance with GB/T1447-2005 “Test Method for Tensile Properties of Fiber Reinforced Plastics” [69] and GB/T1448-2005 “Test Method for Compressive Properties of Fiber Reinforced Plastics” [70], GFRP material properties were tested by taking standard specimens on the surface of GFRP tube, of which the average compressive strength was 118 MPa, the tensile strength was 550 MPa, and the specific gravity was 2000 kg/m³. The mechanical property test of concrete was sampled according to GB/T50080-2002 “Standard for Test Methods of Performance of Common Concrete Mixtures” [71] and configured in the school laboratory. The design codes were C10, C20, C30 and C40, respectively, and the standard cube blocks of 150 mm × 150 mm × 150 mm were cast with the configured concrete. The average compressive strengths of C10, C20, C30 and C40 measured on the testing machine were 17.3, 24.6, 32.5 and 41.3 MPa, respectively. The nano-SiO₂ adopted hydrophilic gas phase nano-silica Hydrophilic-380, with a specific surface area of 380 mm²/g and a particle size of 7–40 nm. The nano-SiO₂ powder and the prepared nano-SiO₂ solution are shown in Figure 3. The concrete added with different nano-SiO₂ is shown in Figure 4. As can be seen from Figure 4, the concrete mixed with nano-SiO₂ becomes viscous with a poor fluidity. The superplasticizer was appropriately added so as to reduce the influence of poor fluidity. All experimental specimens are shown in Figure 5.

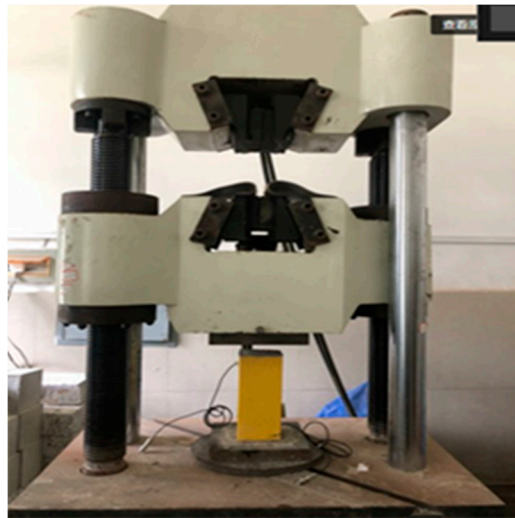
Figure 6. Loading device.

The cross-sections of the specimens were polished smooth prior to each test to prevent bias during loading. The 1000 kN electro-hydraulic servo universal testing machine was used for loading, and the displacement control loading mode was adopted, with a speed of 0.5 mm/min. The loading device is shown in Figure 6. The whole health monitoring system consisted of a signal generator, a signal acquisition and analysis system, and a computer, as shown in Figure 7. The signal generator, as the signal source, stimulated SS1 to generate stress waves. The maximum response frequency of the piezoelectric ceramic sensor reached 450 kHz. The signal acquisition and analysis system used a USB-6361 signal collector from the American NI company in order to collect the stress waves received by SS2, and finally stored data in the computer. The frequency sweep mode was put into use in the experiment, with a sweep signal amplitude of 10 V, a frequency range of 100 Hz–50 kHz, and a cycle of 1s. The signal collector obtained the stress waves transmitted in the concrete in real time, which could make the amount of data collected too large. Consequently, according to the loading feedback of the testing machine, the loading was recorded and the stress waves were collected every 30 s until all specimens were completely destroyed. The data collected from all specimens are shown in Table 3.

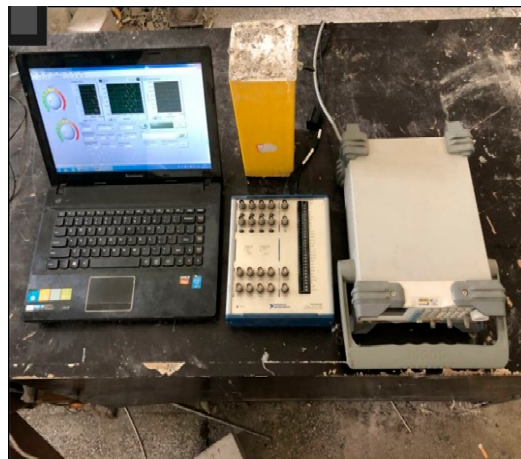
Figure 7. Picture of monitoring system.

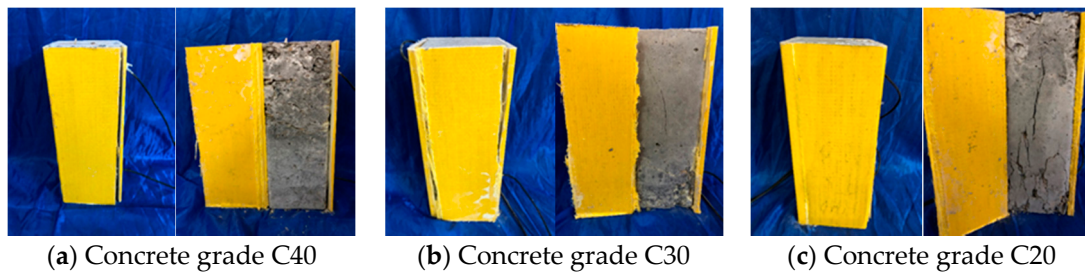
Figure 8. Failure modes of specimens at different concrete grades.

At the initial stage of loading, there was no obvious change in the GFRP tube wall. With the continuous increase in the load, the top end corner of the specimen was torn, accompanied by the hissing sound of glass fiber tearing; when approaching the ultimate load, the longitudinal tearing became more and more obvious until complete tearing. In order to further observe the damage of the concrete inside the GFRP tube, the torn side of the GFRP tube was stripped. Figure 8 shows the failure modes of specimens at different concrete grades. Figure 9 shows the failure modes of GFRP tube specimens with different nano-SiO₂ contents.

It can be seen from Figures 8 and 9 that the concrete columns inside the specimens had various degrees of damage, and longitudinal cracks appeared. The C40 concrete column had the smallest crack width and the smallest number of cracks, while the C20 concrete column had the largest crack width and the largest number of cracks; the concrete with 3% nano-SiO₂ had the smallest crack width and the smallest number of cracks, whereas the concrete without nano-SiO₂ had the largest crack width and the largest number of cracks.

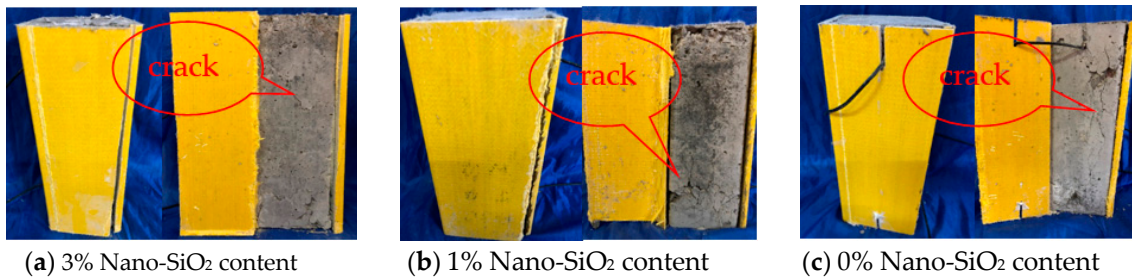
Figure 9. Failure modes of specimens with different nano-SiO₂ contents.

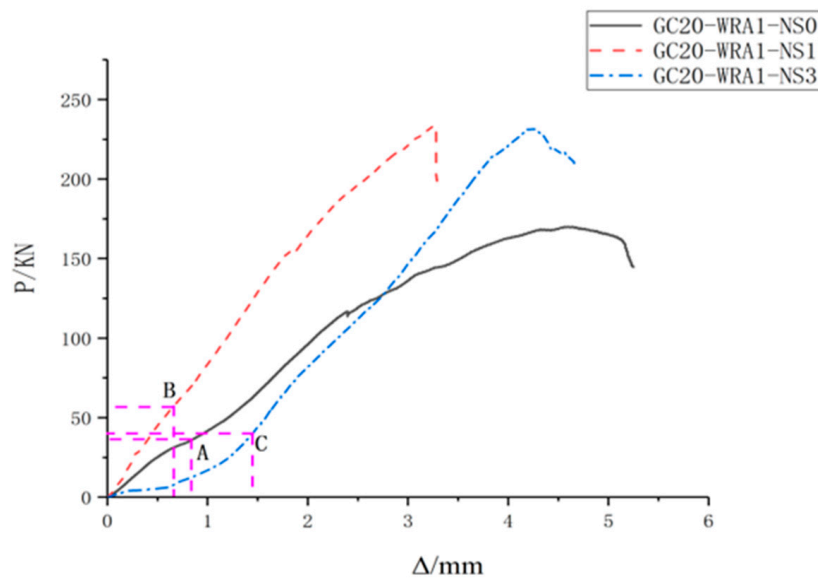
Figure 10. Load–displacement curves of specimens with different nano-SiO₂ contents.

As can be seen from Figure 10, when the load is 24.6% of the ultimate load, specimens with 1% nano-SiO₂ content are damaged; however, when specimens with 0% and 3% nano-SiO₂ contents are damaged, the loads are respectively 18.7% and 17.9% of the ultimate load. As can be seen from Figure 11, when the applied loads are 3%, 3.2% and 6.5% of the ultimate load, specimens at the concrete grades of C20, C30, and C40 are damaged, respectively.

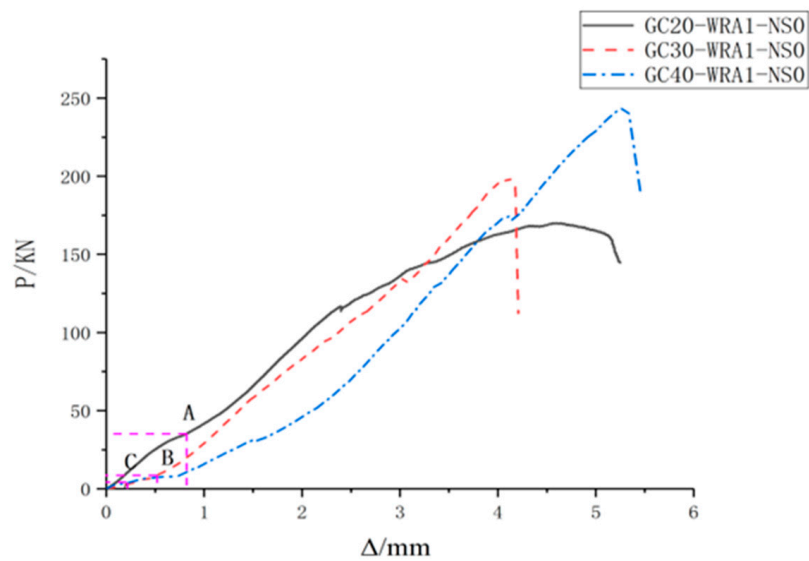
Figure 11. Curves of specimens at different concrete grades.

The experimental data were processed to obtain load–displacement curves, where the horizontal axis (Δ) represents displacement, the vertical axis (P) represents load, and A, B and C represent corresponding loads when the sensor receives the maximum energy. Figure 10 shows the load–displacement curves of specimens with different nano-SiO₂ contents, and Figure 11 shows the load–displacement curves of specimens at different concrete grades.

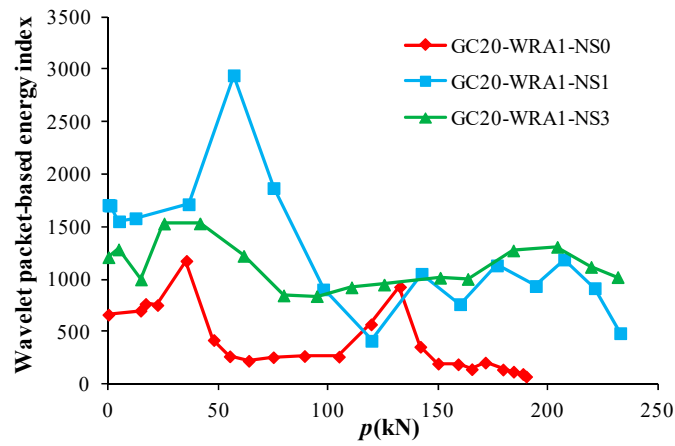
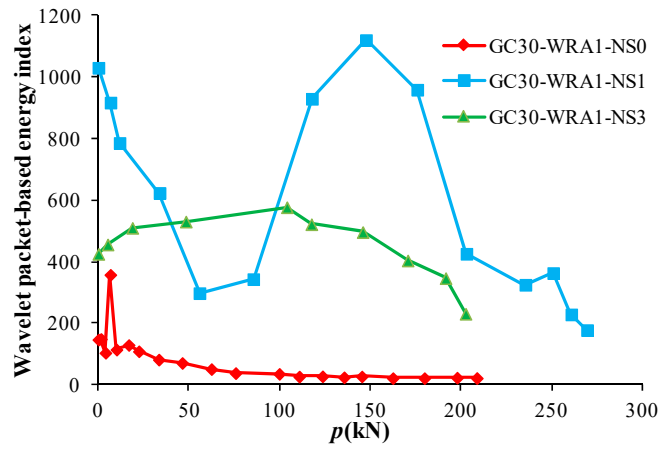
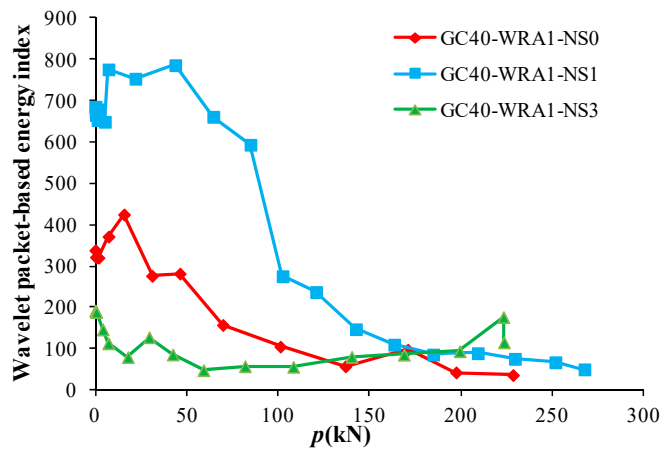
(a) Concrete grade C20

(b) Concrete grade C30

(c) Concrete grade C40

Figure 12. Load–energy index curves of superplasticizer-added specimens with different nano-SiO₂ contents.

The collected data were analyzed and calculated by wavelet packet to obtain the load–energy index curves of specimens with superplasticizer. Figure 12 shows the load–energy index curves of superplasticizer-added specimens with different nano-SiO₂ contents, and Figure 13 shows the load–energy index curves of superplasticizer-added specimens at different concrete grades.

At the initial stage of loading, the compression and compaction of concrete in GFRP tube played a major role, and the energy of the received signal increased and gradually reached the maximum. Then, with the further increase in load, the concrete was damaged under compression, and micro-cracks began to develop, resulting in a gradual decrease in energy. As can be seen from Figure 12, specimens with 1% nano-SiO₂ content have the highest initial energy, and can bear the largest load with the increase in load until being destroyed. However, when the concrete inside specimens is damaged, specimens with 1% nano-SiO₂ content have the maximum energy attenuation slope value of 4.71, whereas specimens with 3% nano-SiO₂ content have the minimum energy attenuation slope value of 0.53., implying that adding 3% nano-SiO₂ content to concrete can effectively delay the development of damage.

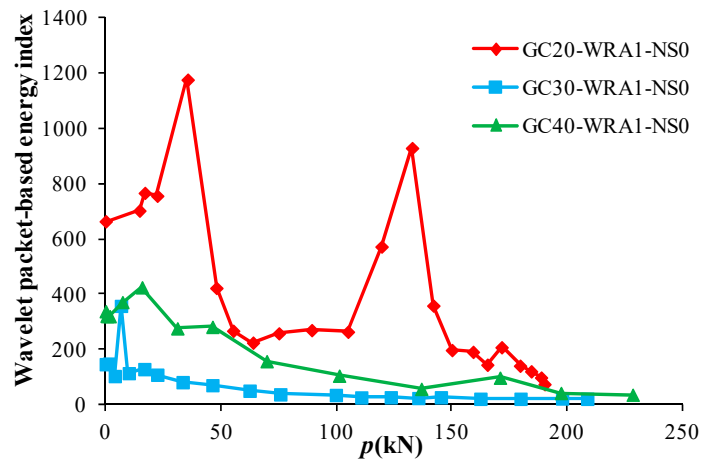
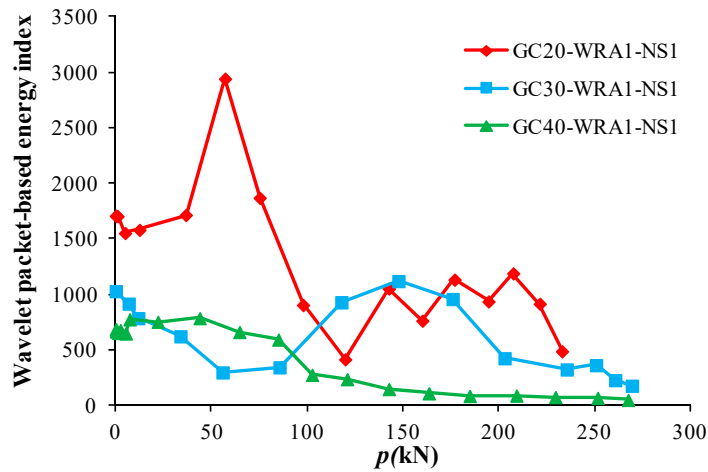
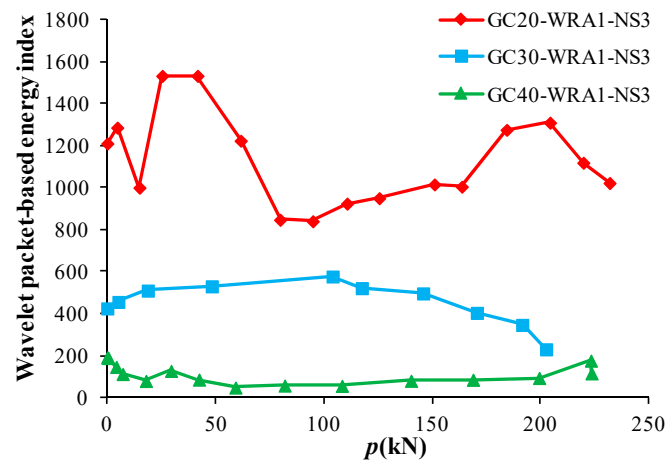
(a) 0% Nano-SiO₂ content

(b) 1% Nano-SiO₂ content.

(c) 3% Nano-SiO₂ content

Figure 13. Load–energy index curves of superplasticizer-added specimens at different concrete grades.

As it can be seen from Figure 13, during the entire loading period, the energy of superplasticizer-added specimens at a concrete grade of C20 is basically higher than that at the concrete grades of C30 and C40, indicating that there are relatively few cracks in C20 concrete. Nevertheless, in the process of increasing load, the energy attenuation slope value of specimens at a concrete grade of C20 is the largest, which is 6.31. However, the energy attenuation slope value of specimens at the concrete grades of C30 and C40 are relatively smaller. This indicates that after the addition of superplasticizer, the higher the concrete grade of the specimen, the slower the development of cracks in concrete, and the stronger the resistance to damage.

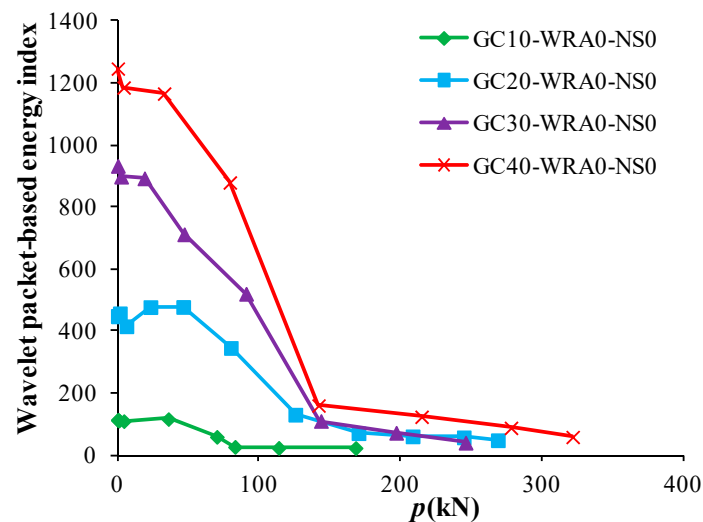
Figure 14. Load–energy index curves of specimens without superplasticizer at different concrete grades.

Figure 14 shows the load–energy index curves of specimens without superplasticizer at different concrete grades. As it can be seen from Figure 14, when no superplasticizer is added, the initial energy of specimen at a concrete grade of C10 is the smallest, whereas that at a concrete grade of C40 is the largest. With the increase in load, the energy attenuation of specimens at a concrete grade of C40 is the fastest, indicating that when superplasticizer is not added, the higher the concrete grade, and the faster the development of specimen damage.

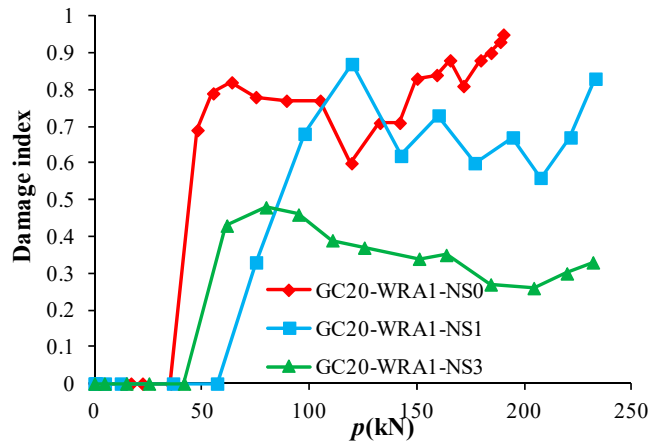
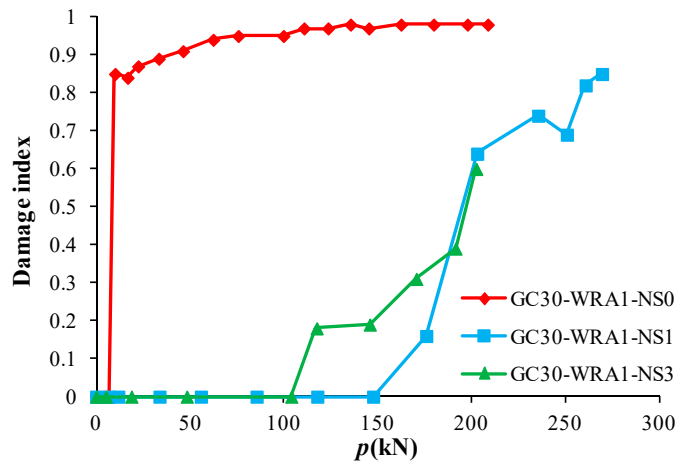
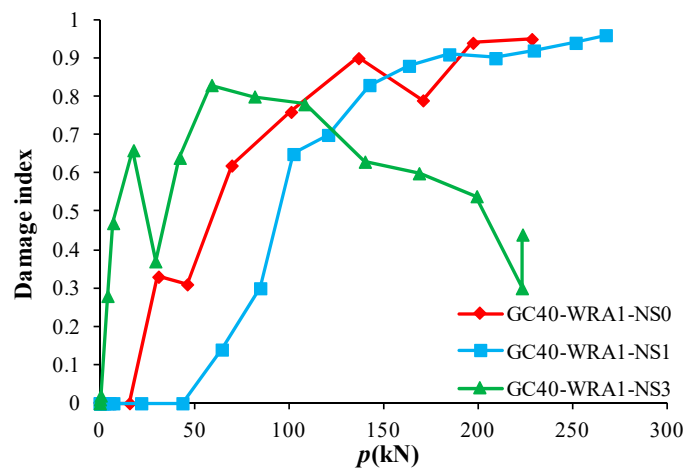
(a) C20 concrete grade

(b) C30 concrete grade

(c) C40 concrete grade

Figure 15. Index curves of specimens with different nano-SiO₂ contents.

The load–damage index curve of each specimen can be gained from Table 3. Figure 15 shows the load–damage index curves of specimens with different nano-SiO₂ contents, and Figure 16 shows the load–damage index curves of specimens at different concrete grades.

As can be seen from Figure 15, specimens with 1% nano-SiO₂ content have the highest load at the beginning of damage, indicating that the damage of specimens with 1% nano-SiO₂ content occurs the latest, followed by specimens with 3% nano-SiO₂ content, yet the damage without the nano-SiO₂ specimen occurs the fastest. With the increase in load, the damage index of specimens without nano-SiO₂ increases rapidly to over 0.8, followed by specimens with 1% nano-SiO₂ content, while the damage index of specimens with 3% nano-SiO₂ content changes the slowest, demonstrating that the damage of specimens without nano-SiO₂ content develops the fastest. The damage index of each specimen changes relatively slowly when reaching 0.6. As can be seen from Figure 16, the change rate of the damage index of specimens at a concrete grade of C20 is the largest, while that at a concrete grade of C40 is the smallest, implying that the higher the concrete grade, the lower the damage rate.

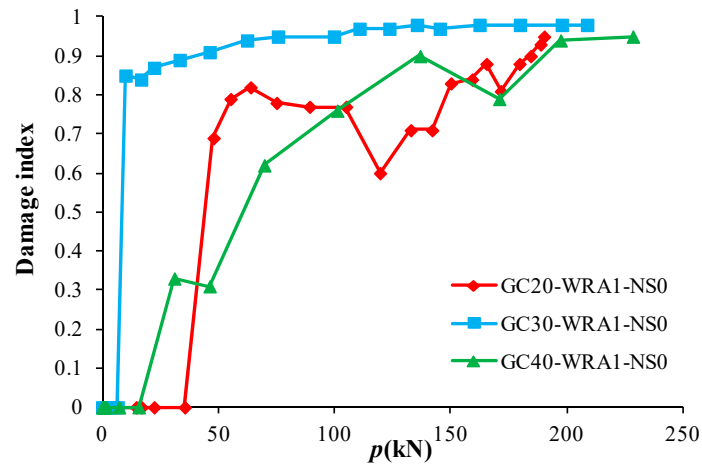
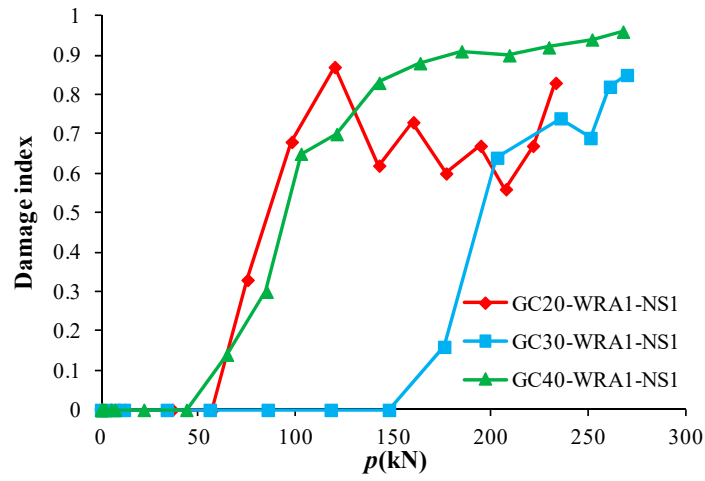
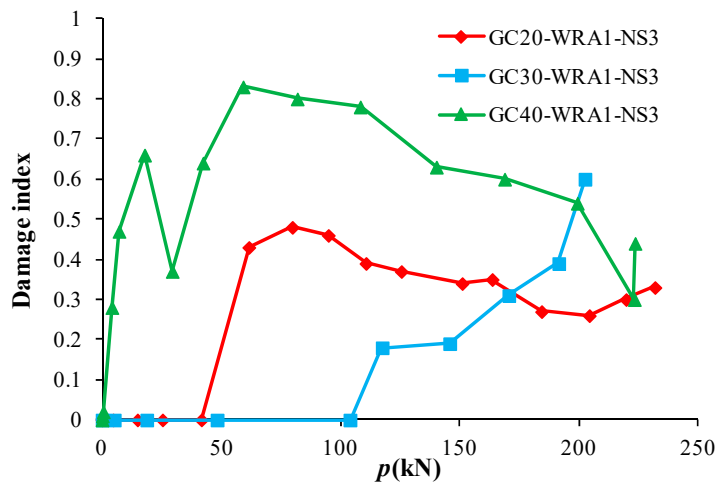
(a) 0% Nano-SiO₂ content

(b) 1% Nano-SiO₂ content

(c) 3% Nano-SiO₂ content

Figure 16. Load–damage index curves of specimens at different concrete grades.
