Case report

Adverse reaction to metal debris in a patient with acetabular shell loosening 8 years after ceramic-on-metal total hip arthroplasty

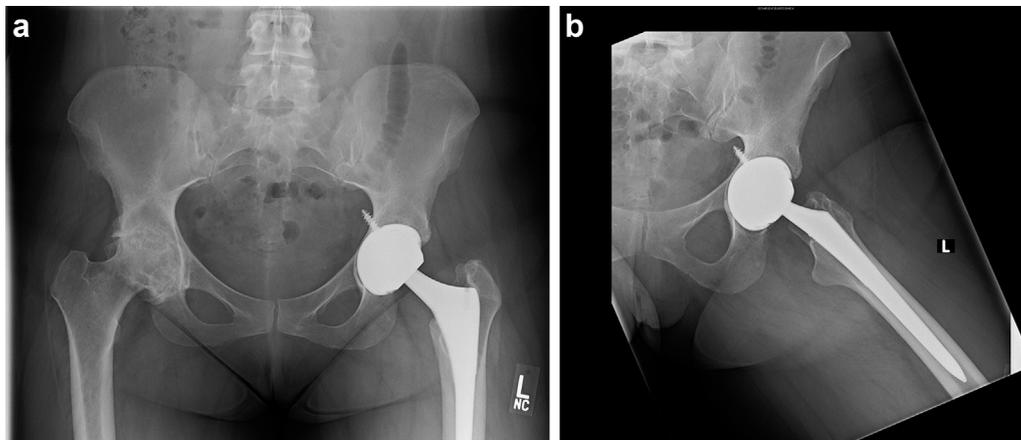
Figure 1. AP pelvis radiograph (a) and lateral view (b) of a 41-year-old woman with a hard-on-hard bearing surface combination demonstrating a complete radiolucent line surrounding the acetabular shell. The femoral stem appears to be well fixed.

Radiographs of the left hip demonstrated THA with a hard-on-hard bearing surface combination. There was no radiographic evidence of catastrophic hardware failure. There was a complete radiolucent line surrounding the acetabular shell which was

concerning for acetabular loosening. Acetabular inclination was 59° . The femoral stem appeared to be well fixed (Fig. 1). Laboratory analysis revealed a mild leukocytosis of 10.9×10^3 white blood cells/ μL (normal: $4.6\text{--}10.2 \times 10^3$ white blood cells/ μL). The erythrocyte sedimentation rate was within normal limits at 16 mm/h (normal: 0–20 mm/h), and the C-reactive protein was mildly elevated at 1.5 mg/dL (normal: <1.0 mg/dL). Serum cobalt and chromium levels were markedly elevated at 18.0 ppb and 13.4 ppb, respectively. Aspiration of the left hip joint was performed which revealed a white blood count of 1850 cells/mL with 87% segmented neutrophils on the differential. Bacterial cultures of the synovial fluid were negative for growth at 72 hours for aerobic, anaerobic, and acid-fast species.

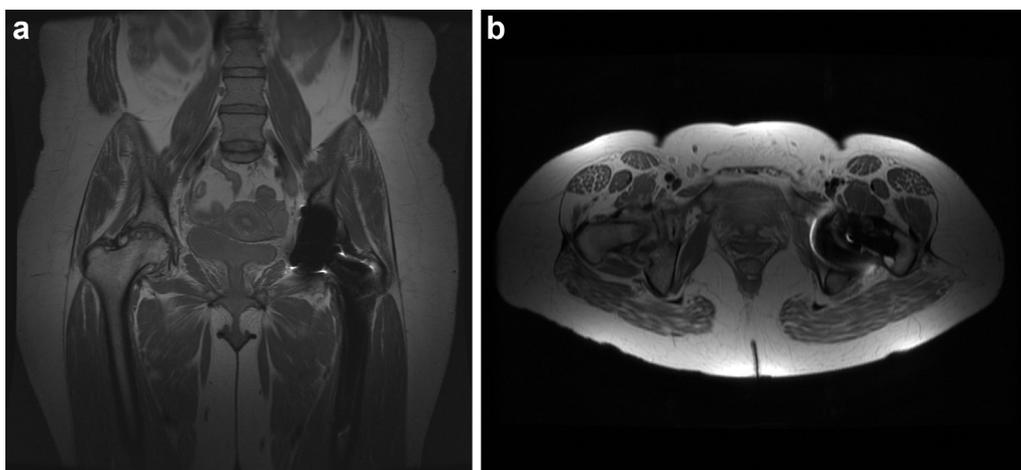
Figure 2. Coronal (a) and axial (b) MARS MRI demonstrating no evidence of pseudotumor or abductor insufficiency.

The patient subsequently underwent metal artifact reduction sequence (MARS) magnetic resonance imaging (MRI) of the left hip which demonstrated intact hip abductor tendons on the greater trochanter and no evidence of pseudotumor (Fig. 2).

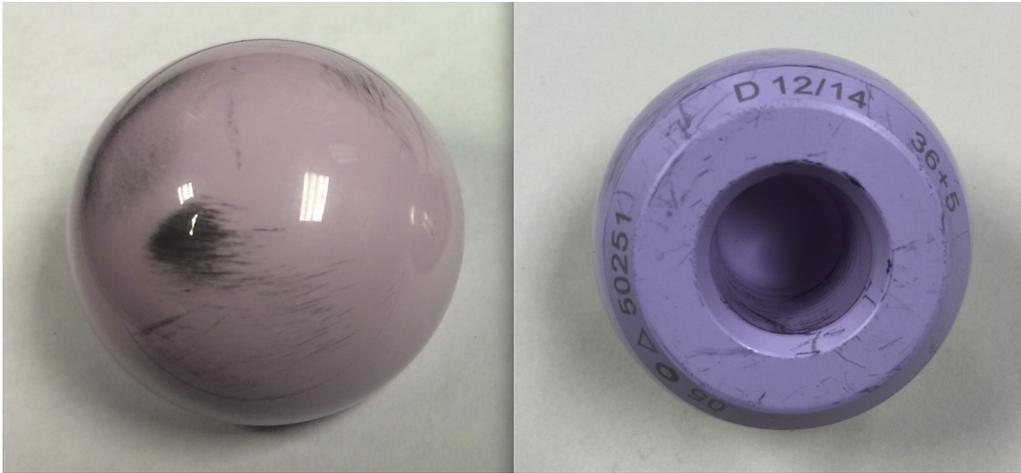
Figure 3. Photographs of explanted Biolox (CeramTech, Plochingen, Germany) Delta ceramic femoral head. There is evidence of metal transfer onto the ceramic femoral head.

The femoral head was solidly engaged onto the femoral neck. After disimpaction, gross inspection of the explanted femoral head demonstrated evidence of metal transfer most pronounced on the posterior-superior aspect (Fig. 3). The femoral component appeared to be well fixed into the proximal femur on manual manipulation. Gross inspection of the trunnion demonstrated no evidence of fretting or discoloration. The acetabular liner demonstrated no evidence of edge loading, backside wear, fretting, or discoloration (Fig. 4), and it was noted to be appropriately engaged into the acetabular shell before explantation. The acetabular shell was found to be grossly loose on manual manipulation with a Kocher clamp, and it pivoted about a single well-fixed screw in the posterior-superior zone. The screw and acetabular shell (Fig. 5) were removed. The acetabular shell had minimal bony in-growth noted on inspection of the backside. No macroscopic evidence of fretting or discoloration was observed at the acetabular shell–screw interface.

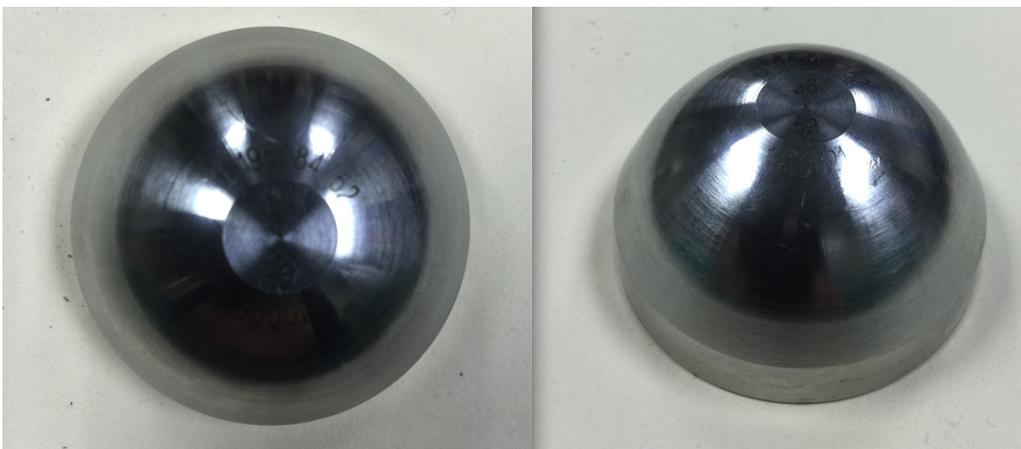
Figure 4. Photographs of explanted DePuy cobalt-chromium acetabular liner (Johnson and Johnson–DePuy Orthopaedics, Inc., Warsaw, IN).

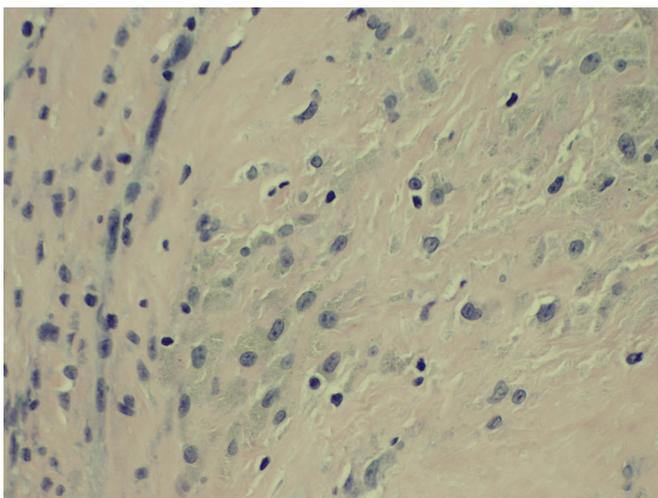
Figure 6. High-power histologic image of the left hip synovium. Chronic inflammation and pigment-laden macrophages are demonstrated.

Intraoperative bacterial cultures were negative for aerobic, anaerobic, and acid-fast species at 72 hours. Histologic analysis of the synovial tissue of the left hip was notable for pigment-laden macrophages consistent with inclusion bodies (Fig. 6) and perivascular lymphocytic infiltrates (Fig. 7).

In our patient, the histologic presence of aggregates of perivascular lymphocytic infiltrates is consistent with at least some element of ALVAL; however, the presence of inclusion bodies in macrophages is suggestive of third-body wear. Thus, the histologic diagnosis is a mixed process. In the presence of a well-fixed screw and a loose acetabular shell, it is hypothesized that fretting between the acetabular shell–screw interface led to the formation of metal debris despite no macroscopic evidence on intraoperative inspection. It is currently unknown whether the single screw used during the index procedure provided sufficient stability to allow bony ingrowth to occur. To our knowledge, the titanium shell used at the index procedure has not been associated with a lack of bony in-growth. The debris generated from this articulation may have resulted in third-body wear and could be responsible for the metal transfer observed on the femoral head at the time of explantation and the macrophage inclusion bodies noted on histology. This could also explain the elevated serum cobalt and chromium levels reported in this patient preoperatively. Although previous literature has associated failure of hard-on-hard bearing surfaces to

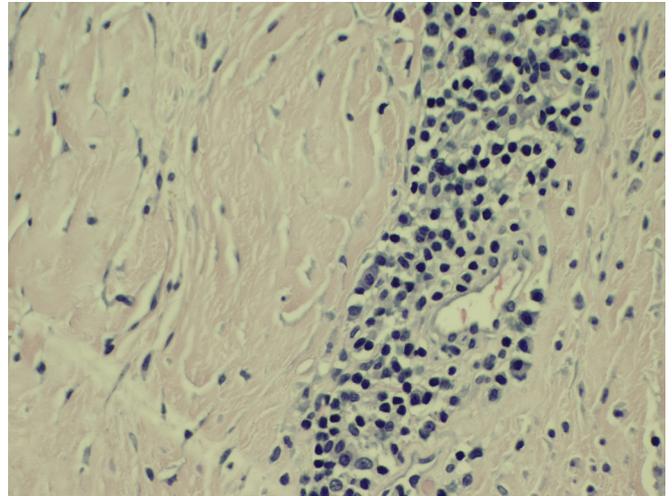
Figure 7. High-power histologic image of the left hip synovium. Perivascular lymphocytic infiltrates are demonstrated.

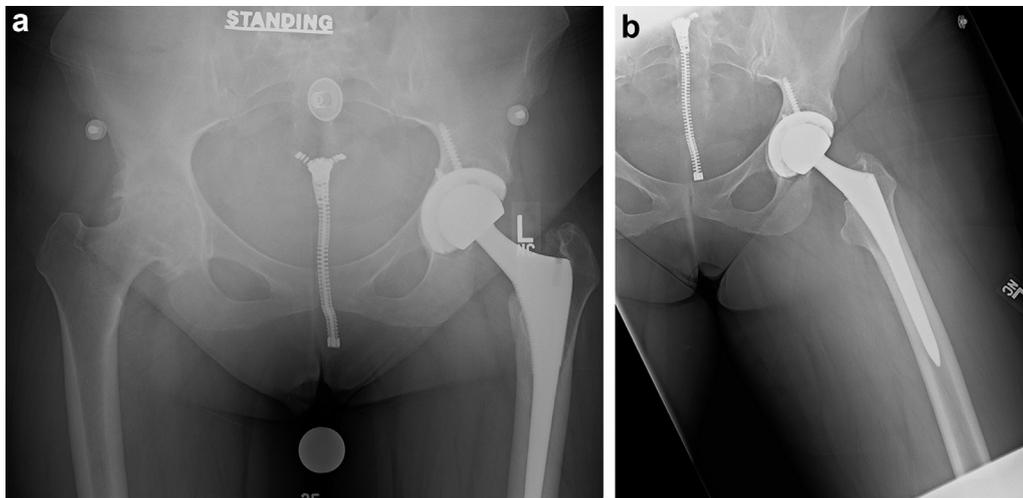
Figure 8. AP pelvis radiograph (a) and lateral view (b) 12 weeks after revision of the left acetabular shell and exchange to a polyethylene acetabular liner and a ceramic femoral head.

devices. At the 12-week postoperative visit (Fig. 8), the patient had no pain in the left hip or groin and had returned to full-time employment. Because of her good outcome with revision left THA, she elected to undergo elective right THA at this time point as treatment for osteoarthritis which had not responded to nonoperative measures. At 9 months from revision left THA (and 6 months from primary right THA), the patient was pain free in the bilateral hips and groin and had again returned to full-time employment. She ambulated without a limp and was satisfied with her outcome. Repeat serum cobalt and chromium levels were 1.3 ppb and <1.0 ppb, respectively.
