# Bilateral neck fracture in bimodular femoral stem after primary total hip arthroplasty: a case report

**Case presentation:** In this report, the literature regarding one of the most popular bi-modular stems with specific neck-stem coupling (oval Morse taper) is reviewed and illustrated with a case of bilateral modular neck fracture in a patient with idiopathic aseptic necrosis of femoral heads treated with primary bi-modular THA. Because of bilateral modular femoral neck fracture, which occurred 3 years on the left side and 20 years after implantation on the right side, the patient required a total of 6 revisions and 208 days of hospitalized care.

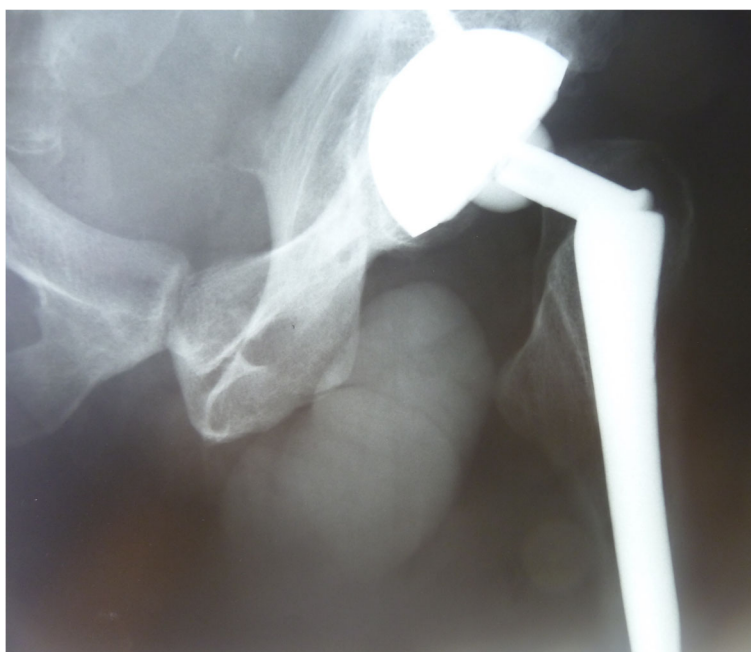
Three years after primary left THA, the patient presented with sudden left groin pain and inability to bear weight on the affected leg. Radiographs revealed a fracture of the left modular femoral neck (Fig. 1). At revision, no signs of polyethylene wear, local tissue adverse reaction or pseudotumor formation were present. However, it was impossible to disengage the modular neck from the femoral taper. An extended trochanteric osteotomy was performed to remove the original implant and a Wagner-type revision modular stem (Limacorporate S.p.A., Udine, Italy) was inserted. Tissue samples were sent for bacteriology and have remained sterile. However, the patient underwent subsequent revision surgeries for stem subsidence, instability and eventually for *Staphylococcus Epidermidis* infection. The infection was eliminated through a two-staged procedure and the patient was finally successfully reconstructed in 2017 with Alloclassic Zweymüller SL stem, Continuum acetabular component and BioloX Delta

**Fig. 1** Emergency room X-ray of the left hip with fractured modular femoral neck 3 years after primary THA

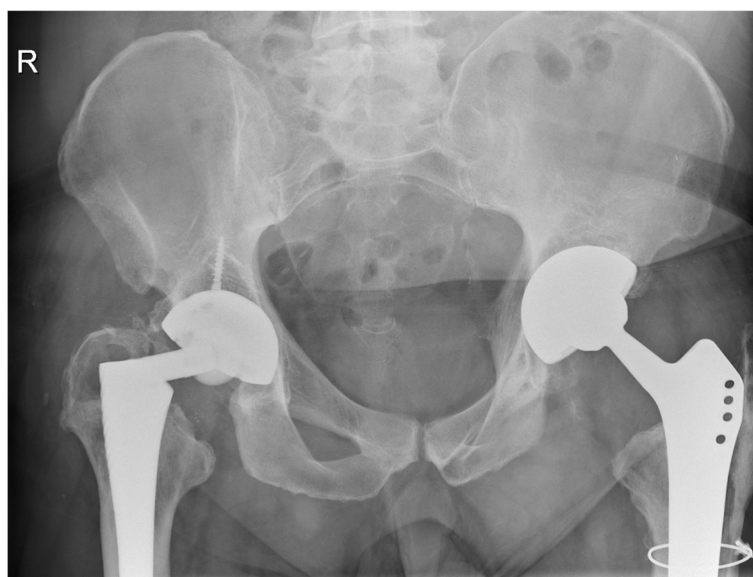
Unfortunately, 20 years after the right THA insertion, the patient presented again to the Emergency Clinics with a fracture of the right-side modular neck (Fig. 2). At revision, no significant local tissue adverse reaction or pseudotumor formation were present. Again, it was impossible to disengage the modular neck from the femoral taper (Fig. 3). The femoral component was extracted via a single longitudinal proximal splitting and two-chisel technique. The acetabular component was revised as well due to excessive polyethylene wear. A replacement liner was not available. The hip was reconstructed with a long Wagner-type revision stem (Limacorporate), Continuum acetabular component (Zimmer Biomet) and ceramic femoral head (BioloX Delta). Tissue samples taken during revision surgery and sent for cultures remain sterile. Immediate postoperative course was uneventful and patient was discharged as usual. However, he was readmitted 1 month after surgery with signs of deep wound infection. The revision procedure was debridement, antibiotics and implant retention (DAIR) with exchange of femoral head and liner only. Operative cultures found *Cutibacterium (Propionibacterium) acnes*. The patient was treated with antibiotics for 3 months.

**Fig. 2** Pelvic X-ray with modular neck fracture shown on the right and situation 1 year after fourth revision of the left THA, respectively

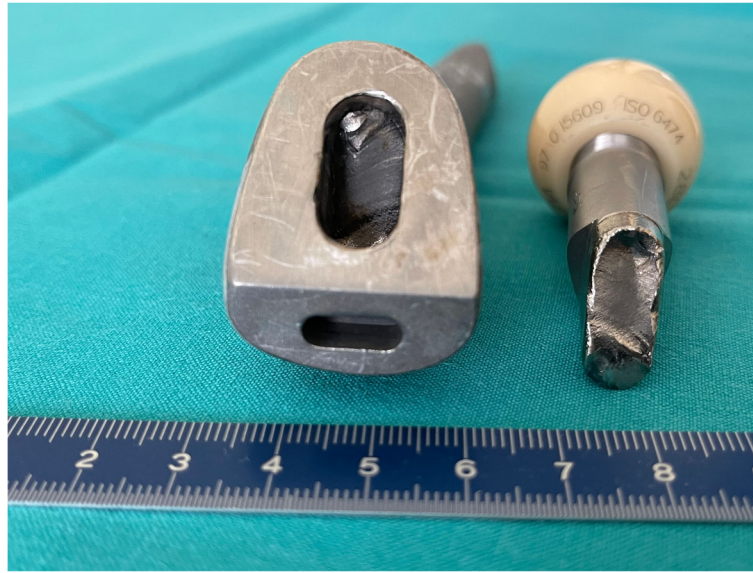
**Fig. 3** Optical photograph of the fractured surface of the modular neck with the distal part still engaged in the conical cavity of the femoral stem

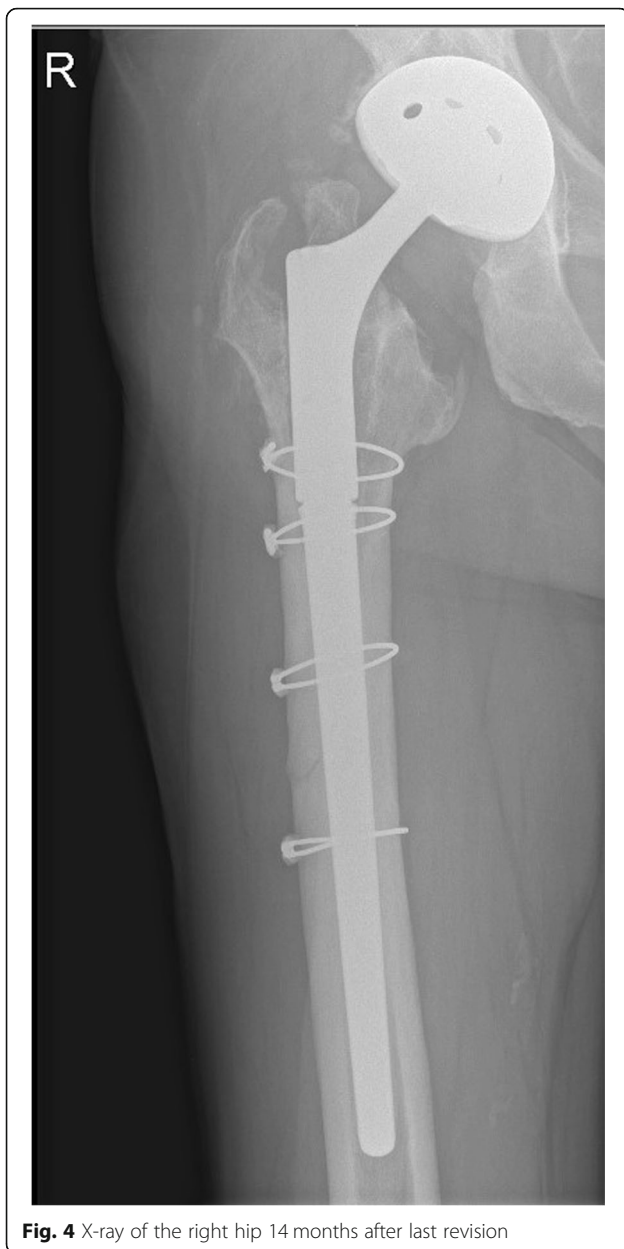
pain, physical functioning, and limitations due to physical health were 75, 50, 60, 45 and 25%, respectively, 40% each for social functioning, emotional wellbeing and energy/fatigue, and 0% for role limitations due to emotional problems. The radiographs demonstrated stable fixation of all THA components of both hips (Fig. 4).

**Fig. 4** X-ray of the right hip 14 months after last revision
