Femoral Stem Fracture and Successful Reimplantation Using Femoral Window Technique in Canine Cemented Total Hip Replacement: Case Report

A fractured stem is a very rare, late complication in total hip replacement procedure in dogs. Here, we present one case after cemented total hip replacement with successful reimplantation, including clinical signs and radiographic findings.

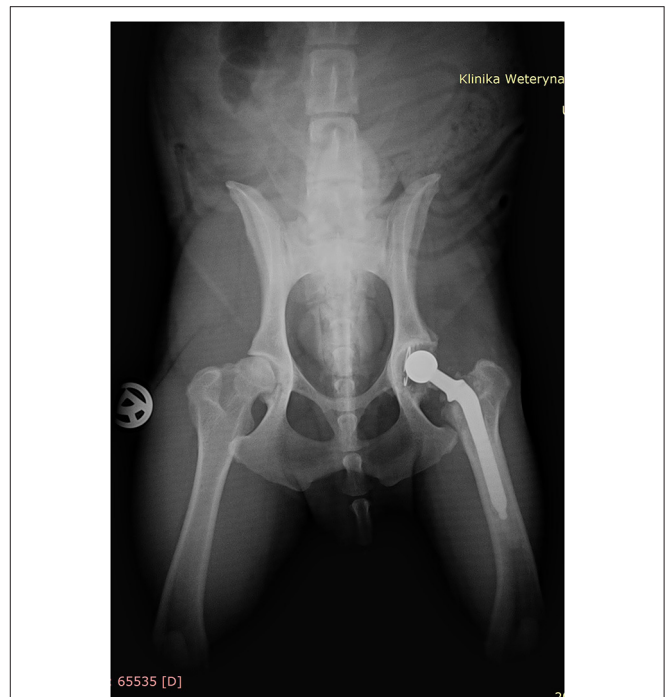
FIGURE 1 | Ventrodorsal radiograph of the dog 2 years after cemented total hip replacement (left hip); radiopaque cement mantle surrounding the femoral and acetabular component is visible.

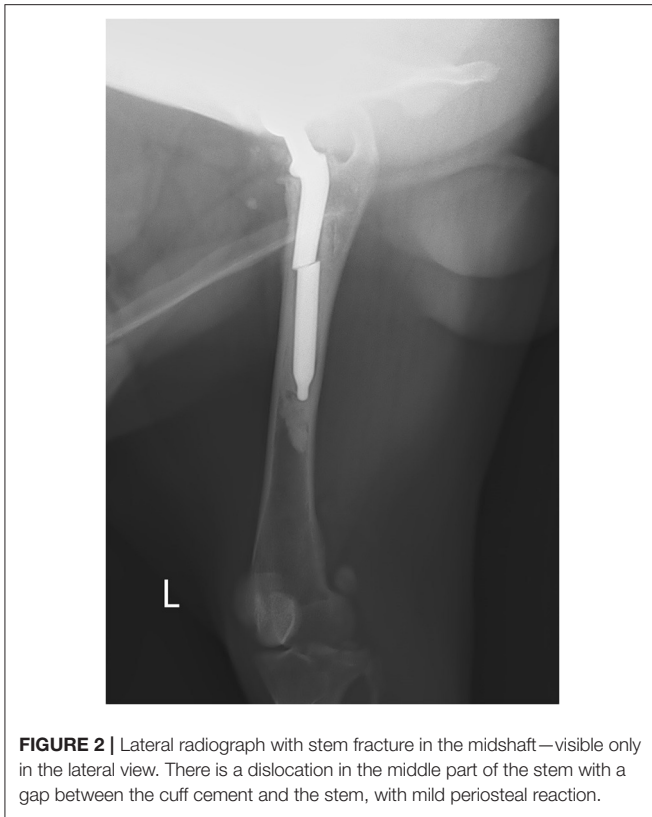
Two months later, the x-ray re-examination in lateral and ventrodorsal projections of the hips demonstrated visible stem fracture in the midshaft. It was well visible only on the lateral view as a step in the middle part of the stem (Figure 2). The cortical bone re-modeling was slightly visible on the level of the stem fracture in the cranial part of the femur with the formation of the new periosteal bone. There was also a noticeable gap between the cuff cement and the stem and a thin gap between the cement mantle and the femoral bone below the major trochanter.

FIGURE 2 | Lateral radiograph with stem fracture in the midshaft—visible only in the lateral view. There is a dislocation in the middle part of the stem with a gap between the cuff cement and the stem, with mild periosteal reaction.

Failure of the femoral stem in the cemented procedure is likely a consequence of fatigue in the stem in a situation in which the distal part of the implant is rigidly fixed into the cement mantle while the proximal one is not rigidly stable. This was probably the cause of the problem in the case described in this report. Loosened border between the cement mantle and the bone in the proximal part of a femur due to aseptic loosening, lack of cortical support, and the stress associated with stem overloads may lead to fatigue of the stem material. Slow loosening of the proximal cement mantle and subsequent cantilever bending leads to stem fracture.

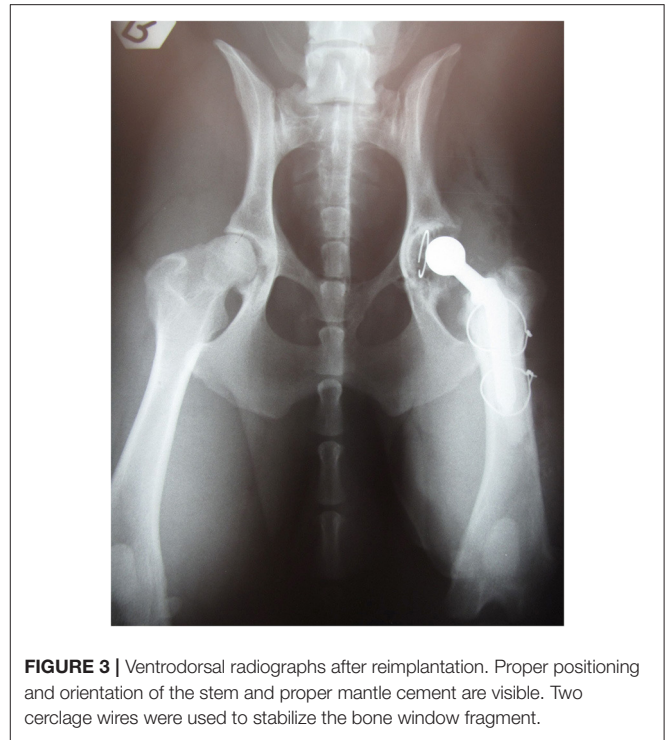
FIGURE 3 | Ventrodorsal radiographs after reimplantation. Proper positioning and orientation of the stem and proper mantle cement are visible. Two cerclage wires were used to stabilize the bone window fragment.

Post-operative lateral and ventrodorsal radiographs of the pelvis were assessed for implant positioning and orientation and to ensure the complete filling of the medullary canal by the cement. The positioning of the implant was correct, and the bone fragment cerclage wires appeared stable (**Figure 3**). Radiography was repeated at 8 weeks and at 6 months (**Figure 4**) post-operatively and recommended yearly.

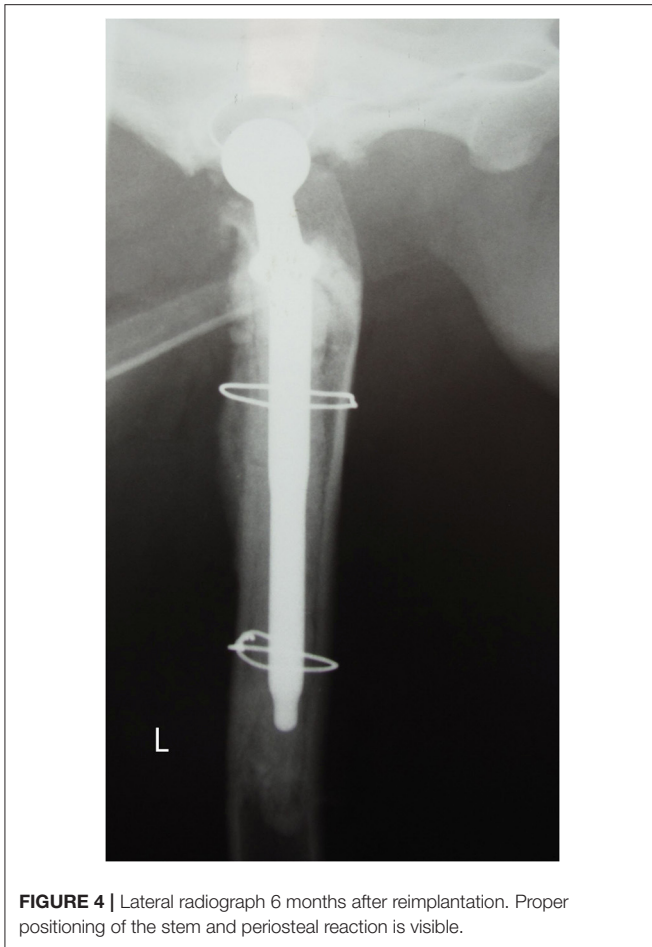
FIGURE 4 | Lateral radiograph 6 months after reimplantation. Proper positioning of the stem and periosteal reaction is visible.
