Original Article

Effects of three surface conditioning techniques on repair bond strength of nanohybrid and nanofilled composites

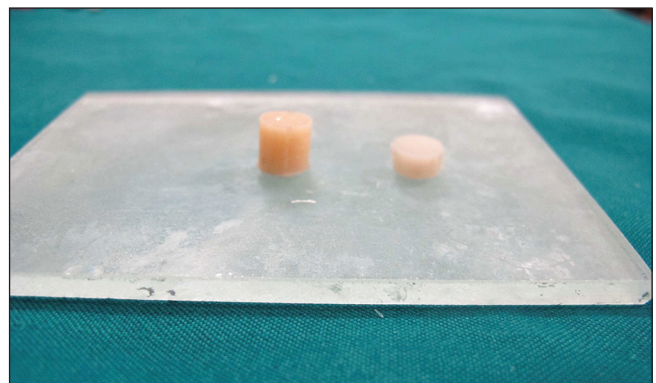
Figure 2: A control composite block (left) versus an experimental one (right).

The control composite blocks were built up in four increments of 2 mm each [Figure 2]. Each layer was light-cured (40 s) vertically from a 1 mm distance. The light-curing unit was calibrated at 600 mW/cm², after curing each composite block. In this group, no transparent matrix strip was used. The 8 mm high control stainless steel templates were later used for repairing the experimental composites as well.

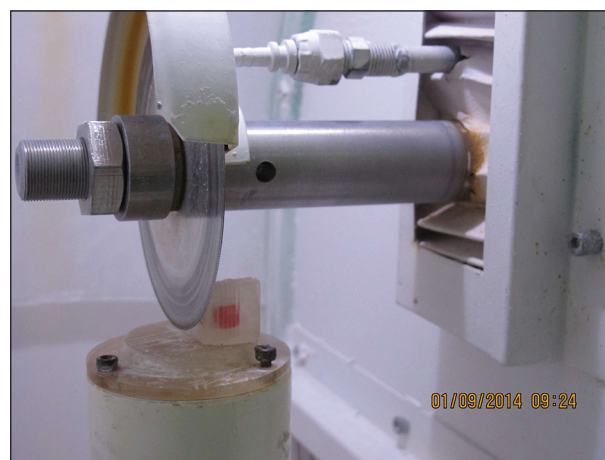
Figure 3: The composite specimen (red) merged in transparent acrylic resin.

Since the composite specimens were small and light, they could not be conveniently cut by a high-speed disk cutter (Nemofanavaran Pars, Mashhad, Iran), as the disk would throw them out instead of preparing them. Therefore, they were first modified temporarily to a heavier and bulkier specimen with squared angles, so that the disk cutter would not throw them out. This was done by adding transparent acrylic resin [Table 1] to the composite: First, a layer of red formaldehyde-free nail polish [Table 1] was applied to all composite surfaces. When the nail polish was dried, the self-curable transparent acrylic resin was poured into a cubic plastic template of 10 mm height, 15 mm width, and 25 mm length. The composite cylinder was placed in the acrylic resin. Once the resin was cured, the block was removed from the plastic template and subjected to cutting machine [Figure 3].^[19-22]
