A Missing Guide Wire After Placement of Peripherally Inserted Central Venous Catheter

Patient: Male, 50
Final Diagnosis: Retained guidewire removal by interventional radiology
Symptoms: Swelling
Medication: —
Clinical Procedure: Fluoroscopic retrieval of the guidewire
Specialty: Critical Care Medicine

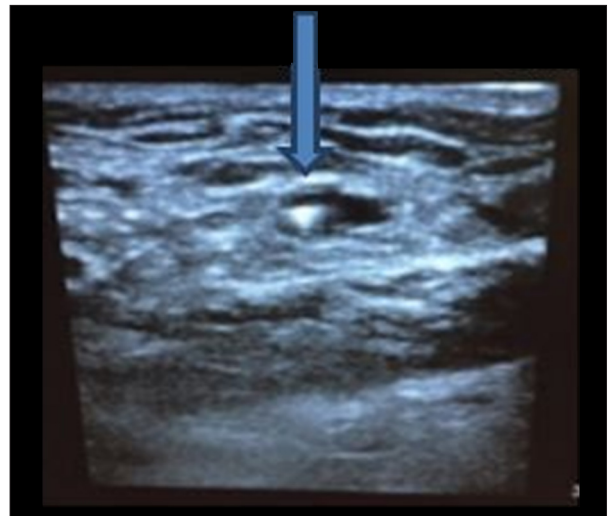
Figure 1. Transverse image depicting guide wire within the lumen of the left basilic vein.

staphylococcal pneumonia and required placement of a peripherally inserted central line in his left upper extremity for antibiotics and vasopressor administration. After resolution of septic shock, the peripherally inserted central line was removed. On day 14 of hospitalization, a routine physical examination revealed left upper extremity swelling that was out of proportion to the rest of the extremities. Immediate bedside ultrasound performed by the intensivist revealed a foreign body in the left arm (Figures 1, 2). It was determined to be the retained guidewire from the previously inserted central line. A chest radiograph confirmed this finding (Figure 3). Interventional radiology was consulted and the guidewire was retrieved under fluoroscopic guidance through a percutaneous procedure that used a snaring coaxial system (Figure 4). The remainder of his hospitalization was uneventful and the

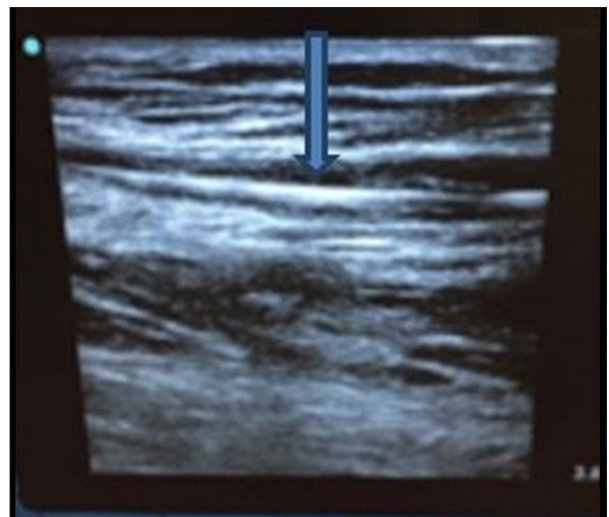
Figure 2. Longitudinal image depicting guide wire within the lumen of the left basilic vein.

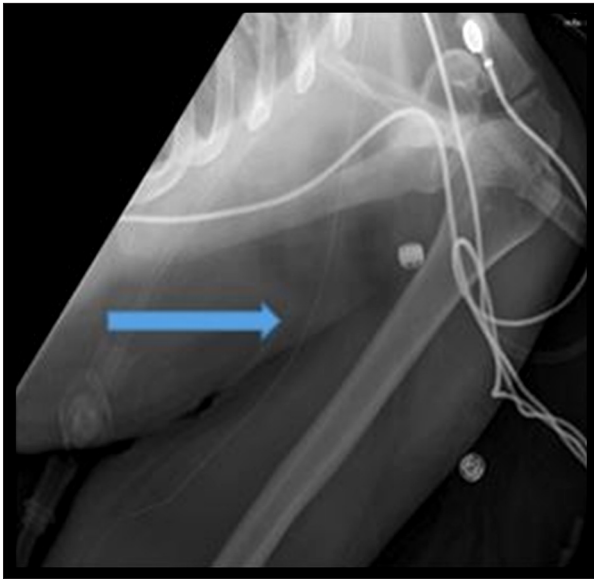
Figure 3. Chest radiograph A/P view showing retained foreign body.

There are often challenges during the initial insertion of the guide wire. If the guide wire cannot be inserted or passed easily without resistance, the procedure should be stopped immediately, and the guide wire and needle should be removed. The distal portion of the guide wire can detach and resemble a pulmonary embolism [8]. The J-tip of the guide wire can become entrapped in a vena cava filter and may cause difficulty in retrieving the guide wire [9]. Breakage of the guide wire has been reported in the literature and is not necessarily due to handling mistakes, but may also be attributed to inherent design flaws or manufacturing errors [10]. The retained guide wire in our case was likely a consequence of a fractured guide wire at the time of initial placement of the PICC.

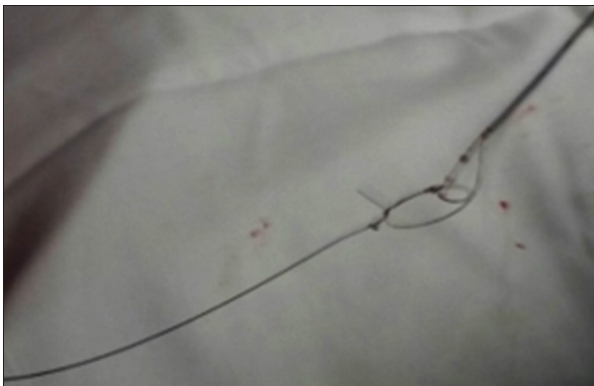
Figure 4. Image of the guide wire after successful retrieval by interventional radiology.

A retained guide wire should be removed as soon as possible to prevent complications like vascular damage, arrhythmias, thrombus, or embolism [15]. Retained guide wires can be removed by interventional radiology with the help of endovascular forceps [16]. Our case is unique as there are few studies that emphasize missing guide wire after PICC line placement. Use of bedside ultrasound helps in early detection of a foreign body, leading to its retrieval.
