# Bridge Crack Inspection Efficiency of an Unmanned Aerial Vehicle System with a Laser Ranging Module

**Abstract:** In this study, an unmanned aerial vehicle (UAV) with a camera and laser ranging module was developed to inspect bridge cracks. Four laser ranging units were installed adjacent to the camera to measure the distance from the camera to the object to calculate the object's projection plane and overcome the limitation of vertical photography. The image processing method was adopted to extract crack information and calculate crack sizes. The developed UAV was used in outdoor bridge crack inspection tests; for images taken at a distance of 2.5 m, we measured the crack length, and the error between the result and the real length was less than 0.8%. The developed UAV has a dual-lens design, where one lens is used for bridge inspections and the other lens is used for flight control. The camera of the developed UAV can be rotated from the horizontal level to the zenith according to user requirements; thus, this UAV achieves high safety and efficiency in bridge inspections.

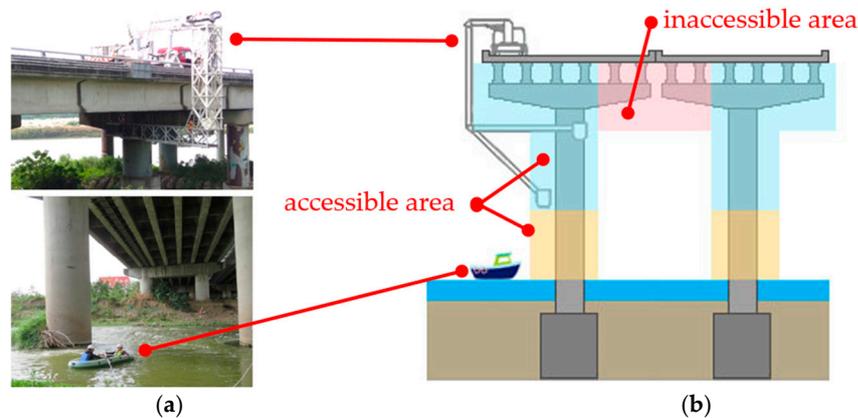
**Figure 1.** Traditional bridge inspection operations. (a) Bridge inspection equipment (b) Bridge inspection area.

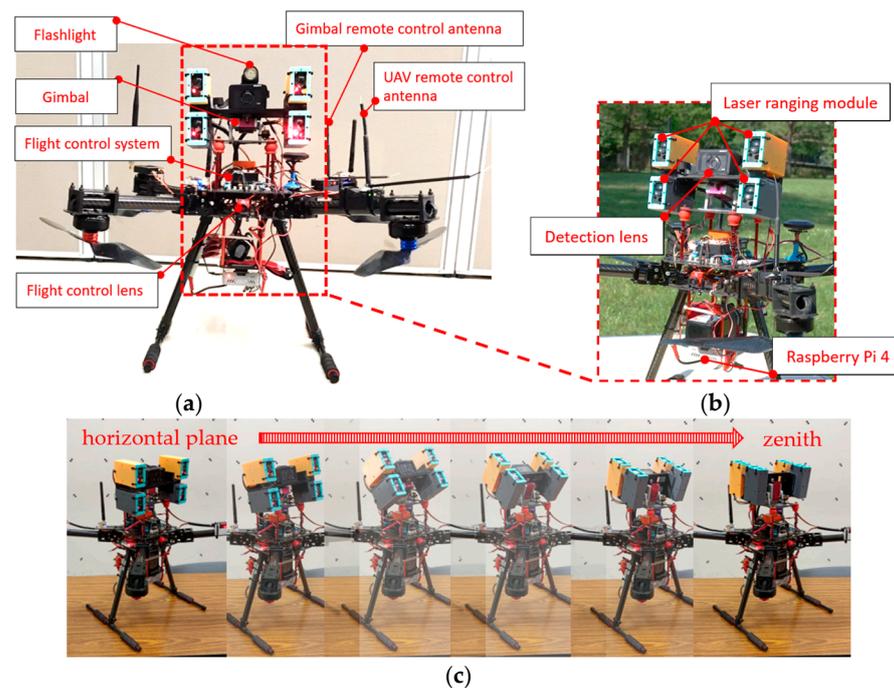
**Figure 2.** Self-assembled unmanned aerial vehicle (UAV) system for bridge inspection: (a) architectural diagram of the UAV; (b) architectural diagram of the inspection lens; (c) inspection camera from horizontal plane rotated to zenith.

In this study, a light UAV with a wheelbase of 63 cm was designed to clearly photograph the deteriorations in various bridge components and make relevant measurements close to the components. To prevent the UAV's propeller from colliding with the main beams at the bottom of bridges and the subsequent crashing of the UAV, the propeller was installed under the main shaft of the UAV, which improves the UAV's safety and convenience of operation under bridges. The developed UAV comprises three basic components: a camera (SONY DSC-RX0), a ranging module (Lidar-100), and an embedded system (i.e., Raspberry Pi 4; Figure 2a). The tripod head installed on the body of the UAV can rotate from  $90^\circ$  (horizontal plane) to  $180^\circ$  (zenith), which enables the UAV to inspect the sides and bottom of bridges. The camera of the UAV has a dual-lens design, where one lens is used for inspections and the other lens is used for UAV control. The inspection lens is placed on the tripod head (Figure 2b,c), whereas the control lens is placed in front of the UAV to enable the UAV to inform users about its dynamic conditions, thereby ensuring flight safety. Pixhawk2 Cube Orange is used as the data transmission and flight control system. It offers a one-button return for launch and route-planning functions, and considerably enhances the operation efficiency of aerial photography. The maximal effect distance at which the UAV digital remote-control equipment can transmit a video can reach 3 km, which makes it suitable for inspecting large or cross-river bridges.

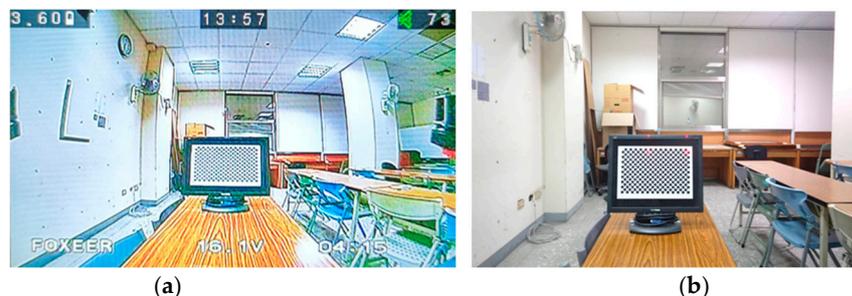
**Figure 3.** Camera's field of view and lens distortion. (a) original UAV camera image (b) inspection camera image.

When we process and calculate the images taken by this camera, low levels of lens distortion, a long focus and high image resolution are the main factors. The UAV camera, which is market-sell or self-assembled, is usually used with a fish-eye lens. This allows us to obtain a wider field of view and more conveniently control the UAV. This could lead to more lens distortion, causing serious deformations in the image (Figure 3a). We chose the inspection camera without a fish-eye lens. The lens distortion is smaller (Figure 3b), and image deformation is low. The lens distortion can be improved by some camera methods, but the effect will decline according to the severity level of the lens distortion. In addition, in order to quickly transport real-time images to the ground station, the image resolution

obtained with an original UAV camera is small. Taking our system as an example, there are specifications for original and inspection cameras (Table 1). With a photo-shooting distance of 2 m, the pixel size of projections on the object plane is 6.192 mm with an original UAV camera, but 0.582 mm with an inspection camera. This means that the spatial resolution accuracy is improved by about 10%.

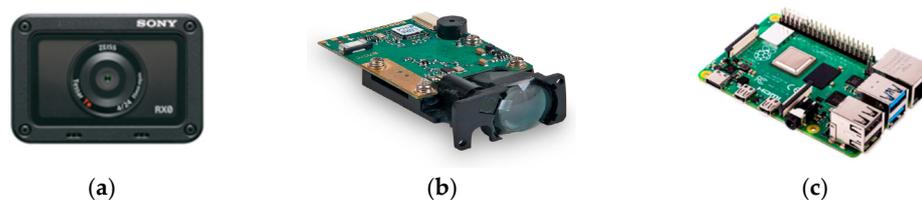
**Figure 4.** Hardware used in the integrated design [24–26]. (a) Camera (b) Laser ranging module (c) Raspberry Pi 4.

As shown in Figure 4a–c, small laser ranging modules (with a self-designed outer casing manufactured through three-dimensional (3D) printing) are installed at the upper left, lower left, upper right, and lower right corners of the camera to determine the relative position and attitude of the camera when capturing bridge photographs. Raspberry Pi 4 is used to collect and control camera and laser ranging modules. For integration, we used some mechanical constructions, as displayed in Figure 5.

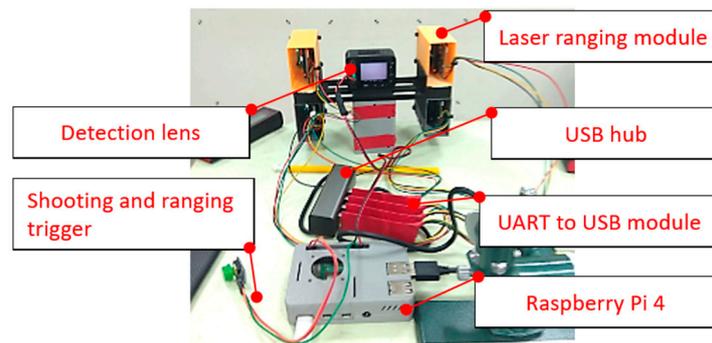
**Figure 5.** Architecture of the camera and laser ranging modules.

When using UAV photos to measure crack information, it is crucial to ensure that the photo-shooting and ranging processes are temporally synchronized. To synchronize the operation times of the camera and laser ranging modules, Raspberry Pi 4 was used as the control system, and buses such as GPIO, UART, I2C, and SPI were used as the Raspberry Pi 4 pinouts. The system employed in this study mainly used a GPIO as its pinout to receive the data transmitted by the laser ranging modules through a UART. The laser ranging modules transmit data to a USB module through the UART, which transmits the data to Raspberry Pi 4 by connecting four transfer modules to the USB hub.

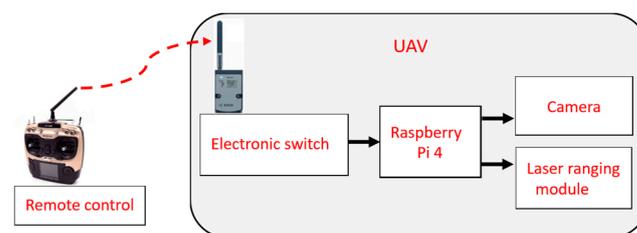
**Figure 6.** System control signal procedure.

The operation process of the system is as follows: Raspberry Pi 4 automatically executes the system program when it is turned on. Subsequently, the rangefinders and camera are turned on. The UAV remote control is used to connect to the electronic switches through the radio to drive Raspberry Pi 4, then simultaneously captures photos and makes ranging measurements. Once the UAV remote control transmits a command, Raspberry Pi 4 will execute an action, so that the writing frequency can be adjusted according to requirements during bridge inspection. When the image is received, the ranging value and time are recorded in the text file (\*.txt) to calculate the projection plane (Figure 6).

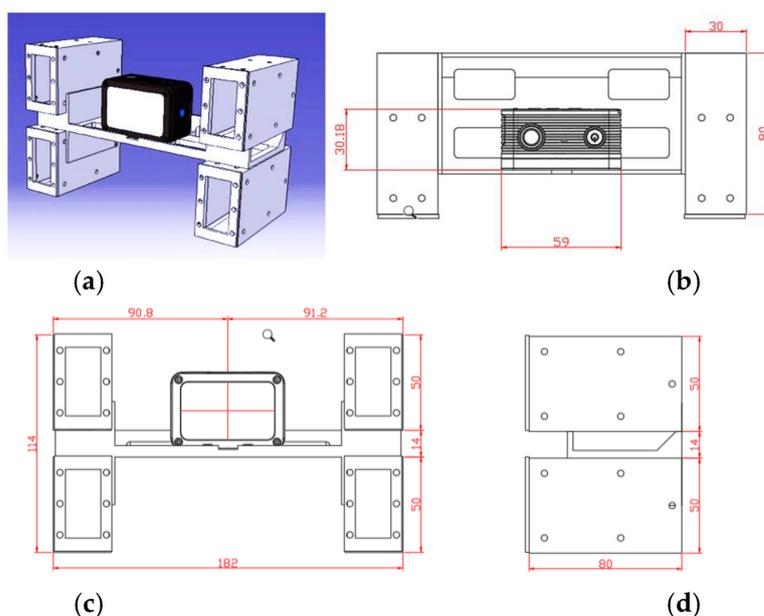
**Figure 7.** Structural dimensions of the camera and laser ranging modules: (a) three-dimensional image; (b) top view; (c) front view; (d) left view.

The integrated structure was designed after considering the shapes of the camera and laser ranging modules and ensuring that they could easily be installed on the UAV tripod head. The structure was manufactured through 3D printing (Figure 7).

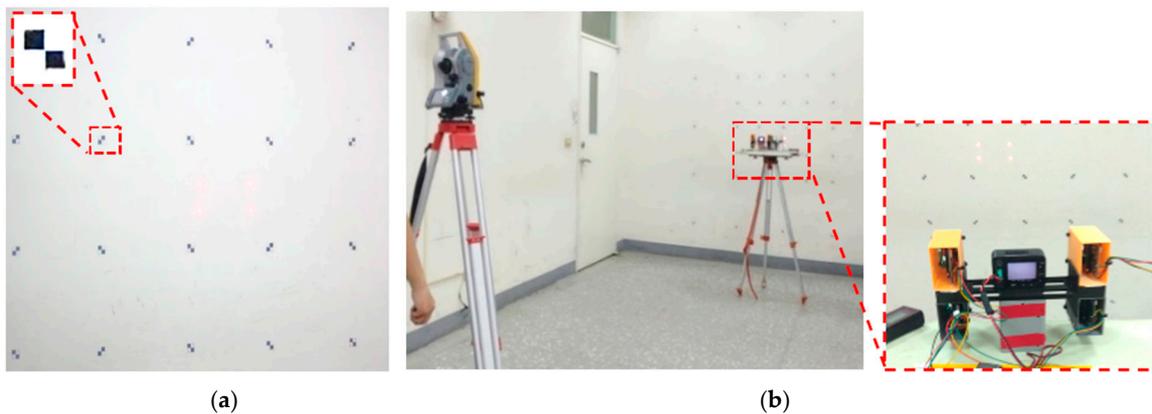
**Figure 8.** Calibrations for the control points, camera, and laser ranging modules. (a) Control points (b) Measurements made using the total station.

The spatial relationships between the laser beam vectors of the ranging modules and the camera focus have crucial effects on the measurement methods for the developed system. Therefore, a calibration procedure was designed to investigate the aforementioned spatial relationships. The steps in this procedure were as follows:

- (1) The positions of the ranging modules were adjusted so that the four laser beams were nearly parallel to each other. Subsequently, the measurement accuracy was increased by measuring the laser beam vectors after calibration.
- (2) As the spatial relationships between the laser beam vectors and the camera focus could not be directly measured, control points were marked on the wall of a research room, and relative spatial coordinates were measured using a total station. The room served as the system calibration site. Photos containing laser light spots and control points were captured from different distances (Figure 8a), and photogrammetry was used to calculate the spatial relationships between the laser beam vectors and the laser light spots, as well as those between the laser beam vectors and the control

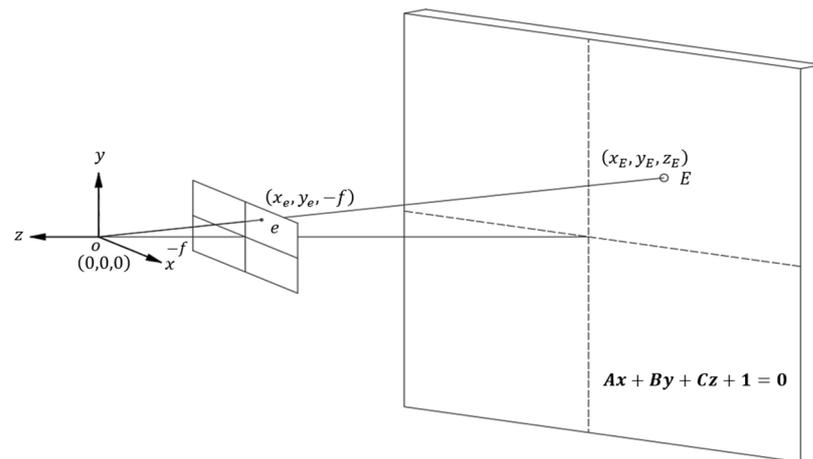
**Figure 9.** Spatial relationships between the photo projection vector and projection plane.

After calibrating the camera and laser ranging modules, photo coordinate systems were constructed with the focal points as origins. The laser ranging modules provided the spatial plane equations of the captured target surfaces, which could be used to calculate the spatial coordinates of object points ( $E$ ) in subsequent measurements when combined with the plane equations and projection vectors of image points ( $e$ ) (Figure 9).

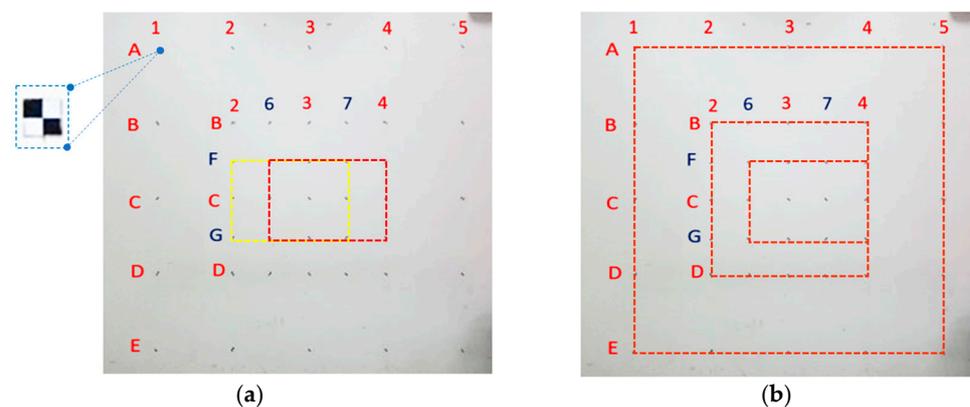
**Figure 10.** Control point distribution. (a) The same dimensions of the rectangular box (b) Different dimensions of the rectangular box.

Control points were marked on an indoor wall (Figure 10) to determine the measurement accuracy of the camera and laser ranging modules after calibrations. The horizontal from 1 to 7 and vertical from A to G mark the location of the control points. The location description rule is A1, A2, A3, A4, A5, and the other five points in the horizontal direction of A. The horizontal direction of B has seven points: B1, B2, B6, B3, B7, B4, B5, etc. There are 41 control points in total. The coordinates of the 41 points are measured by total station (measurement accuracy of  $\pm 1$  mm; this also means that the credibility of the value in Tables 3 and 4 is 1 mm) and used as the true value when analyzing the accuracy of the image projection measurements of this system. The results of the related experimental test and data analysis are as follows.

By maintaining constant dimensions of the four sides of a rectangular box (i.e., 0.50 m × 0.75 m, Figure 10a) and increasing the photo-shooting distance from 1 to 3 m in 1-m increments, this study found that the higher the photo-shooting distance, the higher the measurement error (error is projection measurement value minus true value). At a distance of 3 m, the maximum and relative errors were 6 mm and 0.8%, respectively (Table 3).

By maintaining a constant distance (i.e., 3 m) and increasing the dimensions of the rectangular box (i.e., from 0.50 m × 0.75 m to 1.0 m × 1.0 m and 2.0 m × 2.0 m, Figure 10b), this study found that the larger the rectangular box, the higher the measurement errors. With dimensions of 1.0 m × 1.0 m, the maximum and relative errors were 7 mm and 0.7%, respectively. Moreover, with dimensions of 2.0 m × 2.0 m, the maximum and relative errors were 19 mm and 1.0%, respectively (Table 4).

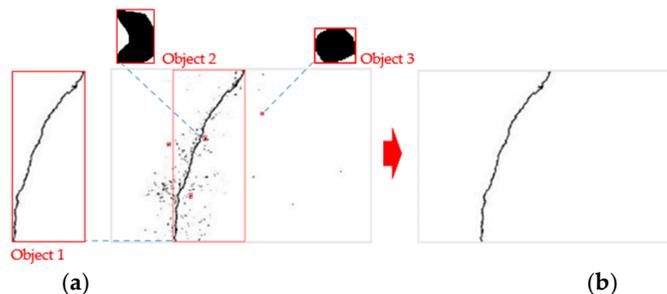
Figure 11. Illustration of noise removal. (a) Object's rectangle frame (b) Result.

binary images of cracks according to the recommendations of Kim et al. [21]. After the binary images were produced, due to stains or potholes in the concrete surface, in addition to the linear objects (cracks), there were also dot-like and plane-like objects in the image (the stains or potholes are regarded as noise). A rectangular frame was drawn for each object in the image according to the maximum range of the shape and the length–width ratio of the rectangle and density of the object in the rectangle were calculated. The “trial-and-error method” was used to determine the threshold of the two to remove the dot-like and plane-like noise in the image (Figure 11). The main crack skeleton and crack outline were calculated with the Zhang–Suen skeletonization algorithm and the erosion algorithm in morphology. Then, we could confirm the crack location in the image (Figure 12).

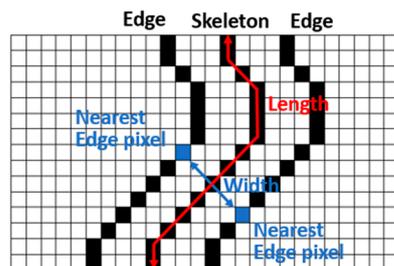
Figure 12. Illustration of crack width and length calculations [23].

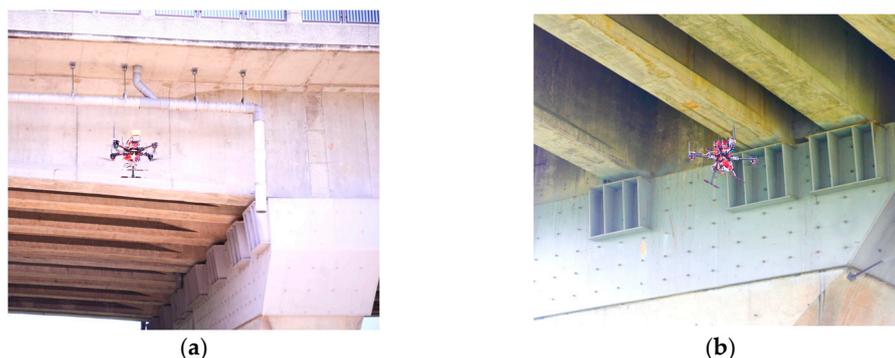
**Figure 14.** Bridge inspections performed by the self-assembled UAV: (a) operation on the side of the Wuling Bridge; (b) operation at the bottom of the Wuling Bridge.

Outdoor bridge inspections were performed at Wuling Bridge, which is a highway bridge that runs across a river in Taoyuan, Taiwan. The developed UAV, which contains a camera and laser ranging modules, has a double-lens design. The control lens of the UAV is a fisheye lens that creates wide views to control the flight of the UAV. By contrast, the ranging camera, which was developed in this study and can be controlled by a user, is used to perform bridge structure inspections. To monitor the UAV flight situations in real time, a wireless numerical transmission system is used to send flight information to a ground monitoring station. The flight information is monitored at all times to ensure flight safety. The self-assembled UAV is equipped with a photo-shooting and ranging system to capture photos of bridge cracks and damages. The bridge inspection camera installed on the tripod head can rotate vertically and horizontally, enabling the UAV to complete all inspections of the sides and bottom of bridges in a single attempt, which results in a high bridge inspection efficiency. The outdoor bridge inspection operations of the developed UAV are illustrated in Figure 14a,b.

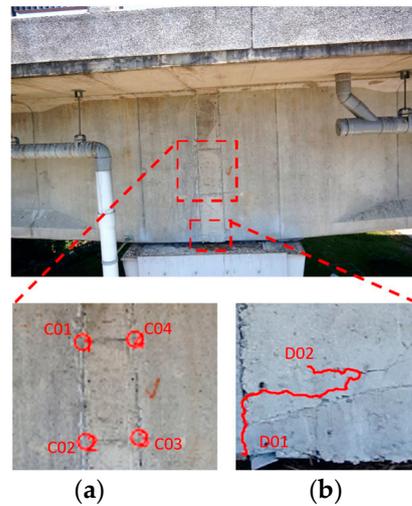
**Figure 15.** Damage on the side of the main beam at the test site: (a) connected concrete cracks; (b) unconnected concrete cracks.

According to the captured images of the Wuling Bridge (file name: DSC00123), it contained two areas of severe damage on the side of the main beam (Figure 15). The photo-shooting times for the top left, bottom left, bottom right, and top right rangefinder data were 4.694, 4.659, 4.637, and 4.676 m, respectively. The captured images were used to detect cracks, after which aspect ratios were used to convert the data into crack lengths and widths. As cracks have lower grayscale values than their backgrounds and are distorted,

Ranging data were used to project the calculated images onto actual object planes to enable the measurement of crack dimensions. Table 5 presents the measured data. The connected concrete cracks had a length and width of approximately 0.738 m and 0.355 m, respectively, whereas the unconnected concrete cracks had a length and width of approximately 0.412 m and 3.9 mm, respectively. To analyze the measurement accuracy, comparisons were conducted between the left- and right-side lengths and between the bottom- and top-side lengths of the connected concrete cracks. The corresponding errors were 11 and  $-23$  mm, respectively, and the corresponding relative errors were 1.5% and 6.1%, respectively. The errors increased considerably because the photo-shooting distance was 4.6 m (Table 6).

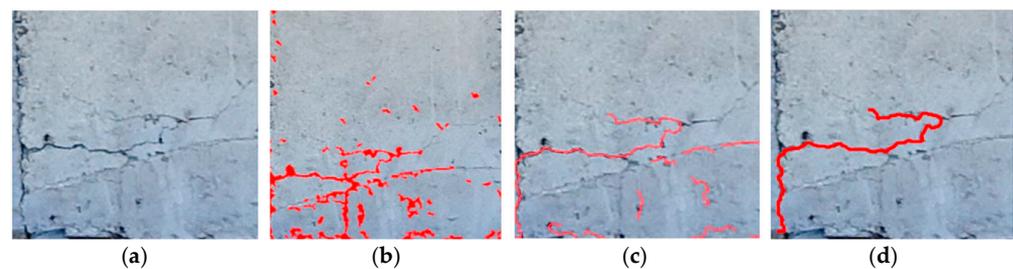
**Figure 16.** Crack identification: (a) original image; (b) binary image; (c) image obtained after noise removal and skeletonization; (d) main cracks.

shape and grayscale value were used to set crack identification rules and remove non-crack regions. The crack identification results are shown in Figure 16.

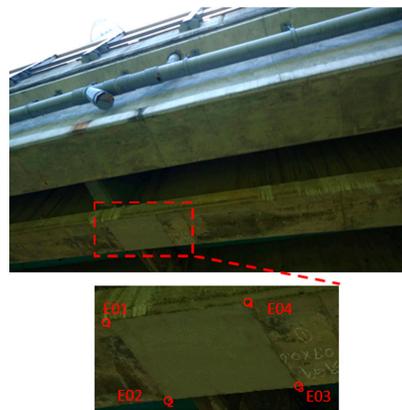
**Figure 17.** Damage at the bottom of the main beam at the test site: Refilled concrete.

According to the images captured of the Wuling Bridge, the bridge (file name: DSC00358) contained two areas of severe damage at the bottom of the main beam (Figure 17). The photo-shooting times for the top left, bottom left, bottom right, and top right rangefinder data were 2.930, 2.969, 2.927, and 2.888 m, respectively.

Ranging data were used to project the images onto actual target planes to allow the measurement of the dimensions of the cracks. Table 7 presents the measured data that were calculated for Case 2. The part of the bridge with refilled concrete had a length and width of 0.638 m  $\times$  0.910 m. To analyze measurement accuracy, comparisons were conducted between the left- and right-side lengths and between the bottom- and top-side lengths of the refilled concrete. The corresponding errors were 19 and 17 mm, respectively, and the corresponding relative errors were 3.0% and 1.8%, respectively. The errors became smaller because the photo-shooting distance was shortened to 2.9 m (Table 8).

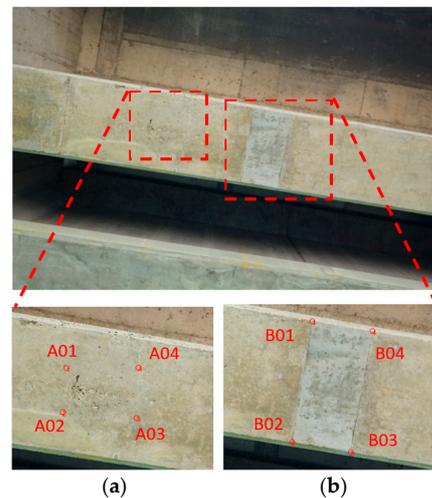
**Figure 18.** Damage at the bottom of the main beam at the test site: (a) incomplete concrete grouting (hive phenomenon); (b) refilled concrete.

According to the images of the Wuling Bridge, the bridge (file name: DSC00451) contained two areas of severe damage at the bottom of the main beam (Figure 18). The photo-shooting times for the top left, bottom left, bottom right, and top right rangefinder data were 2.506, 2.515, 2.515, and 2.508 m, respectively.

Ranging data were used to project the images onto actual target planes to allow for measurement of the crack dimensions. Table 9 presents the measured data that were calculated for Case 2. The part of the bridge with an incomplete concrete grouting had a length and width of approximately 0.23 and 0.383 m, respectively, whereas the part of the bridge with refilled concrete had a length and width of 0.638 m  $\times$  0.319 m, respectively. To analyze measurement accuracy, comparisons were conducted between the left- and right-side lengths and between the bottom- and top-side lengths of the refilled concrete. The corresponding errors were  $-5$  and  $0$  mm, respectively, and the corresponding relative errors were 0.8% and 0.0%, respectively. The errors were less than 5 mm because the photo-shooting distance was 2.5 m (Table 10).
