Case report

Canted seating of the Stryker Modular Dual Mobility liner within a Trident hemispherical acetabular shell

Scott M. Eskildsen, MD, Erik C. Olsson, MD, Daniel J. Del Gaizo, MD *

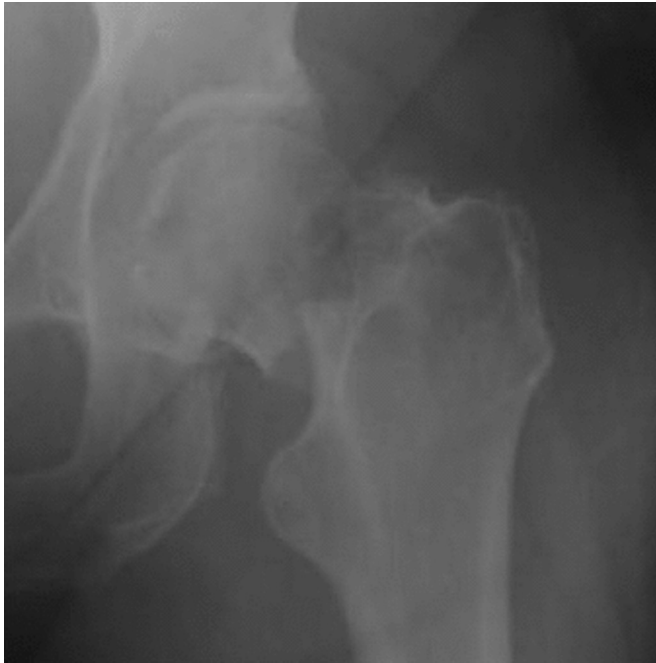
Figure 1. Radiograph of a 75 year-old woman with a displaced femoral neck fracture.

mechanical fall while walking up her driveway. She presented to the Emergency Department at our institution where radiographs demonstrated a displaced left femoral neck fracture (Fig. 1). Prior to this fall, she was ambulatory without the use of an assistive device. She lived self-sufficiently only with her husband and was relatively healthy. Given the patient's activity level and displacement of the fracture, total hip arthroplasty was warranted.

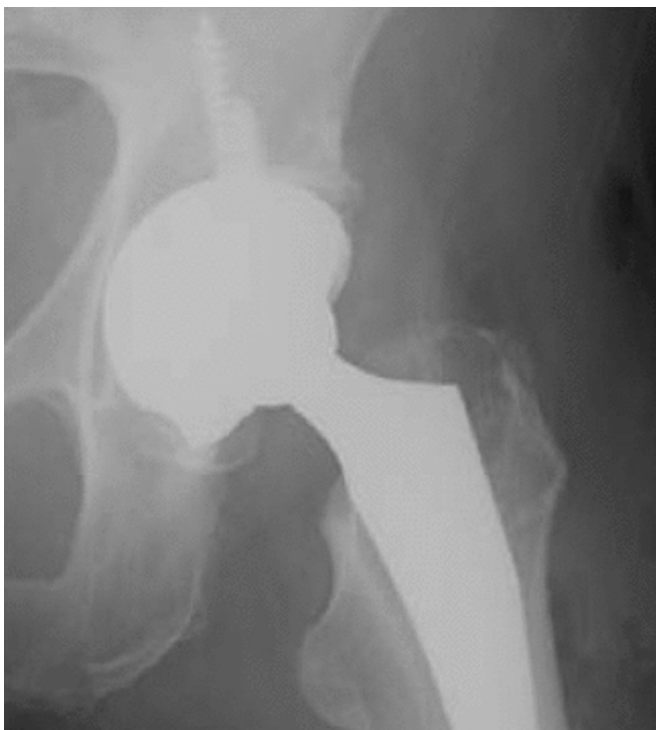
It is our practice to obtain immediate post-op films. Upon review of these films it was noted that the inferior portion of the liner was not completely seated (Fig. 2). Given that the patient's spinal epidural was still in place, we discussed the need to return to the operating room to address the liner. We opened our initial incision and noted upon close inspection that, while the superior liner appeared well seated, the inferior portion was incompletely seated in a canted position. We removed the liner and found no

Figure 2. Postoperative portable AP x-ray of the left hip demonstrating incomplete seating of the MDM liner.

gross abnormalities of the acetabular shell or liner. The liner was again impacted into a clean shell with no interposed tissue and seated appropriately both superior and inferior. Intra-operative radiographs confirmed that this was the case. The patient's post-operative rehabilitation went according to plan and she was discharged from the hospital on post-operative day two. At 6 months follow up the patient is doing well clinically, without pain, and ambulating without the use of an assistive device. Radiographs

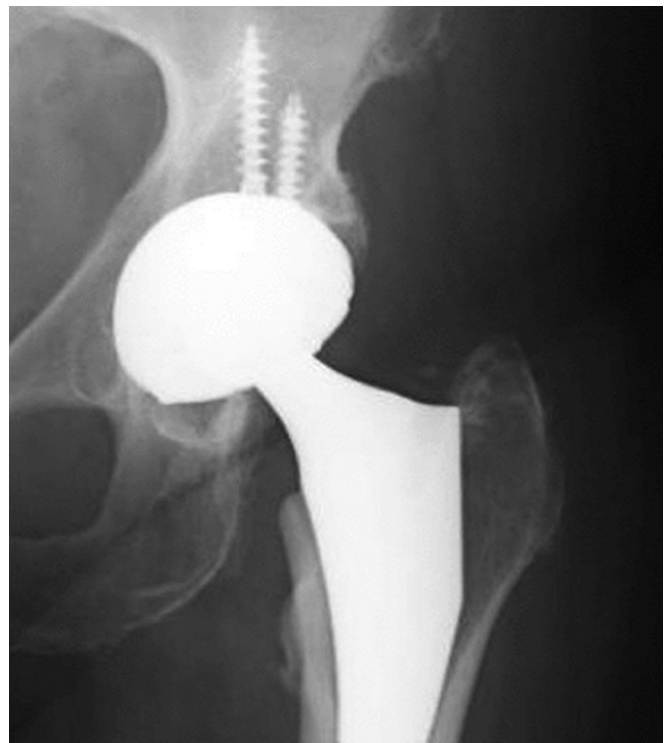
continue to show symmetric seating of the liner without signs of migration (*Fig. 3*).

Figure 3. Anteroposterior radiograph of the left hip at six months after revision left hip Arthroplasty with MDM liner and no further complications.
