Case report

Pacemaker system replacement under local anesthesia allowing MRI access 7 years after the initial surgery: Two case reports

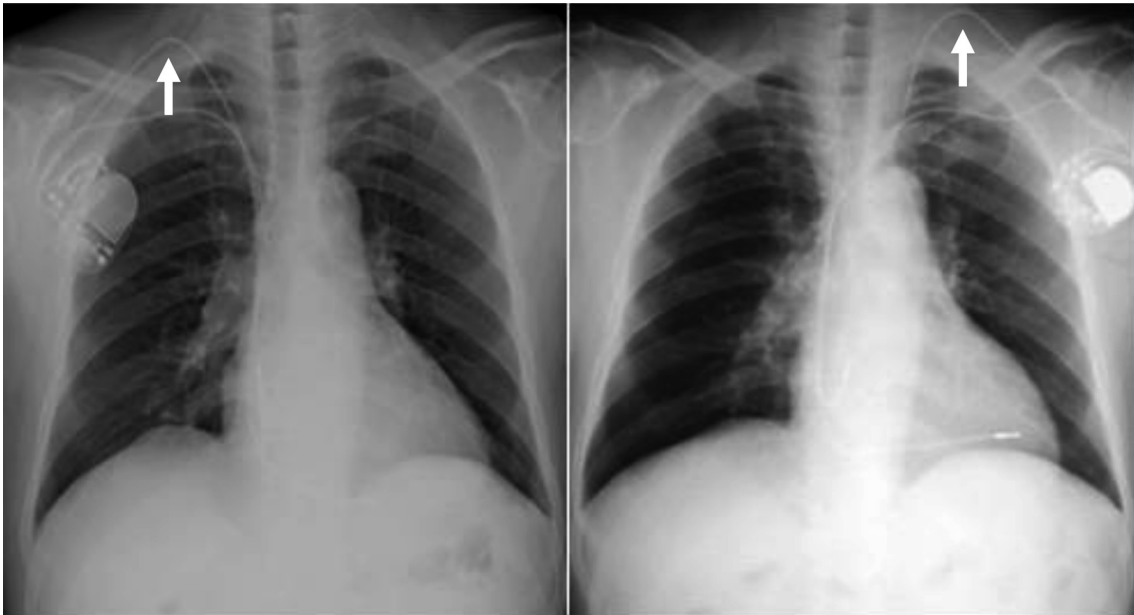
Figure 1 Chest plain radiograph before (right panel) and after (left panel) replacement of the pacemaker system. The cephalic vein and external jugular vein (white arrow) were used, respectively, for access to the ventricular and atrial leads using a cut-down technique.

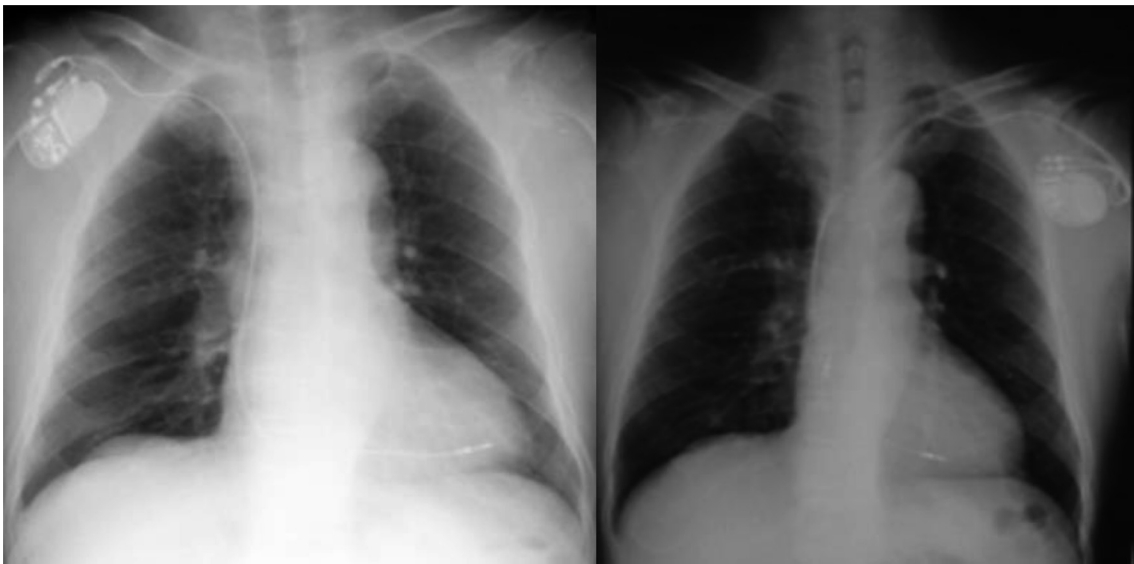
Figure 2 Chest plain radiograph before (right panel) and after (left panel) pacemaker system replacement. Only a ventricular lead was inserted through the right cephalic vein because of the VVI pacing mode.

cm) for atrial fibrillation. The replacement procedure took 75 minutes to complete, and the patient went home the same day. His postoperative chest X-ray results appeared satisfactory (Figure 2), and he undergoes regular follow-up MRIs for his spinal canal stenosis.
