# Effect of Functional Fillers on Tribological Characteristics of Acrylonitrile Butadiene Rubber after High-Pressure Hydrogen Exposures

**Citation:** Choi, B.-L.; Jung, J.K.; Baek, U.B.; Choi, B.-H. Effect of Functional Fillers on Tribological Characteristics of Acrylonitrile Butadiene Rubber after High-Pressure Hydrogen Exposures. *Polymers* **2022**, *14*, 861. <https://doi.org/10.3390/polym14050861>

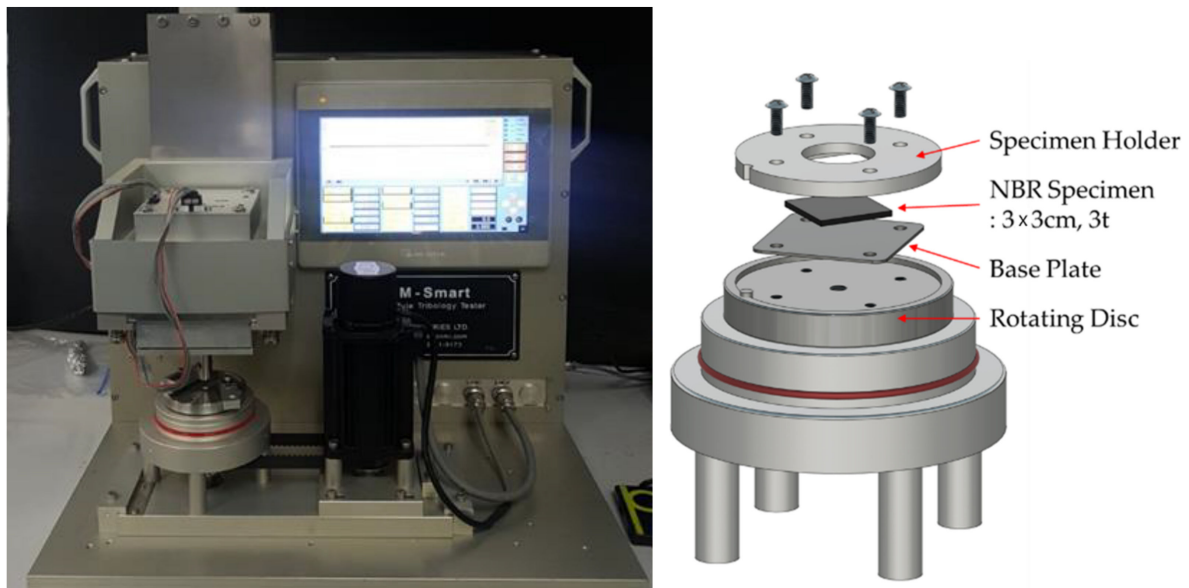
**Figure 1.** Schematics of the pin-on-disc wear apparatus.

A wear test was performed, using a custom-made pin-on-disc tester (Figure 1) with reference to the ASTM G99 standard. The ASTM G99 standard is based on metallic materials. Therefore, the preparation and testing conditions of the specimens were changed for NBR materials. In this study, through the wear test, the wear loss and morphology of the wear tracks were measured before and after the exposure to high-pressure hydrogen for 24 h. Each test was repeated three times for each test condition. The wear loss was calculated as the difference in the specimen weights before and after the wear test. Before weighing the specimen with an electronic balance, the specimens were stored in a desiccator for more than 24 h. They were then measured. In the case of the specimens exposed to high-pressure hydrogen, the final weight was determined one week after decompression. The weight of the specimen was obtained five times, and the average value was used. We compared the wear characteristics and wear resistance of seven types of NBR with the amount of wear loss, friction force, and coefficient of friction derived from the wear test.

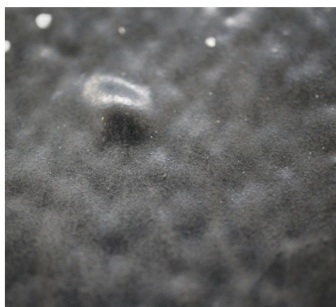
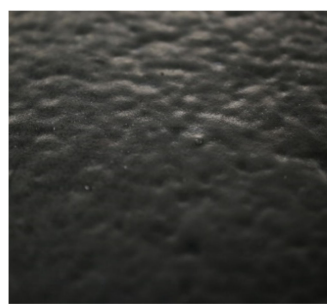
(a) Change in density of NBR at 1 h after decompression

(b) Severe blisters occurring in non-filled NBR

(c) Swelling and whitening of silica-filled NBR after decompression

(d) Small blister observed on the surface of CB-20 after decompression

(e) Bumpy and wobbly surface of CB-40 after decompression

(f) Blister observed on the surface of CB-60 NBR after decompression

**Figure 3.** Summary of density changes and blister formation of NBR after hydrogen exposure.

The mass of a specimen before and after hydrogen exposure is measured by employing the electronic balance with the resolution of  $10\ \mu\text{g}$  under the environments in which both temperature and humidity are well maintained. The volume before and after hydrogen exposure is measured by the calibrated micrometer under the same environments. Thus, the density is determined by dividing the mass by the volume of specimen. The measured value after hydrogen exposure was taken as the measured one at one hour after decompression started. The density of NBR increased with the filler content, and the density of the carbon-black-filled NBR was slightly higher than that of the silica-filled NBR. After decompression, the NBR began to swell because the dissolved hydrogen molecules aggregate to form small bubbles inside the specimen [29]. Therefore, the density of NBR decreased, depending on the filler content and type (Figure 3a). In some cases of non-filled NBR, severe blisters occurred, as shown in Figure 3b. There was swelling and whitening in the silica-filled NBR, although blisters were not observed on the surface. On the other hand, blisters and surface deformations were observed on the surface of carbon-black-filled NBRs. Because of the small blisters inside the specimen, the flat surface of the unexposed specimen became bumpy and wobbly (Figure 3).

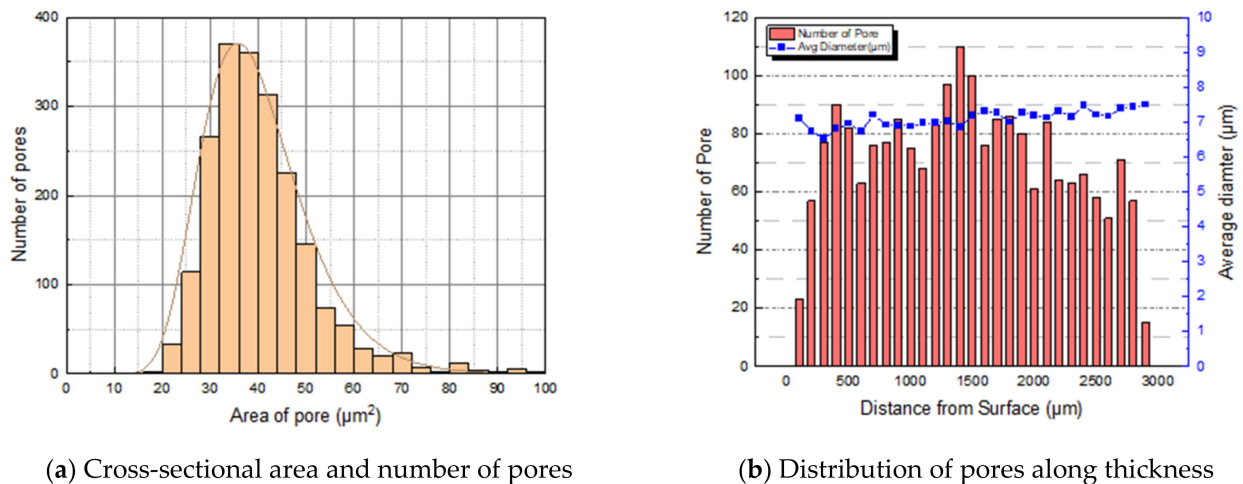
**Figure 5.** Formation and distribution of pores of non-filled NBR specimen.

To quantify the pores found above, the distribution of pores in the area, including the specimen thickness, was measured. Approximately 2080 pores were found in the cross-sectional area of  $6.77 \text{ mm}^2$ . The cross-sectional area between  $30$  and  $40 \mu\text{m}^2$  included a large portion, as shown in Figure 5a. The pores were counted within a section divided by  $100 \mu\text{m}$  along the thickness of the specimen. The pores were distributed predominantly in the middle of the specimen thickness. As shown in Figure 5b, the average diameter of the pores was calculated from the pores located in the same section. The cross section of NBR containing carbon black and silica was also quantitatively analyzed for hydrogen-induced damage in the same manner.

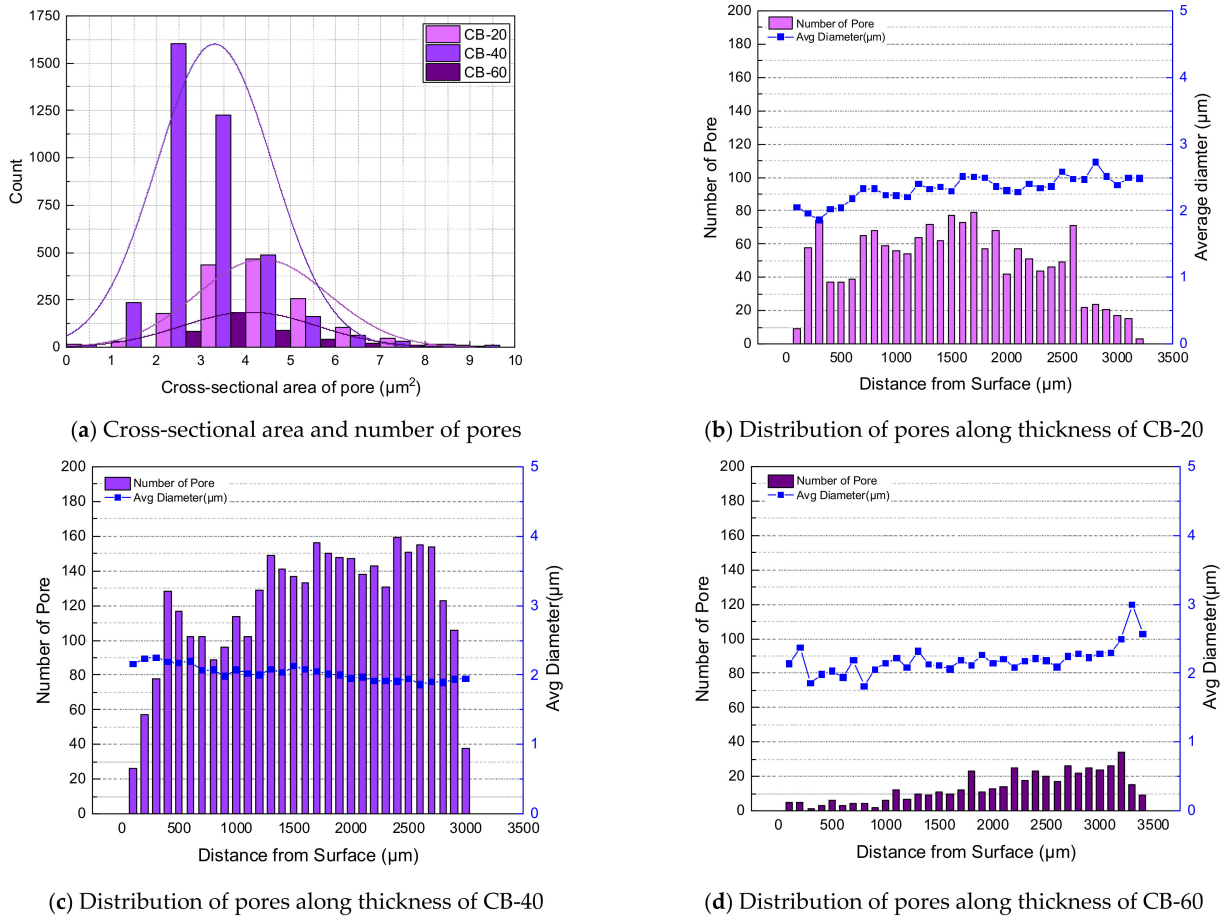
**Figure 7.** Formation and distribution of pores of carbon-black-filled NBR.

The number, cross-sectional area, and distribution of pores per unit area were measured based on the thickness direction of the carbon-black-filled specimen, as shown in Figure 6. In the CB-filled NBR, pores of similar sizes were formed regardless of the filler content. There were approximately 330 pores per  $1 \text{ mm}^2$  in CB-20, 546 pores in CB-40, and 62 pores in CB-60. The areas of pores per  $1 \text{ mm}^2$  were  $0.0014$ ,  $0.0018$ , and  $0.0002 \text{ mm}$ , and less than  $0.2\%$  of the total area was empty as pores. From the CB content of 20 to 40 phr, the number of pores per unit area slightly increased; however, the number decreased significantly at 60 phr. The average diameters of the pores were measured to be  $2.33$ ,  $2.03$  and  $2.19 \mu\text{m}$ , respectively. The carbon black content had a minimal effect on the size of the pores, and the reinforcing effect of carbon black by their content seemed to suppress pore formation. In Figure 7, the distributions of observed pores of carbon-black-filled NBR are summarized.

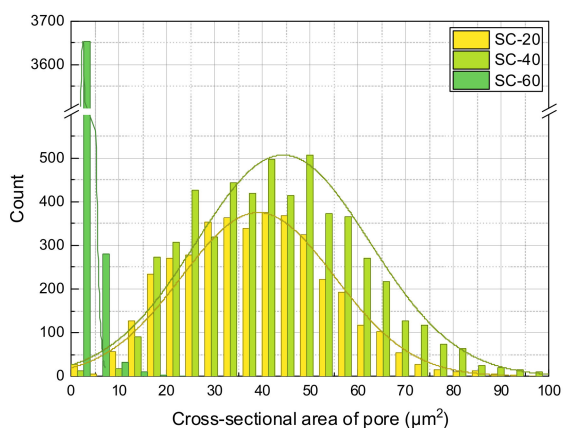
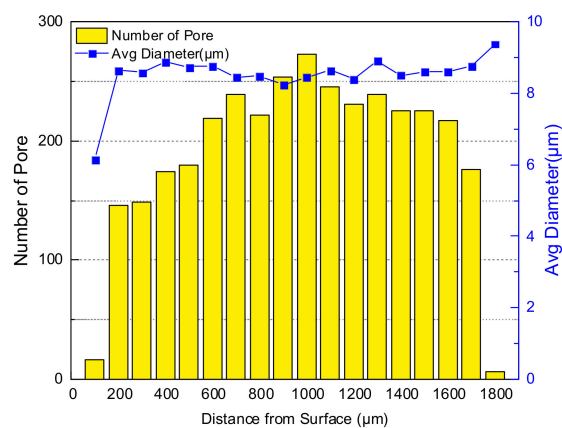
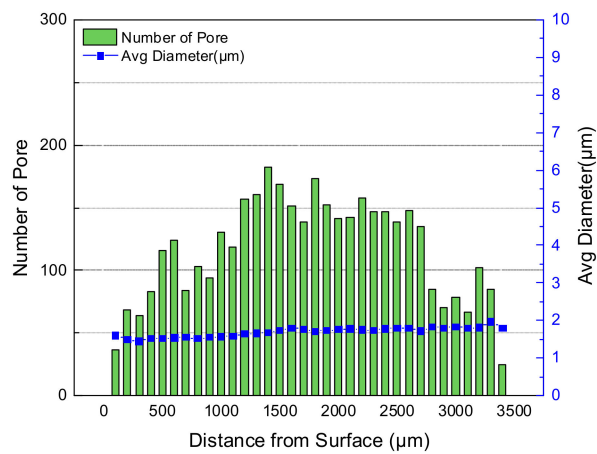
(a) Cross-sectional area and number of pores

(b) Distribution of pores along thickness of SC-20

(c) Distribution of pores along thickness of CB-40

(d) Distribution of pores along thickness of CB-60

**Figure 9.** Formation and distribution of pores of silica-filled NBR.

The number, cross-sectional area, and distribution of pores per unit area were measured based on the thickness direction of the silica-filled specimen, as shown in Figure 8. From SC-20 to 60, there were approximately 288, 414, and 745 pores per 1 mm<sup>2</sup>, respectively. The area of pores per 1 mm<sup>2</sup> was 0.0163 mm<sup>2</sup> in SC-20, 0.0132 mm<sup>2</sup> in SC-40, and 0.0017 mm<sup>2</sup> in SC-60; less than 0.2% of the total area comprised pores. The average diameters of the pores were measured to be 8.5, 6.37 and 1.69 μm, respectively. As the silica content increased, the size of the pores decreased, and the number of pores increased. Silica is considered to be the cause of pore formation; nonetheless, a large amount of silica inhibited the pore size from growing, owing to the reinforcing effect of silica. In Figure 9, the distributions of observed pores of silica-filled NBR are summarized.
